The Case for the 'Do Nothing' Solution for two Heritage-Listed Brick Lined Tunnels Impacted by Motorway Construction Above

Noble¹, Kingsland²

ABSTRACT

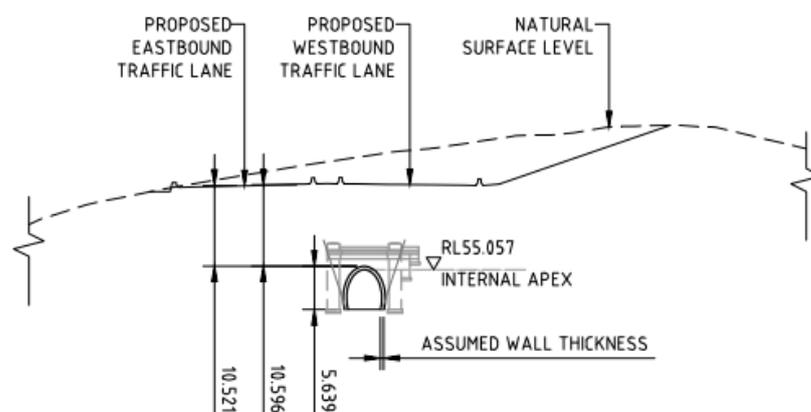
The tunnel and relative position of Cut 8 above it is shown in Figure 2.

Between Chainages 2350m and 2450m along the alignment, the Expressway passes directly over the eastern end of Tunnel 134. This section of the Expressway is in cut, known as 'Cut 8'. The existing ground elevation is approximately 15m above the top of the tunnel and upon completion the deepest part of Cut 8 is 10m above the top of the tunnel. Figure 1 shows the Tunnel 134; a steep approach cutting leading to the southern portal.

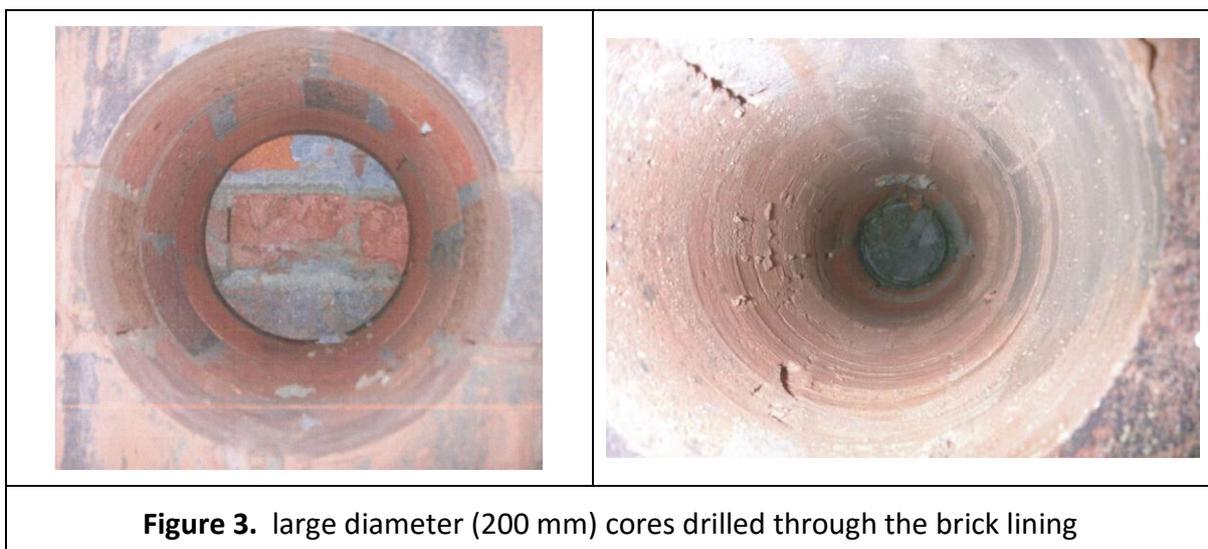
Figure 3. large diameter (200 mm) cores drilled through the brick lining

Four of the drilled holes were 100mm in diameter, whilst two of the drilled holes were 200mm in diameter, all drilled using a diamond coring sleeve.

The lining was found to comprise four brick courses at the locations of the 100mm diameter drill holes, corresponding to an overall thickness of 455mm. For the two 200mm holes, the diamond drill sleeve was of a shorter length and therefore only around 400mm of intact core was retrieved and the final section of lining was left in place. Consequently, the likely void behind the lining in these locations could not be observed. However, the 200mm cores did reach a fourth brick course and so an overall thickness of 455mm was assumed. From testing the lining thickness is believed to be uniform around the full lining profile and over the complete tunnel length. This is the same configuration as observed at the portal entrances to the tunnel.

All cores were shown to be relatively well mortared across radial and circumferential joints. Small voids were present in some mortar beds, but the overall degree of 'completeness' of mortaring was subjectively estimated at >90%.

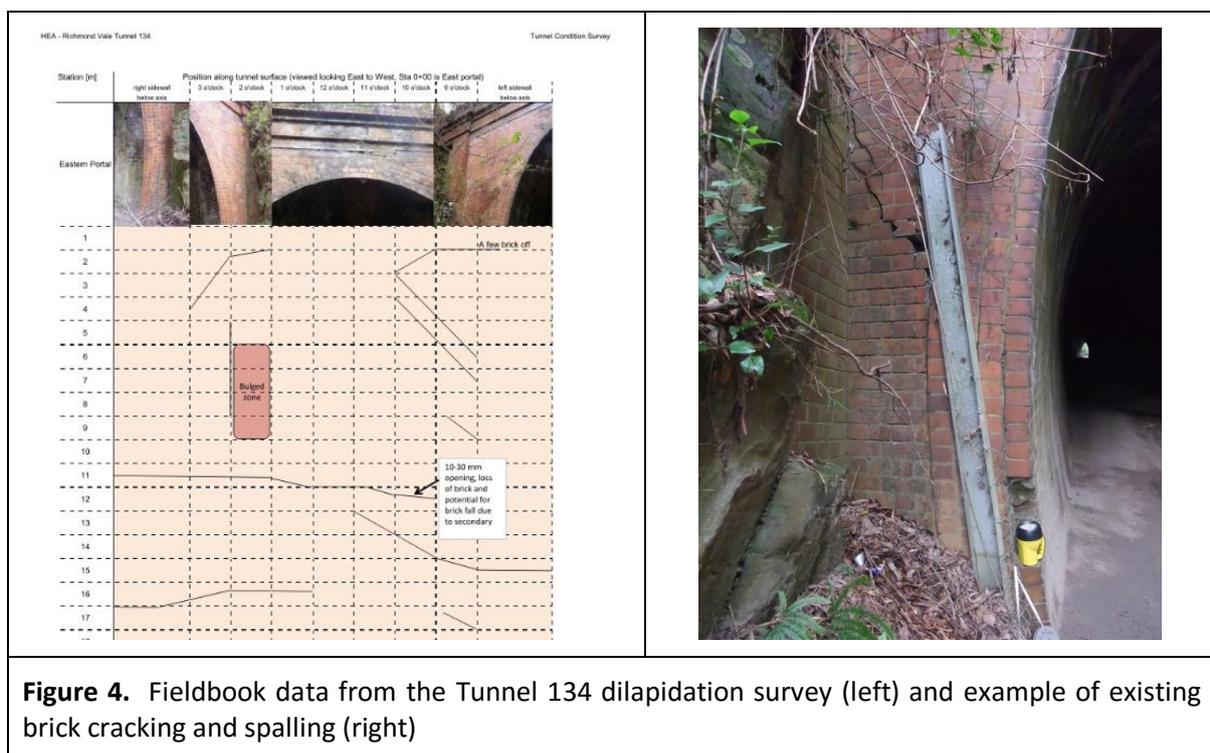
In general, the tunnels appeared to be in a good to fair condition, commensurate with their age. The mortar was in a good condition and almost entirely intact. The intrados of the brick liners in several areas suffered from minor and major cracks which were considered to be most likely as a result of settlement of the tunnel structure. No noticeable severe damage or deterioration of the lining has been noted although the eastern portal headwall of T134 had suffered major cracking and dislodgement of some brick courses.

Both tunnels were reported to be in a stable condition and generally of good quality. T134 has a series of radial cracks towards the eastern end, attributed to mine subsidence. T139 has very few cracks.

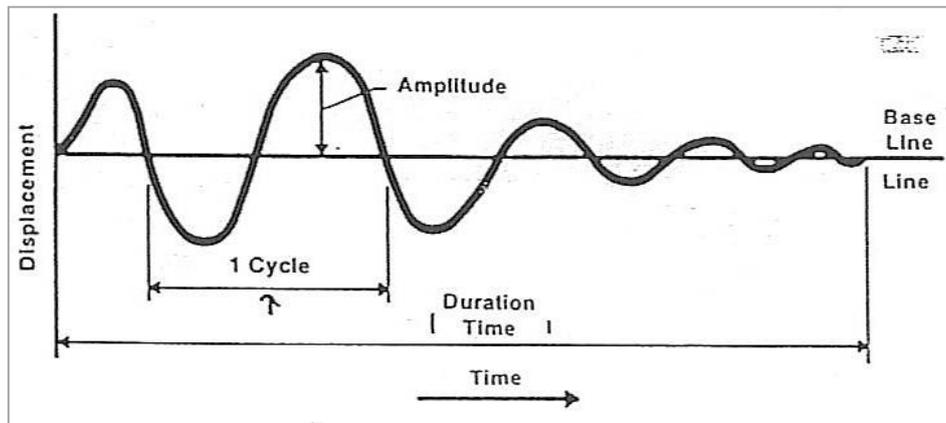
Figure 5. Idealised Vibration Trace (Bellairs, 2011)).

spread over a larger and larger area until they finally die out at some distance from the blasthole (Bellairs, 2011). Figure 5 illustrates an idealised vibration trace from a blast.

The components of any ground vibration are Displacement (D) – the distance that the particles move back and forth, Velocity (V) - the speed that the particles are moving back and forth and Frequency (F) –the number of times a particle completes a complete cycle each second (measured in Hertz (Hz)).

The maximum velocity is called the Peak Particle Velocity (PPV) and is used in most of the Environmental Licence conditions. The velocity can be used to calculate the displacement and the acceleration caused by the ground vibrations.

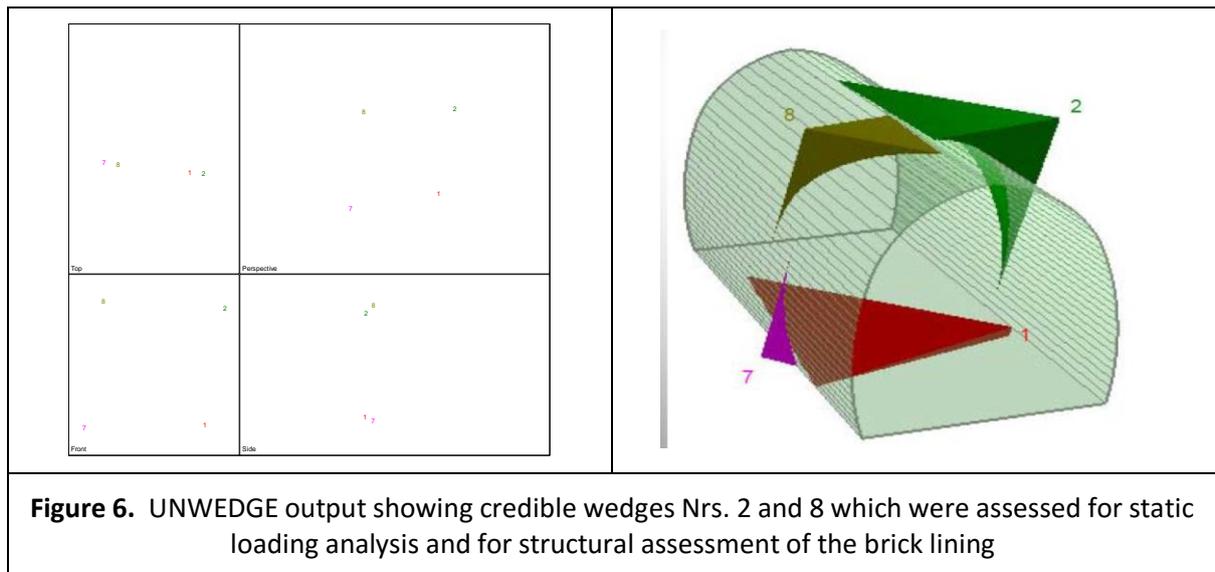
To ensure that some conservatism is included, the analyses assumed no cohesion strength or tensile joint strength. Two particular blocks have been considered. Figure 6 shows the relative size and orientation of blocks No. 2 and 8.

The UNWEDGE results were assessed to derive equivalent two dimensional strip loads for the bedded beam analysis. The worst case wedge (Nr. 2) was calculated to apply an unfactored uniform load of 22.4kN/m and a concentrated load of 146kN (applied across a one metre strip).
