GROUNDWATER MONITORING REPORT - DRY SEASON 2023 - EVANDER

REMEDIATION ORDER NO. 14/11/15/LR68/6

PROJECT NO. 602431 - NOKB246

DATE: JULY 2023

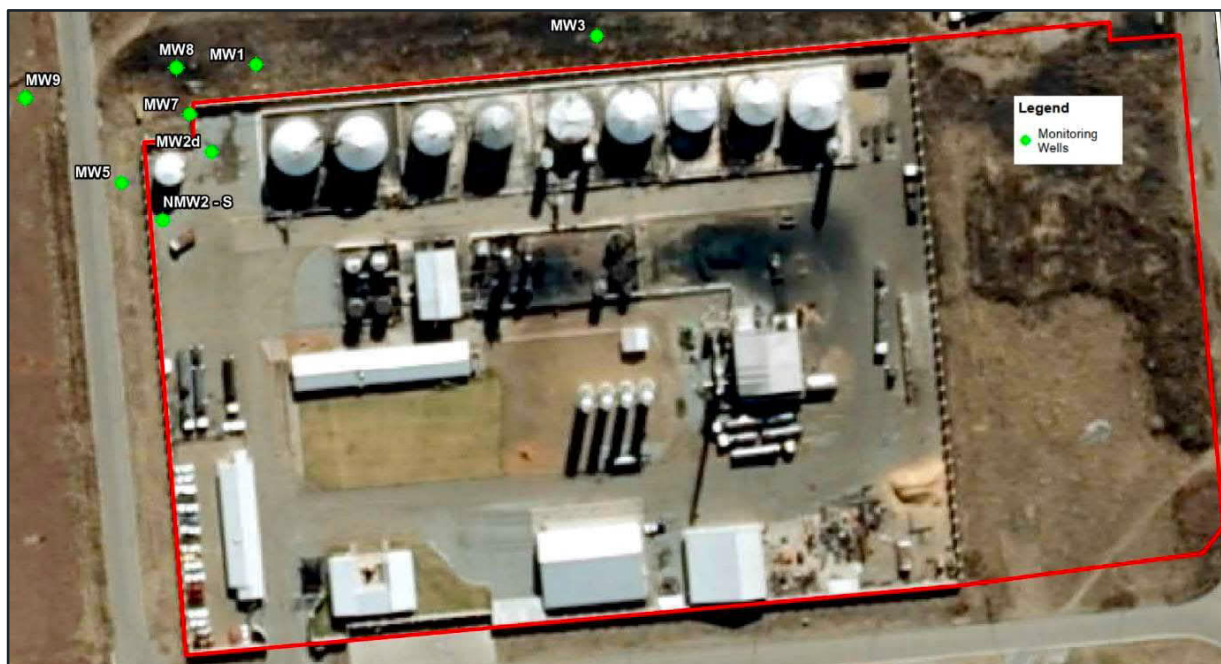
Figure 2-1 – Existing Monitoring Network

The network currently comprises of eight groundwater monitoring wells. The positions are summarised in **Table 2-2** and illustrated on **Figure 2-1**.

Well ID	Coordinates		Installation Depth (m bgl)	Comments
	Latitude	Longitude		
Deep Wells				
MW1	26.485531°S	29.097044°E	28	Off-site perceived down-hydraulic gradient, approximately 8 m north of ASTs
MW2-D	26.485691°S	29.096863°E	30	Perceived down-hydraulic gradient, northwest of the site adjacent to tar AST
MW3	26.485488°S	29.097737°E	30	Off-site perceived down-hydraulic gradient, approximately 8 m north of ASTs and water tank
MW5	26.485846°S	29.096595°E	25	Off-site perceived down-hydraulic gradient, approximately 23 m west of the water tank
MW1	26.485531°S	29.097044°E	28	Off-site perceived down-hydraulic gradient, approximately 8 m north of ASTs
Shallow Wells				
MW7	26.485669°S	29.096717°E	4.5	Off-site perceived down-hydraulic gradient, approximately 15 m north-west of the water tank
NMW2-S	26.485867°S	29.096700°E	6	On-site along the north-western corner of the property down-gradient of the ASTs

MW8	26.485533°S	29.096733°E	7	Off-site roughly 15 m north of MW7, perceived down-hydraulic gradient of 2006 spill
MW9	26.485600°S	29.096367°E	6	Off-site approximately 30 m down-gradient of MW5 and perceived down-hydraulic gradient of the 2006 spill
