GROOTHOEK WIND ENERGY FACILITY

Geotechnical Impact Assessment Report

IMPACT ASSESSMENT REPORT (REV 2) CONFIDENTIAL

PROJECT NO. 41106427

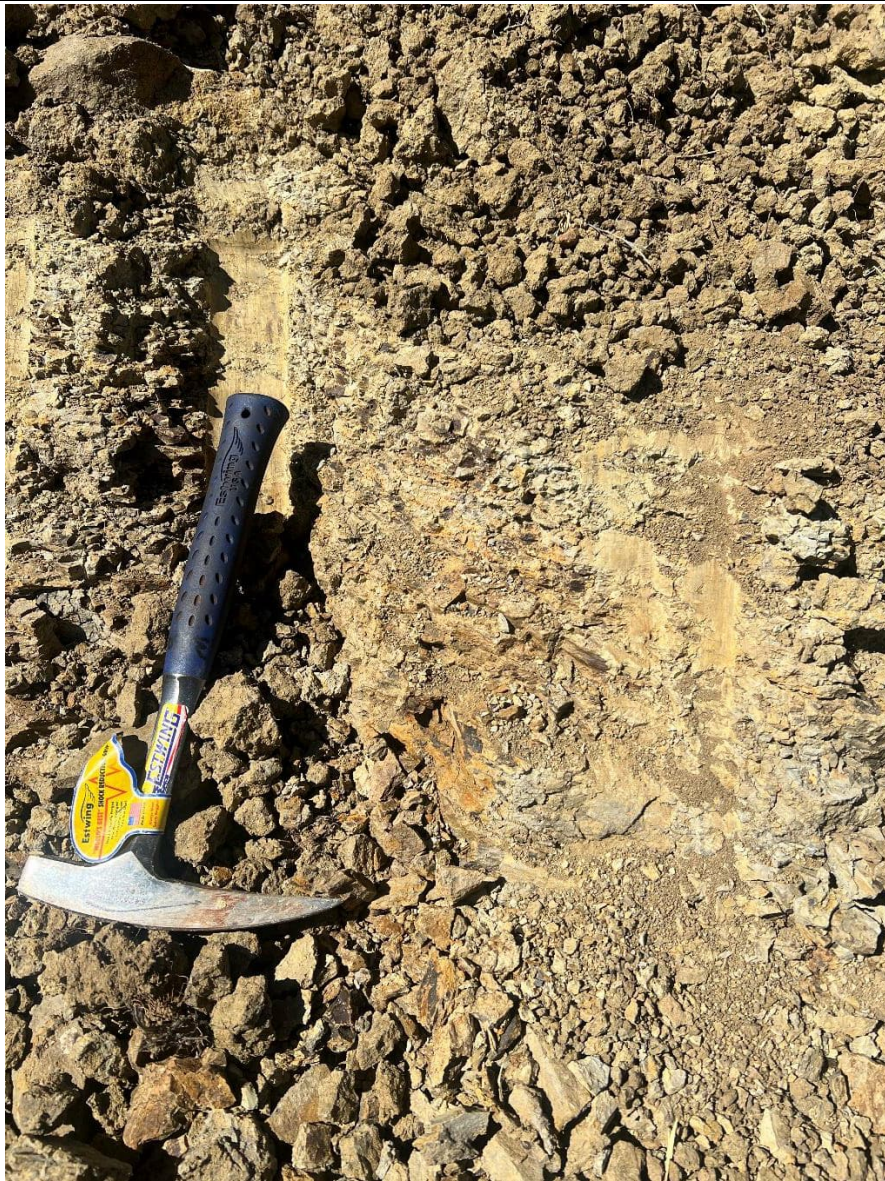
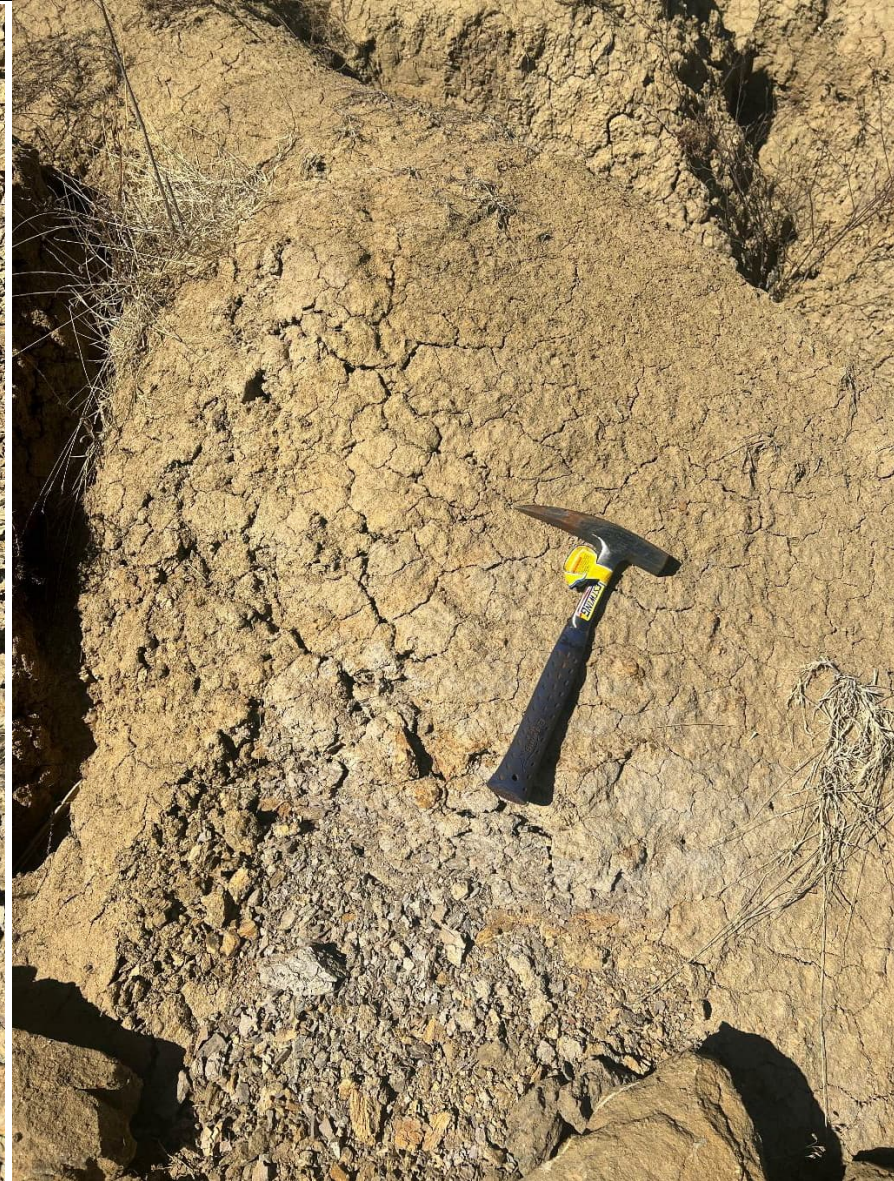
GH1

Scale	Legend	Depth	Description
		0.00	
		-0.10	Dry, light reddish brown, <u>very stiff</u> , fissured, sandy CLAY. Hillwash.
0.5		-0.50	Dry, greyish brown, <u>very stiff</u> , fissured, sandy silty CLAY. Residual Shale.
1.0			Grey stained red and yellow, highly weathered, laminated, close to widely jointed, very soft rock SHALE. 002°/140° (Dip/Strike).
1.5		1.50	
			End of exposure
2.0			
			End of log
2.5			
3.0			
3.5			
4.0			
4.5
