KROMHOF WIND ENERGY FACILITY

Geotechnical Impact Assessment Report

FINAL REPORT (REV2) CONFIDENTIAL

PROJECT NO. 41106427

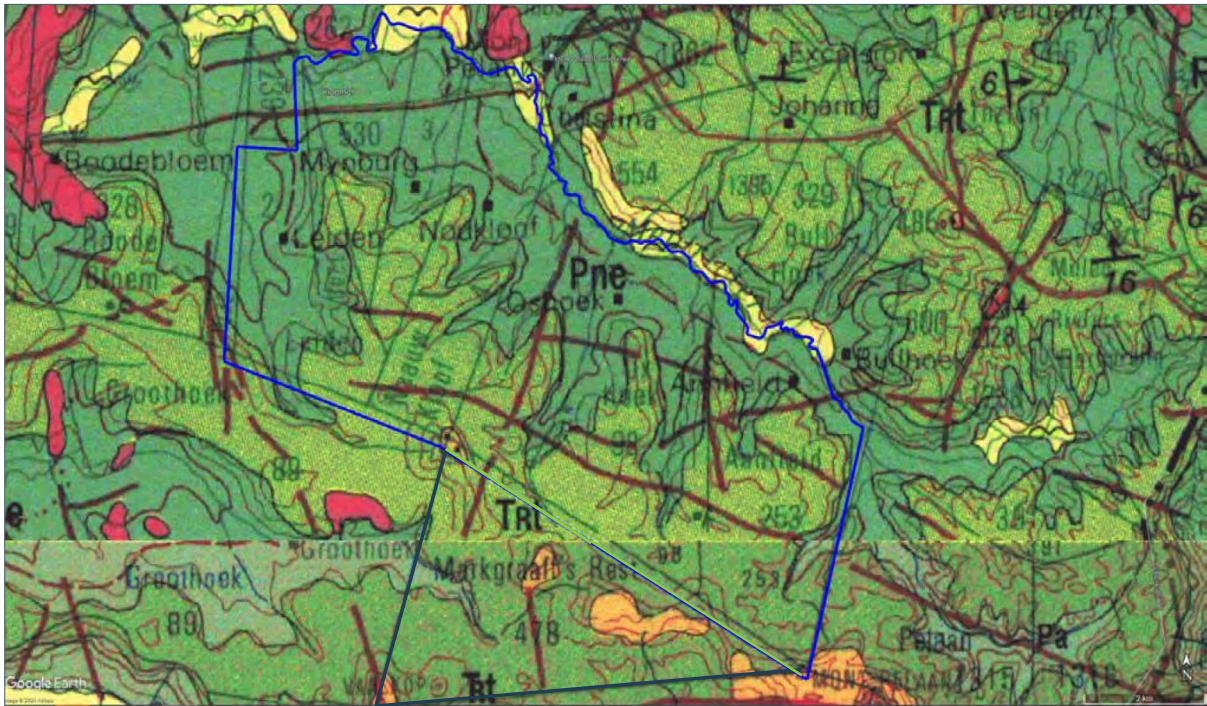
Figure 3-1 – Geological Map of the Project Area

According to the published 1: 250 000 geological maps (Sheet 2728 Frankfort and 2828 Harrismith), the study area is underlain by rocks of the Adelaide and Tarkastad Subgroup, Beaufort Group of the Karoo Supergroup.

An excerpt of the published geological map showing the project area is presented as Figure 3-1 and the lithostratigraphy is presented as Table 3-1.

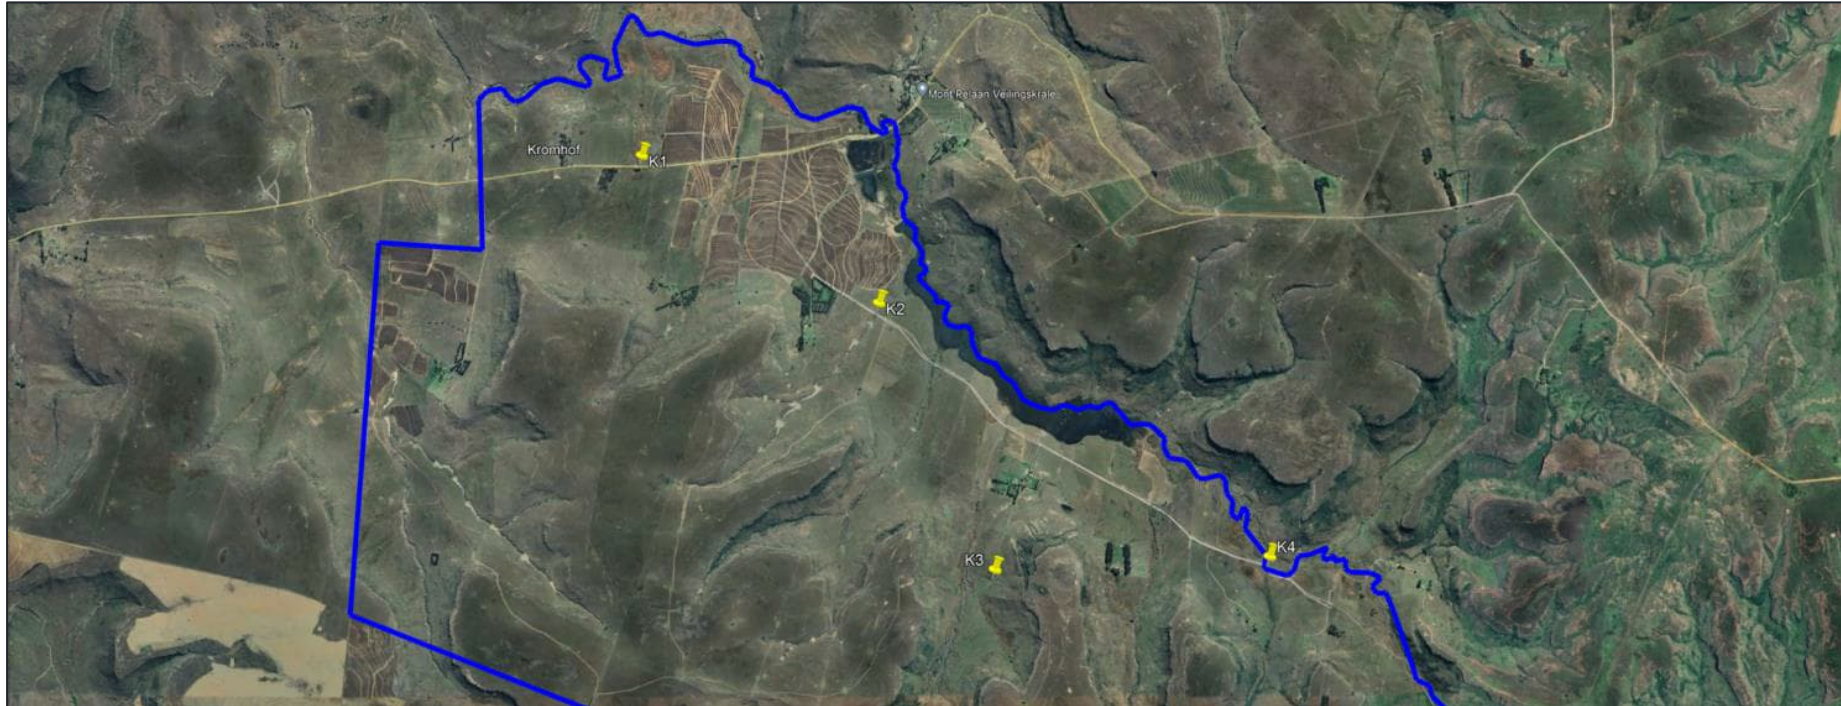
Figure 4-1 - Location of geological exposures across the Kromhof WEF site

A total of three geological exposures, K2 to K4, were observed in the northern part of the site and were profiled according to the current South African standards and guidelines (SANS 633). This was done to confirm or dispute the baseline geological information.

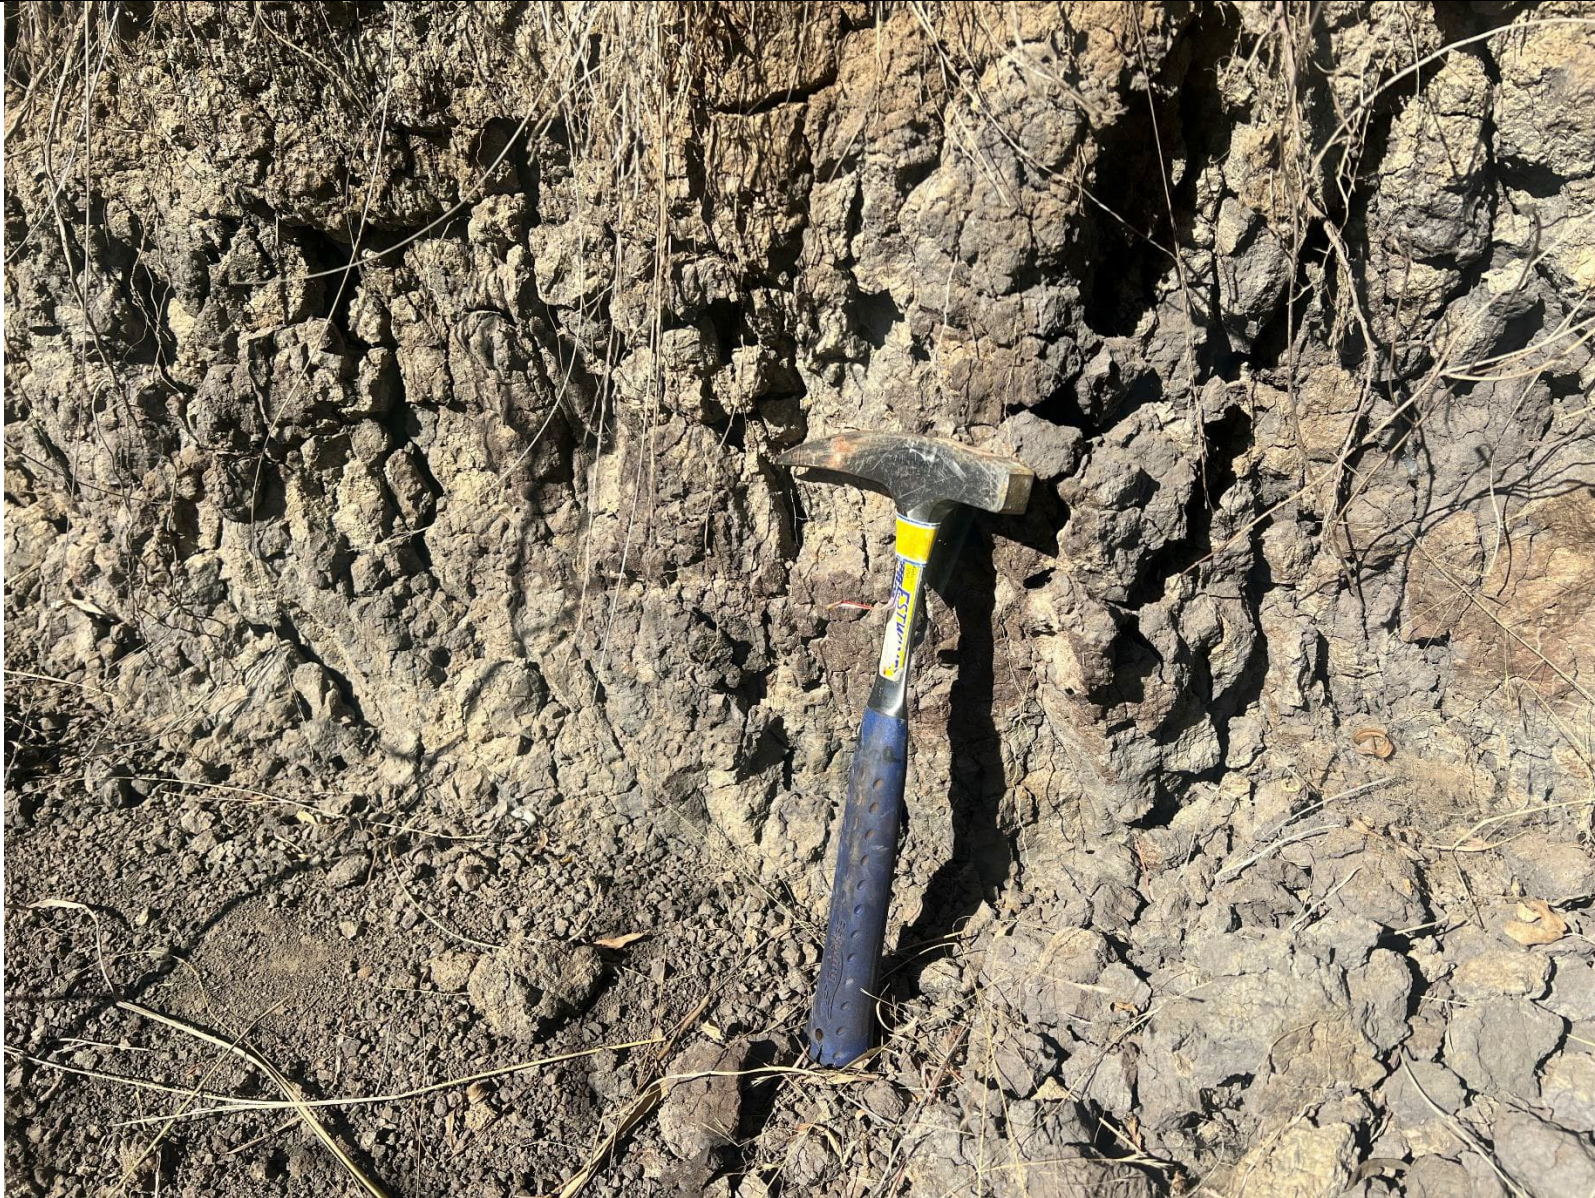
K2

0.40	Dry, dark grey stained white, <u>very stiff</u> , sandy silty CLAY Residual .
		0.80	
1.0			End of exposure
1.5			
2.0			
2.5			
3.0			
3.5			
4.0			
4.5			
			End of log

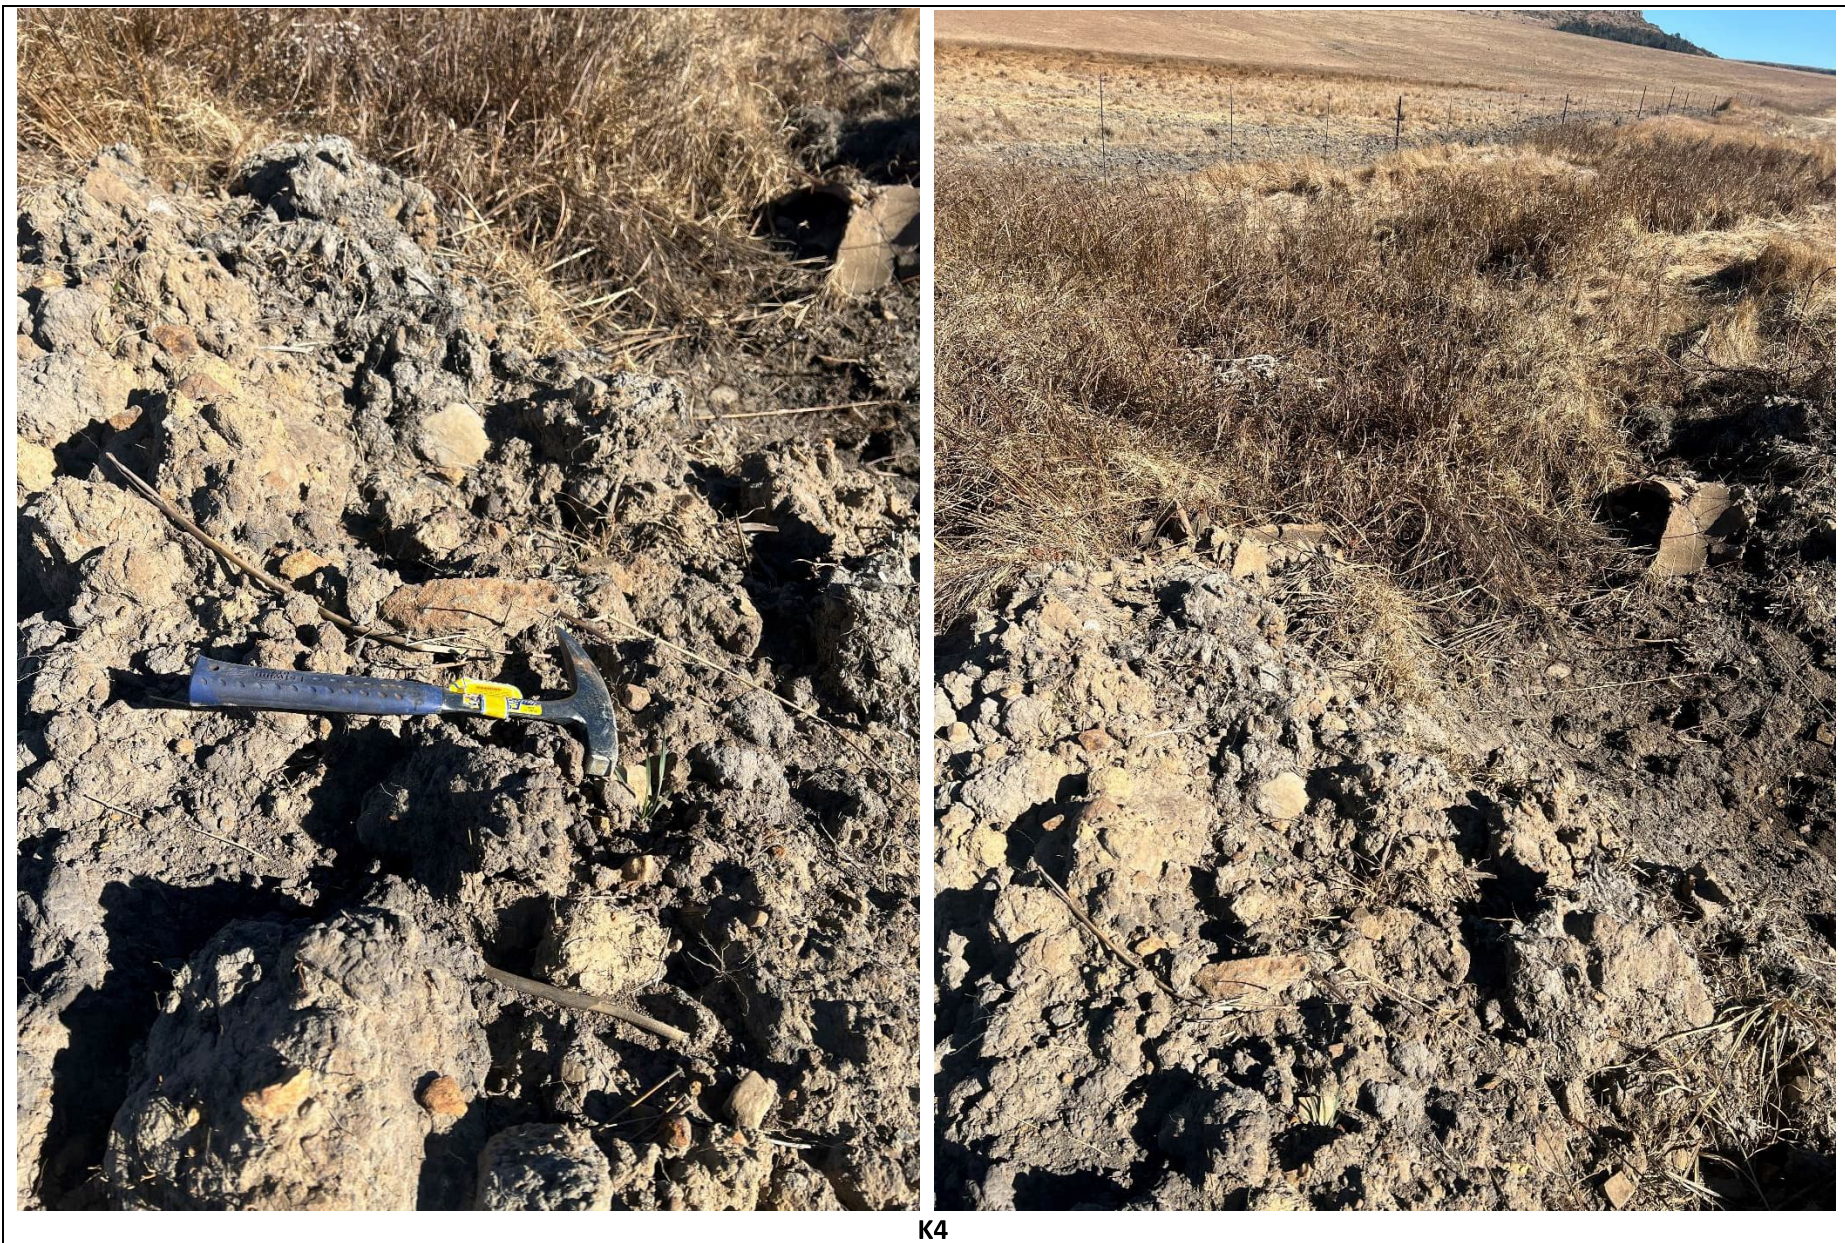
K4

Scale	Legend	Depth	Description
0.5		0.00	Slightly moist, dark greyish brown, <u>firm</u> , sandy CLAY containing abundant sub-angular to rounded sandstone and dolerite gravel and cobbles. Alluvium .
1.0		1.00	End of exposure
1.5			End of log
2.0			
2.5			
3.0			
3.5			
4.0			
4.5
