# GROOTHOEK WIND ENERGY FACILITY

## Geotechnical Impact Assessment Report

**IMPACT ASSESSMENT REPORT (REV 0) CONFIDENTIAL**

**PROJECT NO. 41106427**

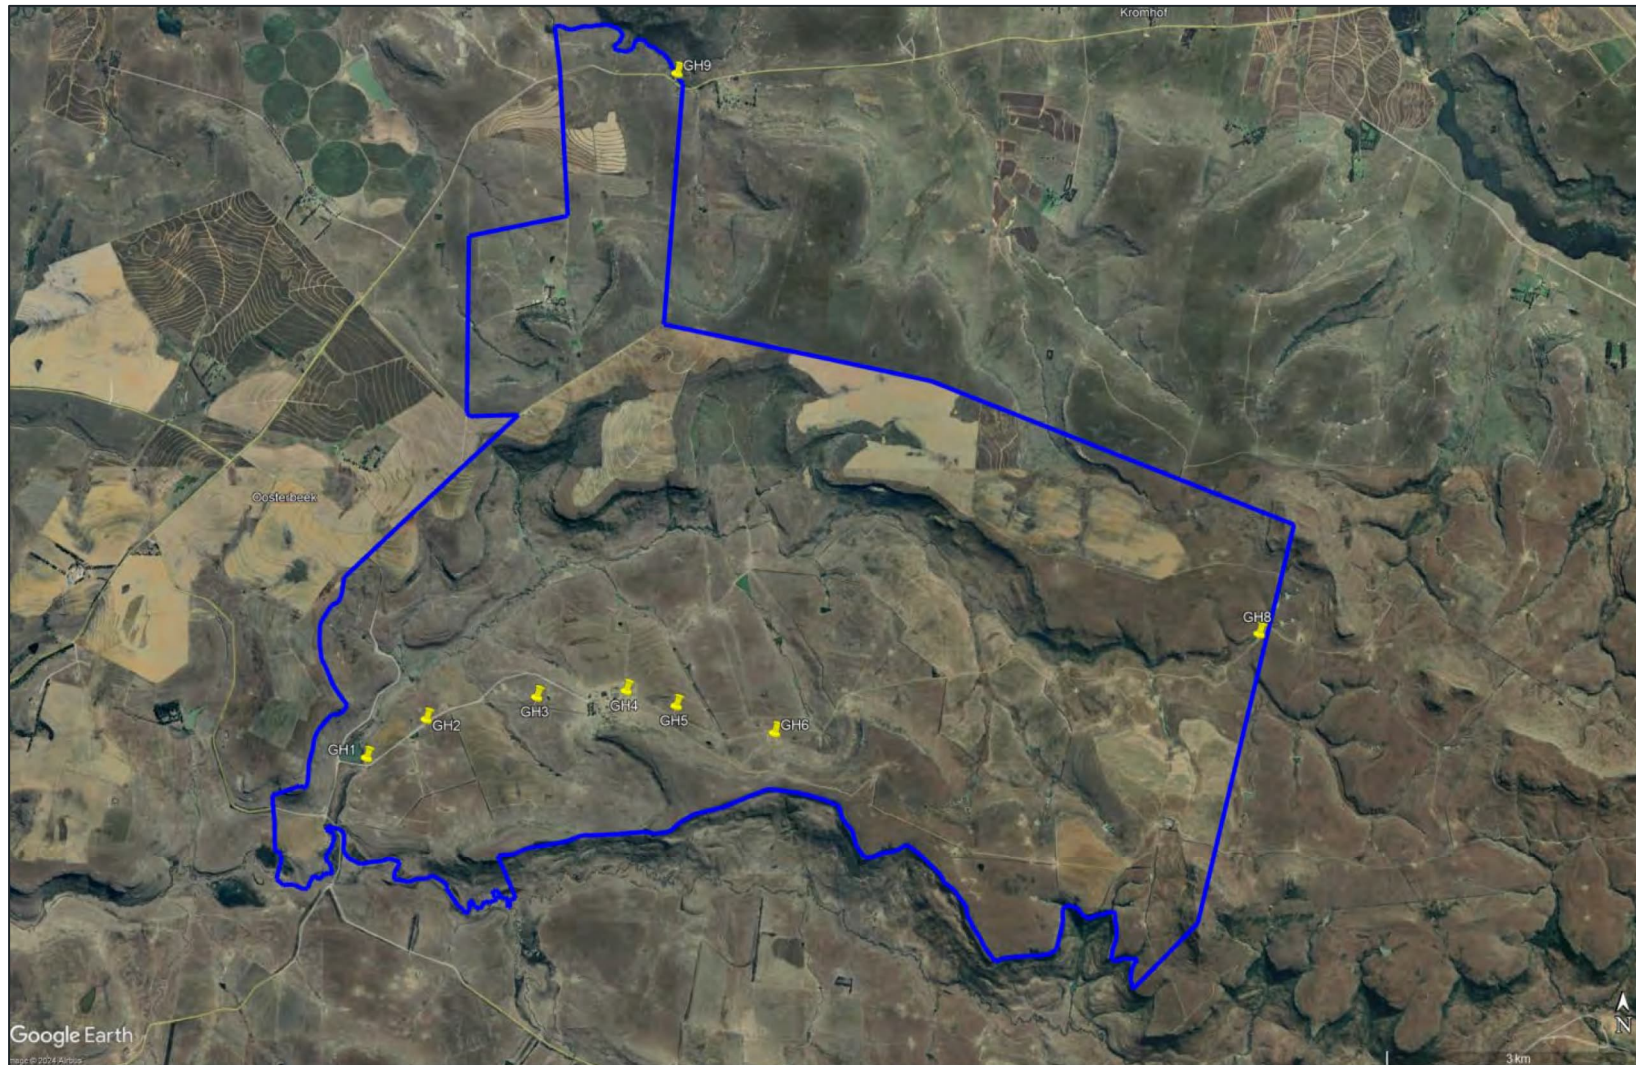
**Figure 4-1 - Location of geological exposures across the Groothoek WEF site**

A total of eight geological exposures, GH1 to GH9, were observed in various areas of the site and were profiled according to the current South African standards and guidelines (SANS 633). This was done to confirm or dispute the baseline geological information.

Exposure No.	Hillwash	Pedogenic	Residual Shale	Residual Dolerite		Rock Properties		
						Depth (m)	Rock Hardness	Rock Type
	Sandy/silty clay	Silty clay	Silty clay	Silty clay with gravel and cobbles	Silty sand			
GH1	0.00 – 0.10		0.10 – 0.50			0.50 – 1.50	Soft rock	Shale
GH2						0.00 – 2.00	Medium hard	Sandstone
GH3						0.00 – 0.90	Soft rock	Sandstone
GH5	0.00 – 0.30	0.30 – 0.50				0.50 – 0.60	Medium hard	Sandstone
GH6				0.00 – 1.50	1.50 – 5.00	5.00 – 15.00	Hard	Dolerite
GH7	0.00 – 0.50		0.50 – 1.50			1.50 – 2.00	Soft	Shale
GH8						0.00 – 2.00	Soft	Siltstone
GH9						0.00 – 10.00	Medium hard to hard	Dolerite

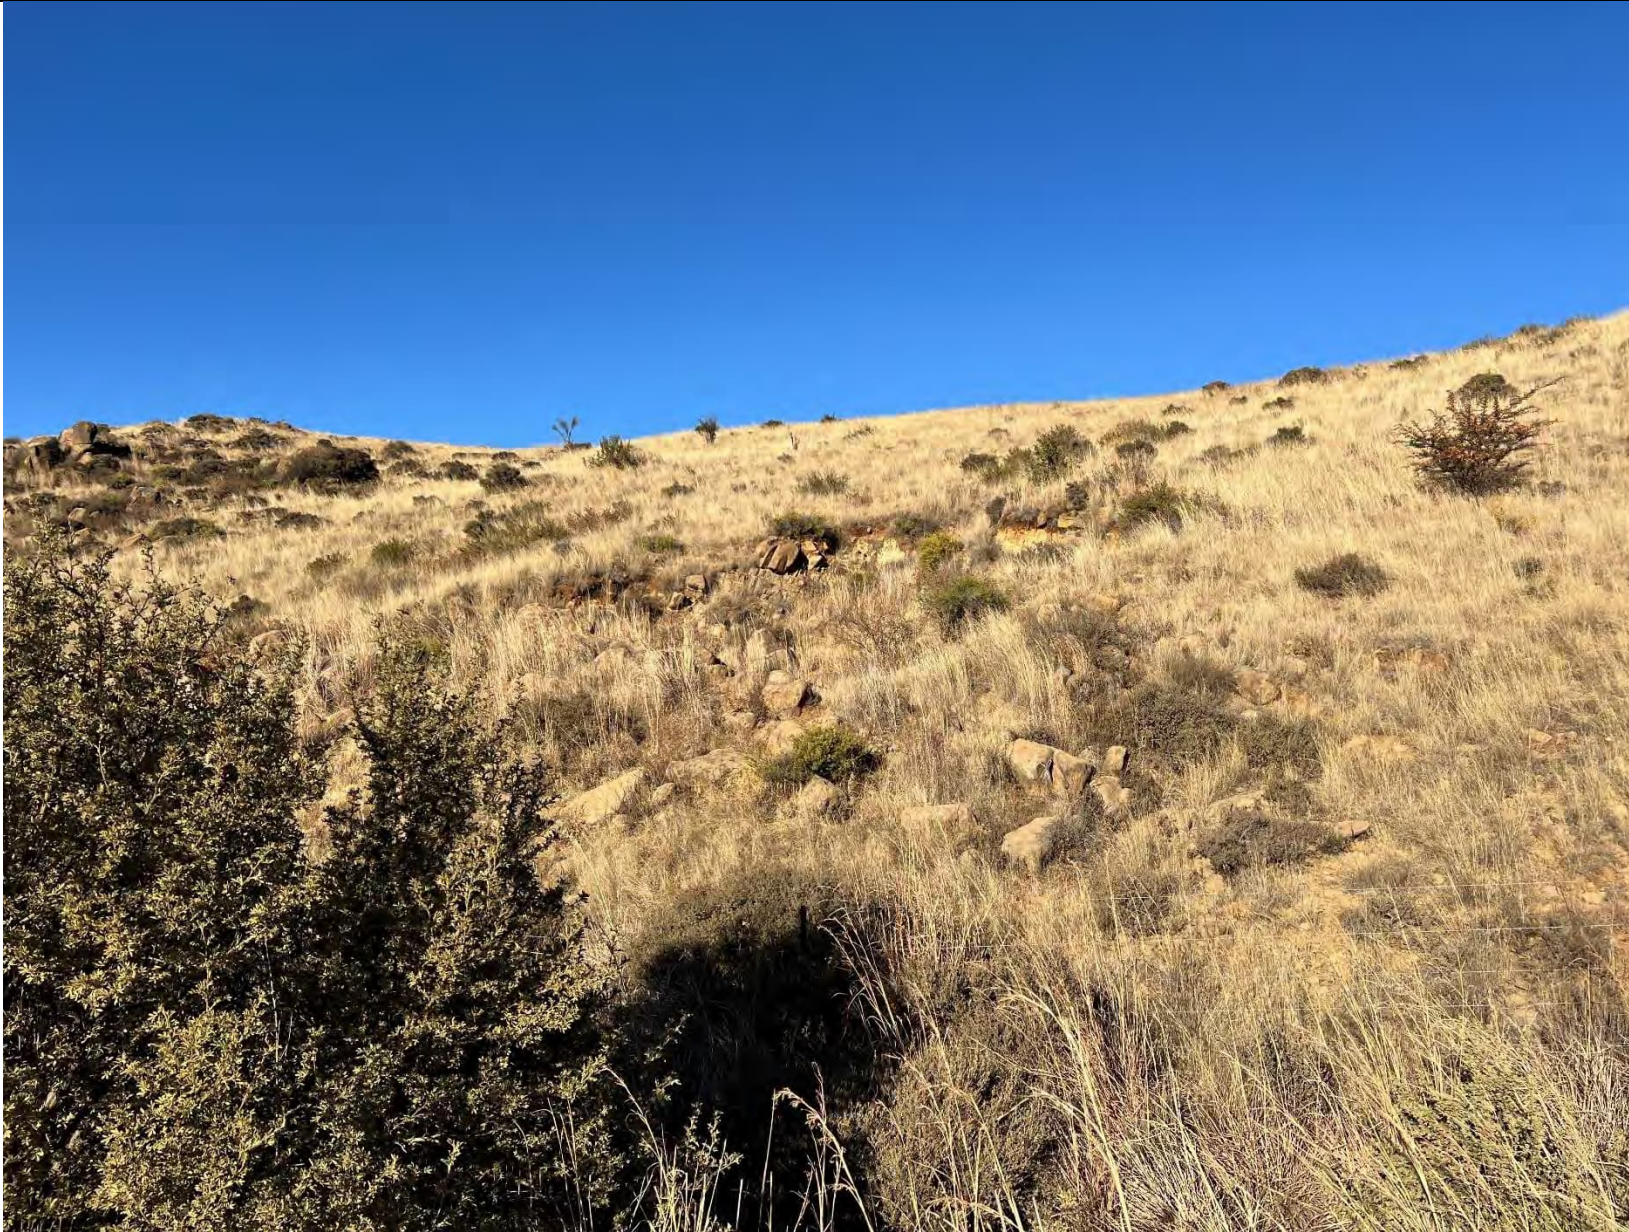
GH9

0.00  1.50  5.00  15.00	Dry, red brown, <u>very stiff</u> , sandy silty CLAY containing minor hard rounded dolerite gravel and cobbles <b>Residual Dolerite</b> .  Dry, yellow brown, <u>very dense</u> , medium to coarse grained SAND. <b>Residual Dolerite</b> .  Yellowish brown stained red, moderately weathered, very close to closely jointed, hard rock DOLERITE.  <b>End of exposure</b>
			End of log
