# **IGOLIDE WIND ENERGY FACILITY ELECTRICAL GRID INFRASTRUCTURE**

Geotechnical Desktop Study

**REPORT (REV2) CONFIDENTIAL**

**PROJECT NO. 41104282**

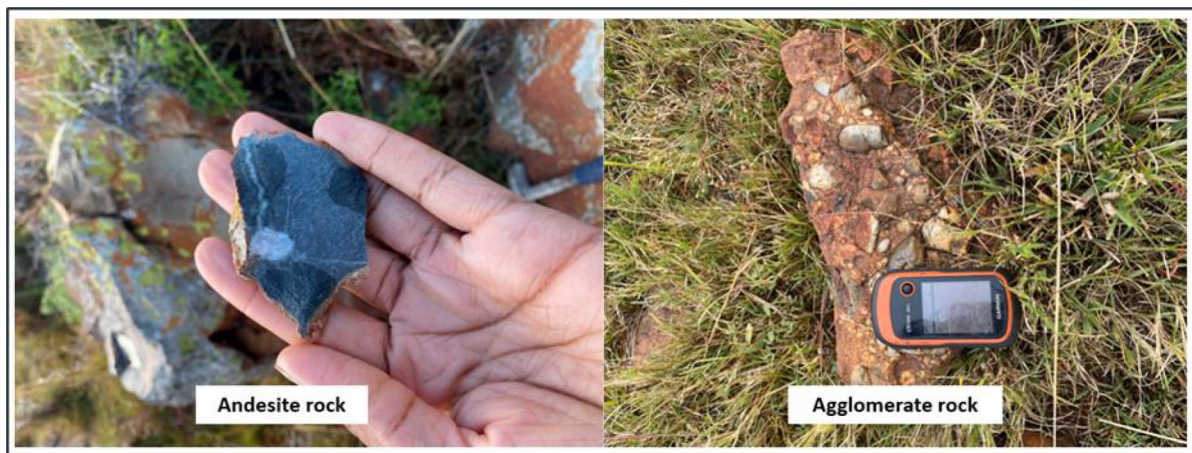
**Figure 4-5 - Hekpoort Andesite rocks encountered on site**

Andesite and agglomerate were observed in outcrops on the southern portion of the route as shown in Figure 4-4. Outcrop 1 refers to the andesite rock outcrop encountered, while Outcrop 2 refers to the agglomerate rock outcrop that was observed. The andesite rock and agglomerate rock, respectively, are shown in Figure 4-5 and were described as follows: -

- Dark grey weathered red and light grey, slightly weathered, fine grained, slightly fractured, hard rock andesite with 10mm to 12mm diameter amygdale crystals.
- Dark grey weathered red, slightly to moderately weathered, medium to fine grained, moderately to highly fractured, medium hard rock agglomerate with 2mm to 40mm diameter, opaque white to greyish white, subrounded, hard rock calcite fragments in rock matrix.
