NORMANDIEN WIND ENERGY FACILITY

Geotechnical Impact Assessment Report

PROJECT NO. 41106427

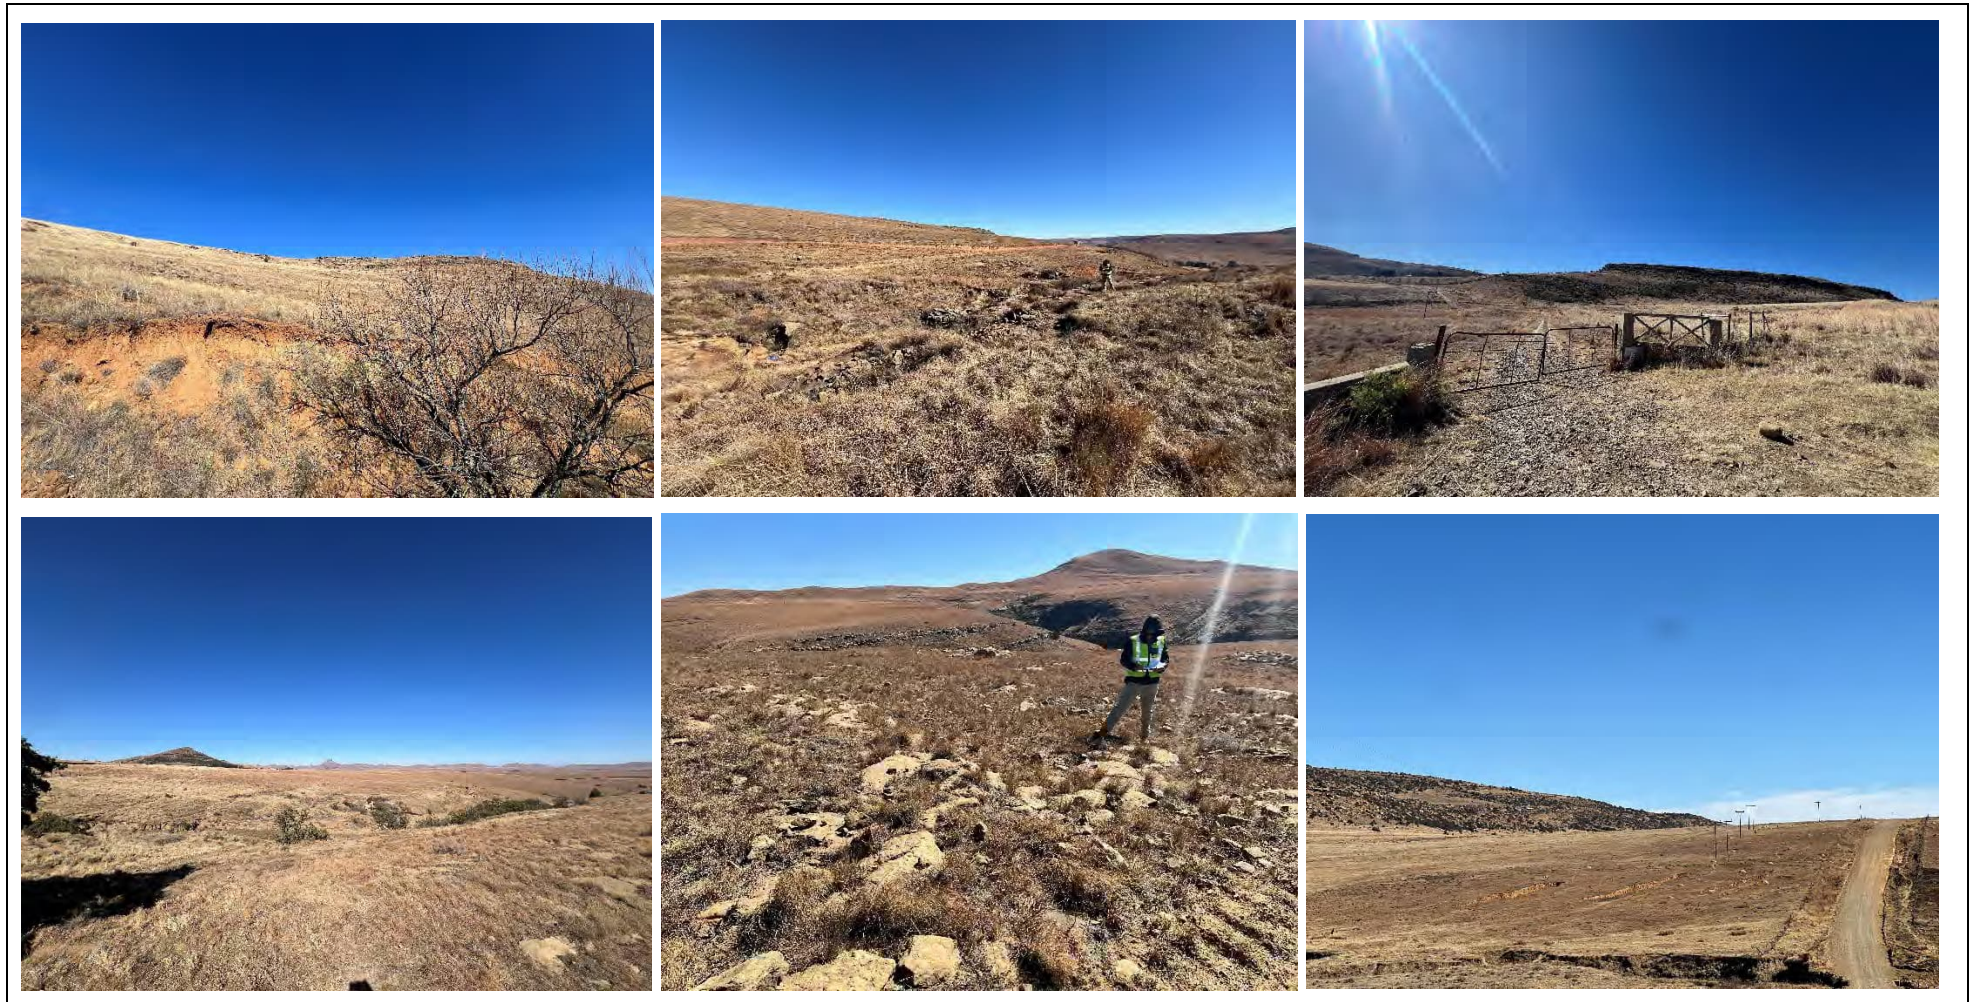
Figure 2-2 - Terrain across the Normandien WEF site

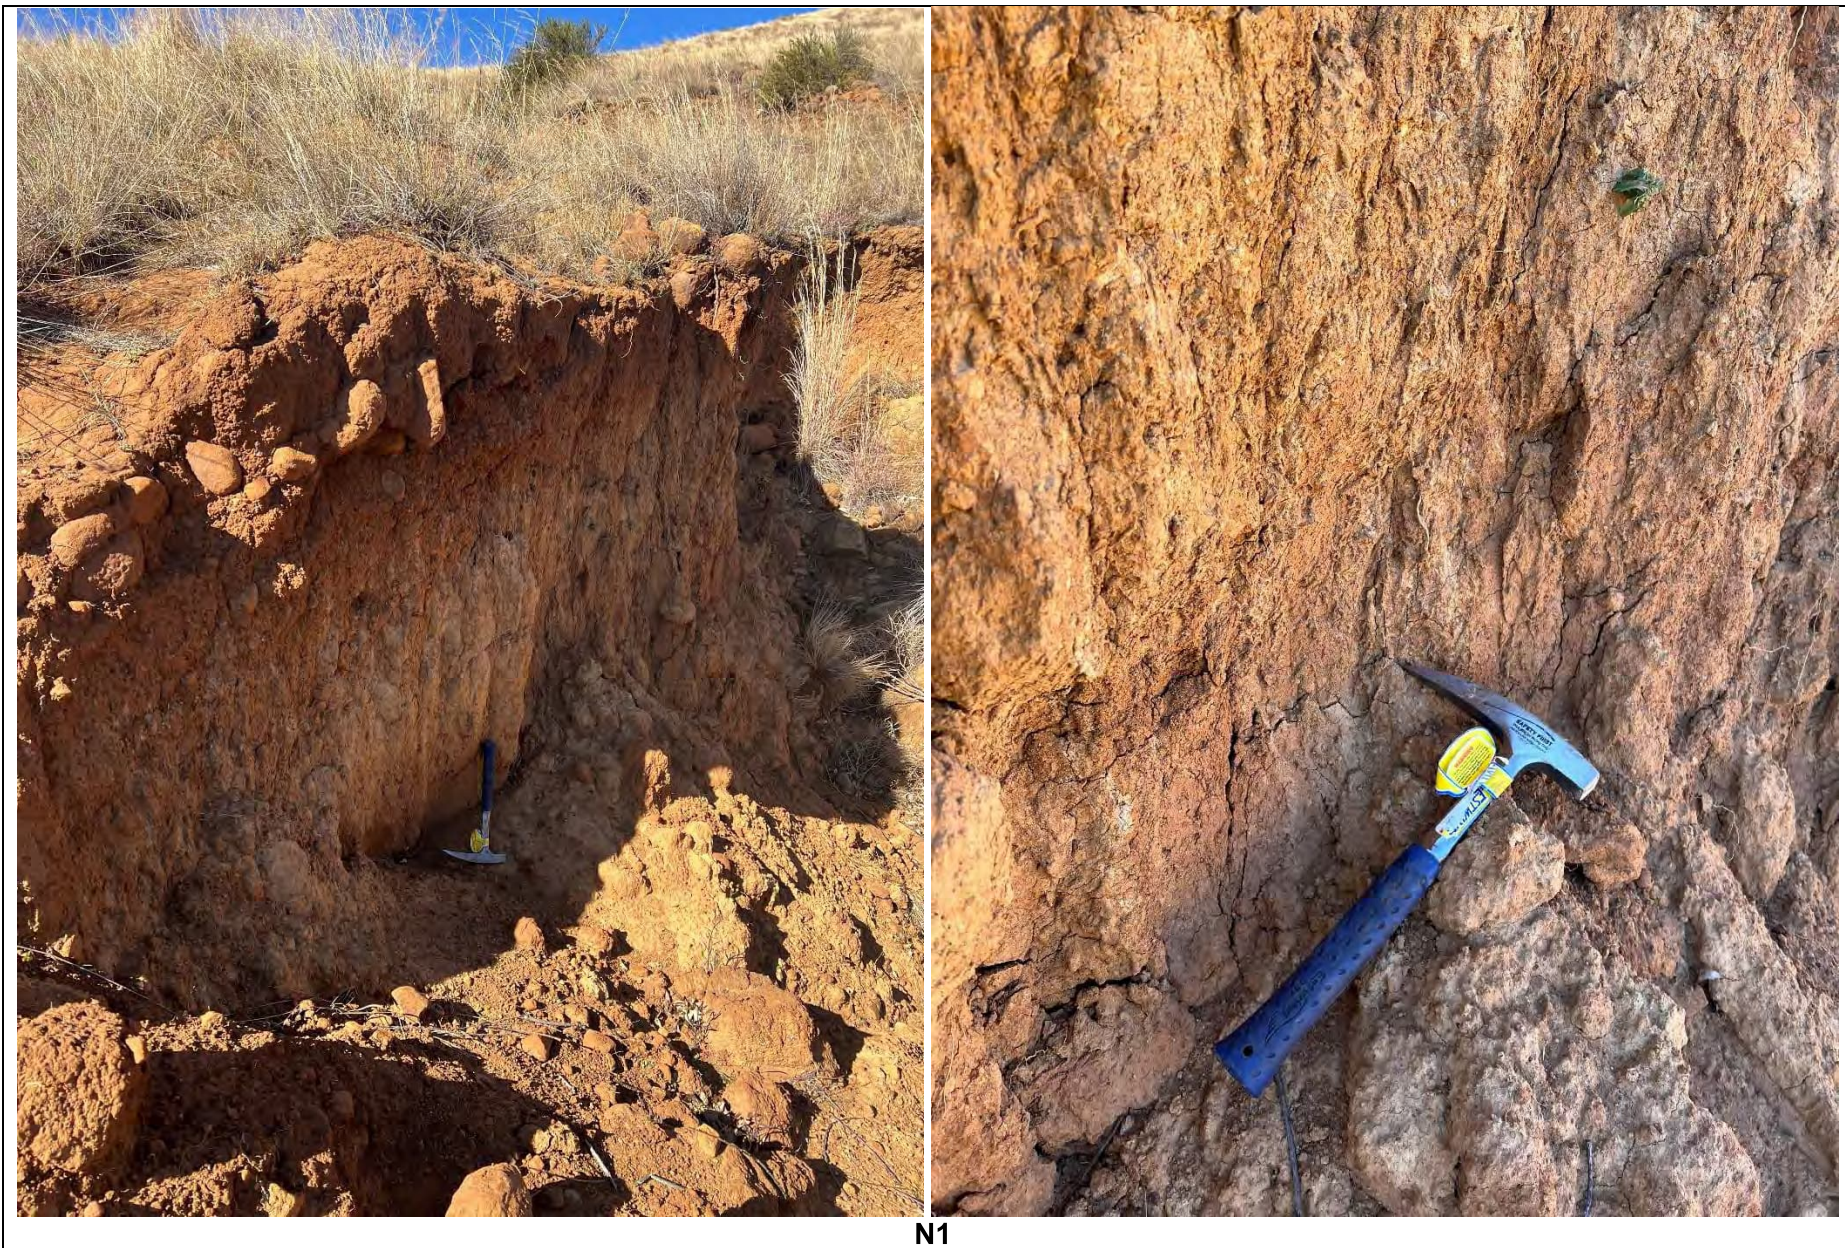
N1

Scale	Legend	Depth	Description
0.0		0.00	Light grey stained red and black, moderately weathered, fine to coarse grained, thinly to medium bedded, closely to medium jointed, soft to medium hard rock micaceous SANDSTONE. 010°/168° (Dip/Strike).
0.5			
1.0			
1.5			
2.0			
2.5			
3.0			
3.5			
4.0			
4.5			
5.0		5.00	End of exposure
5.5			End of log

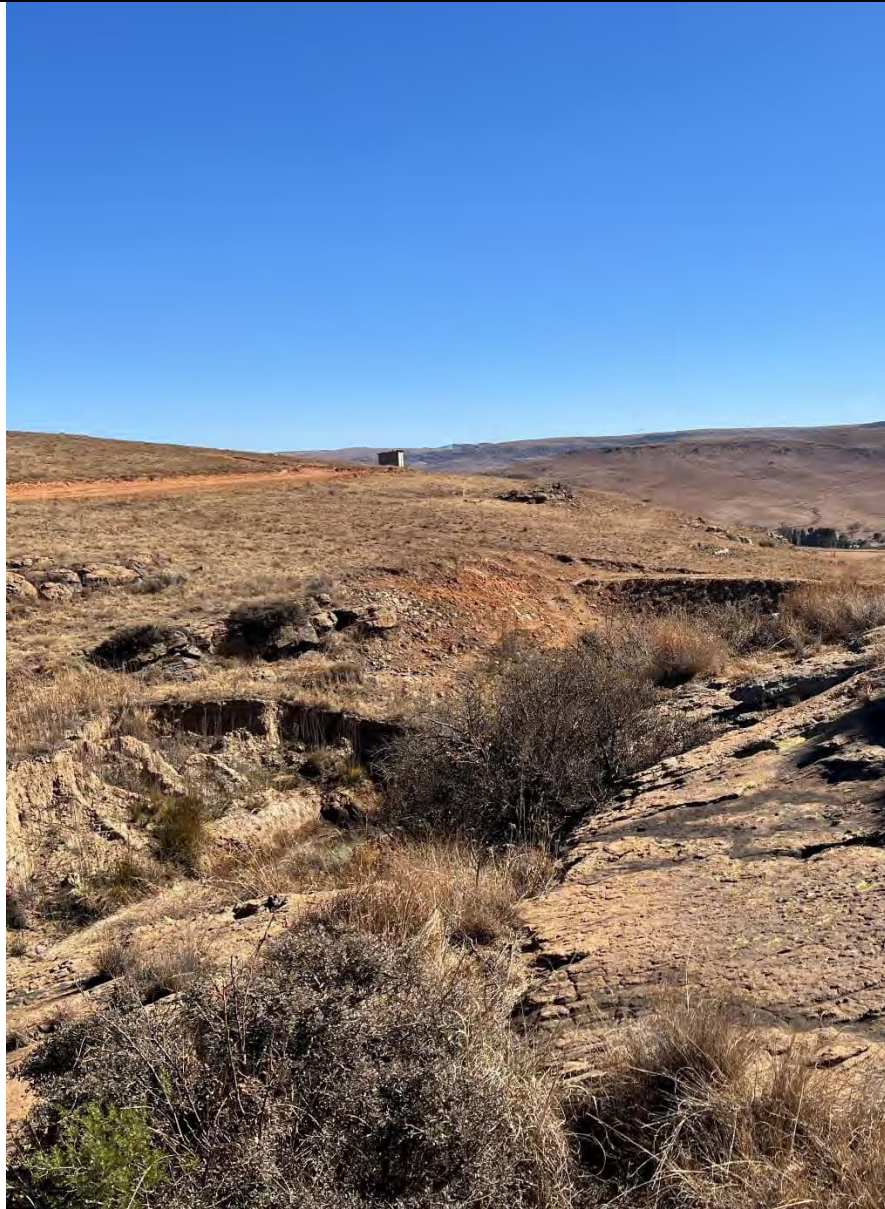
N2

Scale	Legend	Depth	Description
	0.00	Red brown stained yellow, highly weathered, very fine to fine grained, closely to medium jointed, very soft rock micaceous SANDSTONE. 002°/106° (Dip/Strike).
0.5			End of exposure
1.0			End of log
1.5			
2.0			
2.5			
3.0			
3.5			
4.0			
4.5

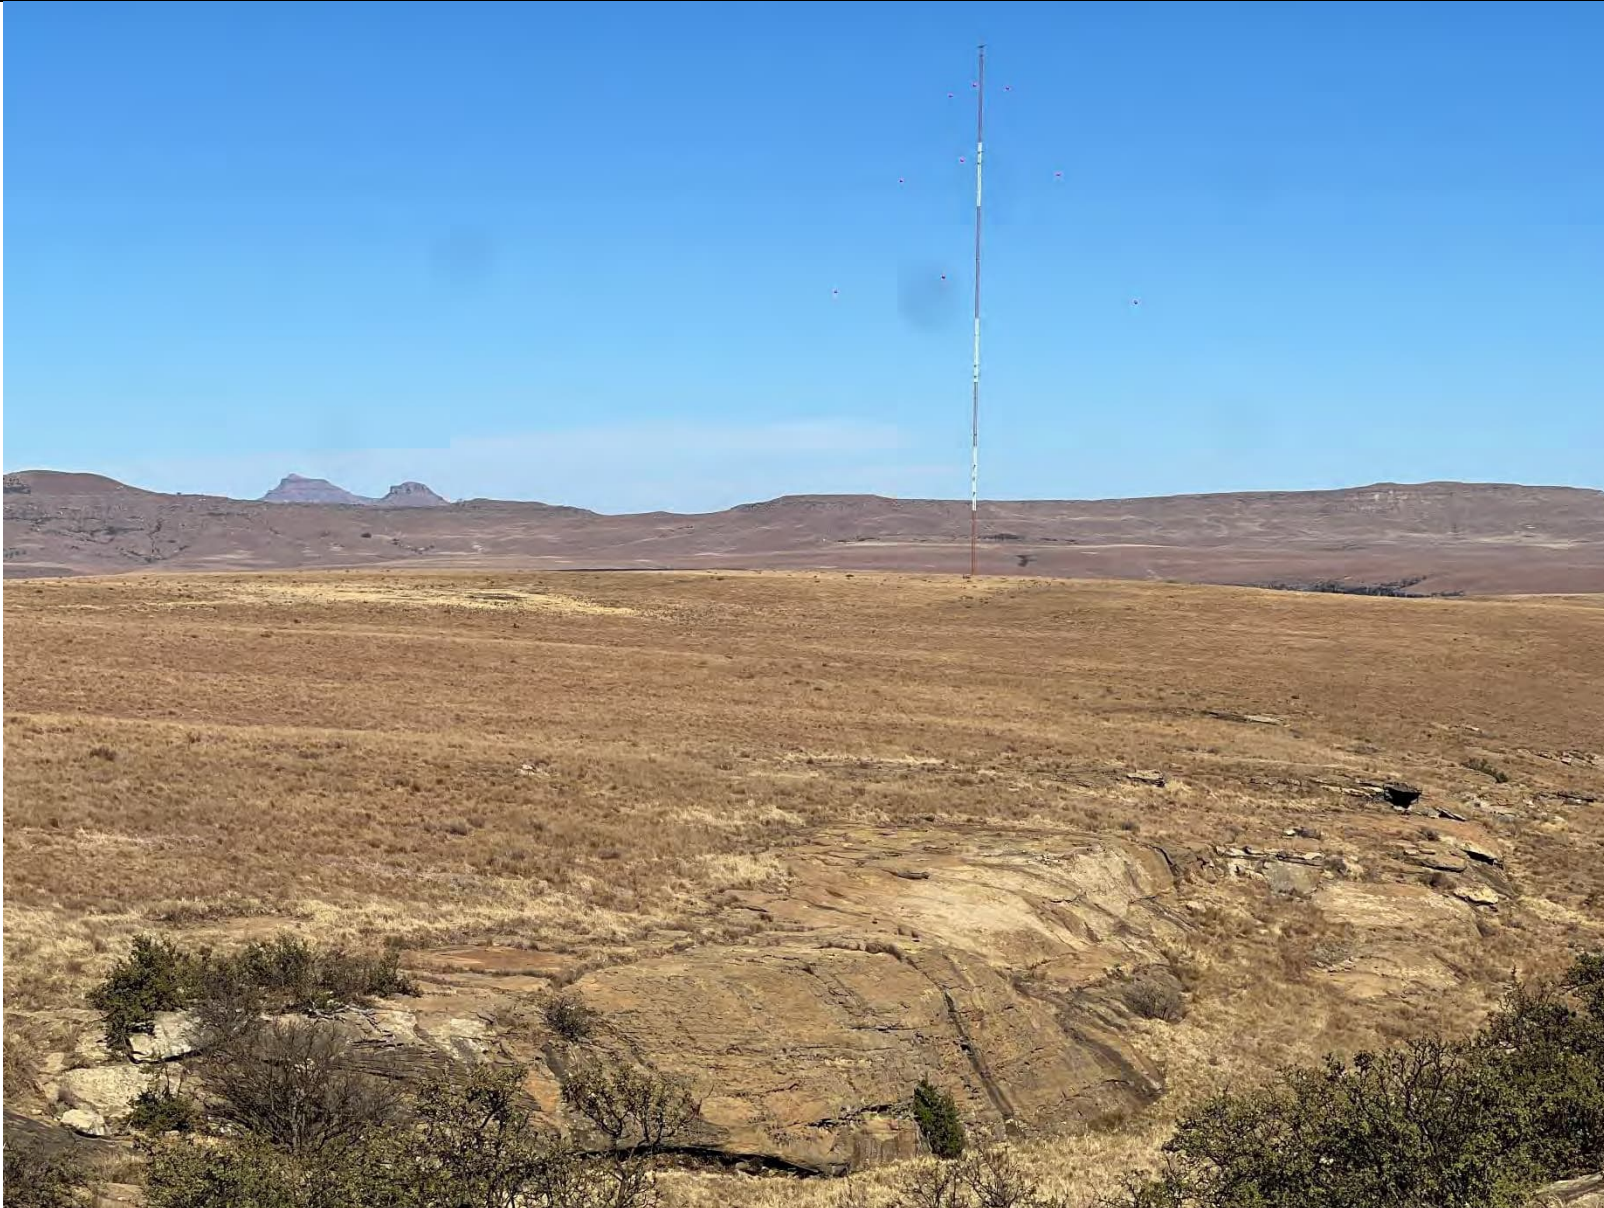
N4

Scale	Legend	Depth	Description
		0.00	Light brown stained red, moderately weathered, very fine to fine grained, very thinly bedded, very close to closely jointed, soft to medium hard rock micaceous SANDSTONE. 010°/144° (Dip/Strike).
0.5		0.50	
1.0			
1.5			
2.0			
2.5			
3.0			
3.5			
4.0			
4.5
