# **ABO UVEMVANE WIND ENERGY FACILITY 1**

## **Geotechnical Impact Assessment Report**

**REPORT (REV4) CONFIDENTIAL**

**PROJECT NO. 41106304**

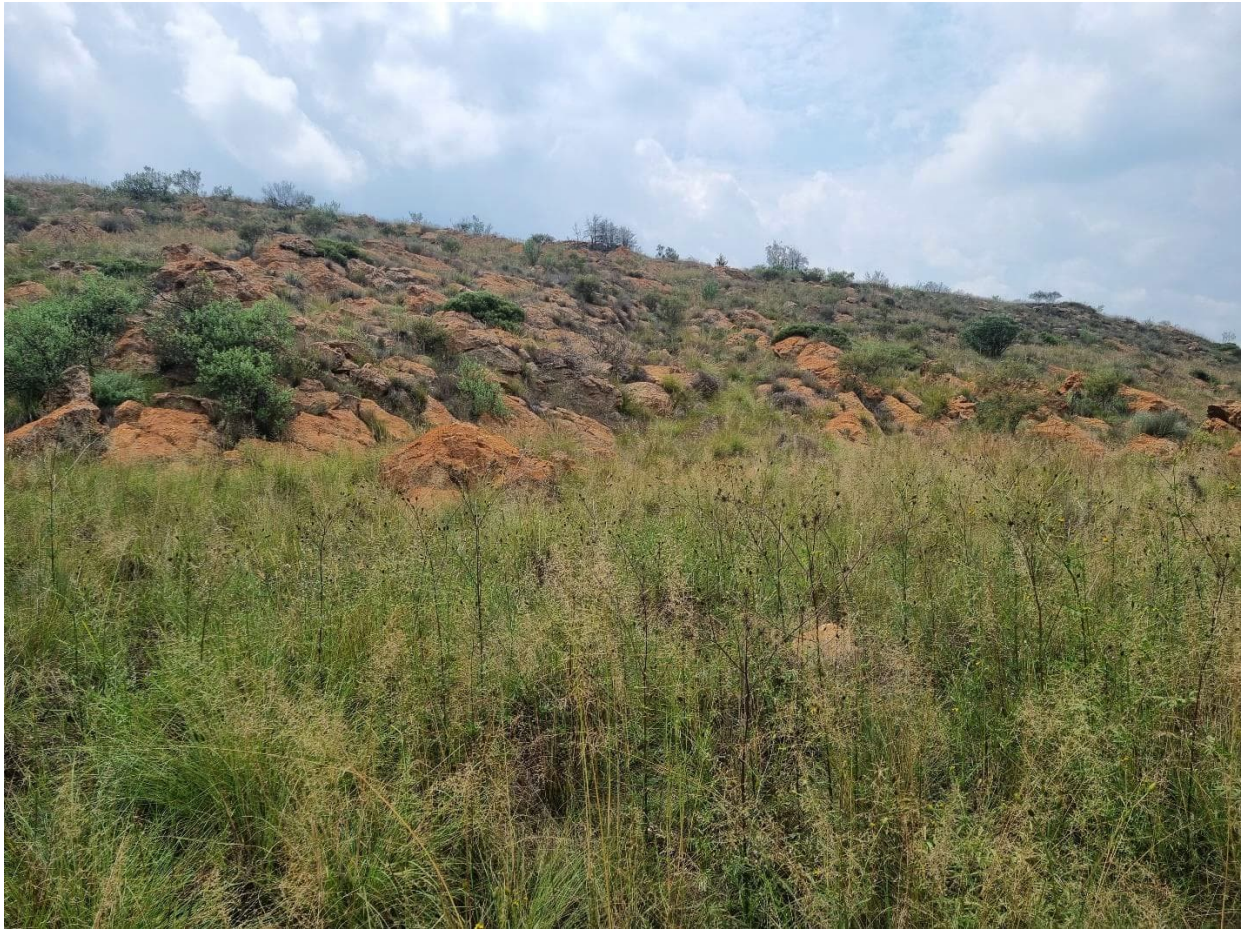
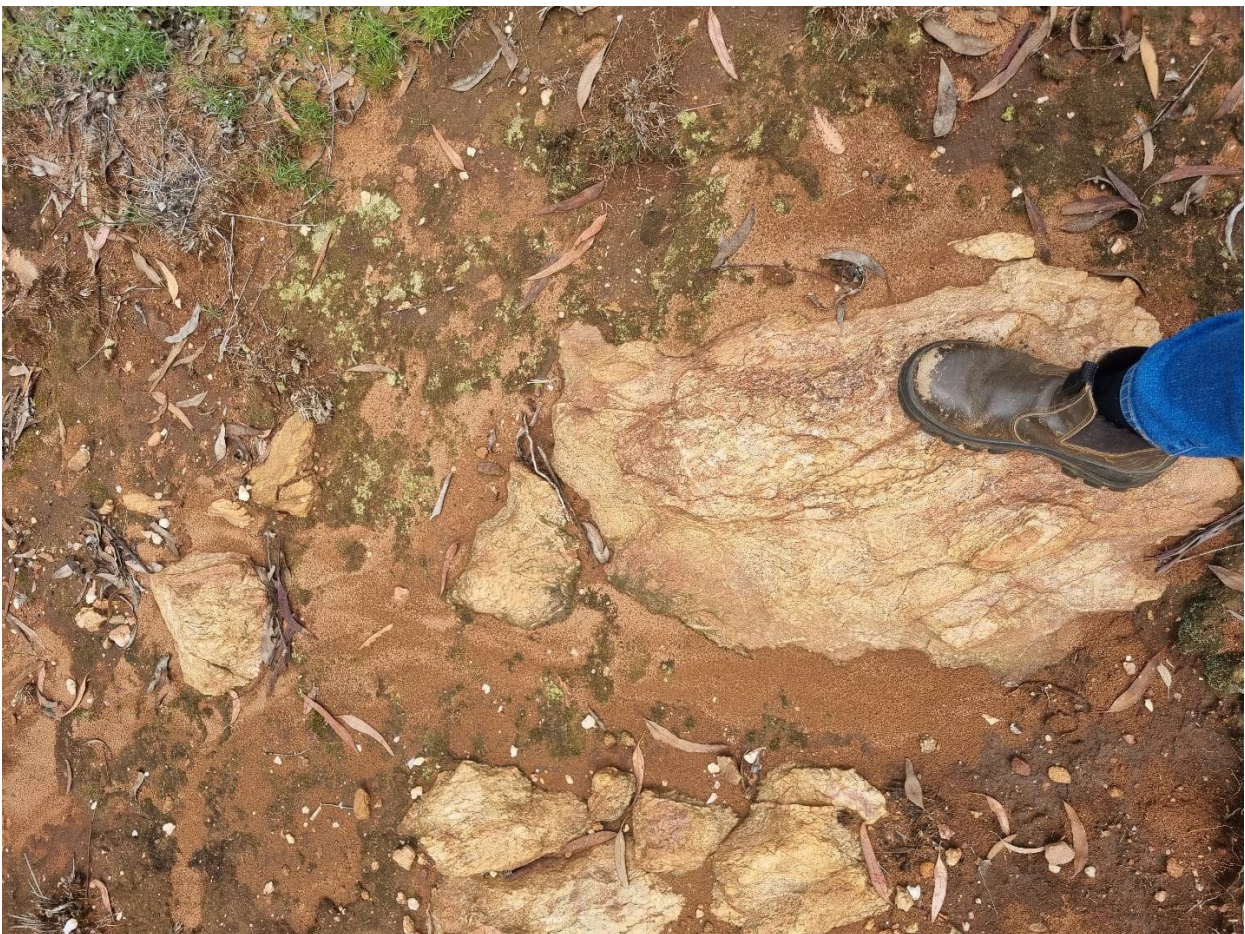
EXP10

| Scale | Legend | Depth | Description |
|---|---|---|---|
| | | 0.00 | Black stained maroon on the outside, moderately weathered, massive, fine grained, <u>medium hard rock</u> . <b>BASALT</b> . |
