20 August 2023  
Our Reference: RG/022/316/Report 1  
Client Reference: PO0000007

**RE: MCCAIN DELMAS - WASTE WATER TREATMENT PLANT (WWTP)**  
**PHASE 1 SHALLOW SURFACE GEOTECHNICAL AND DOLOMITE STABILITY**  
**INVESTIGATIONS**

Rockland Geoscience (Pty) Ltd (Rockland) was appointed by Gleam Hydro (Pty) Ltd (Gleam) in terms of Rockland proposal letter RG/022/316/01, dated 04 June 2022, and Gleam purchase order number PO0000007 dated 05 June 2023, to undertake phase 1 shallow surface geotechnical and dolomite stability investigations for a new Waste Water Treatment Plant (WWTP) at McCain Food SA (Pty) Ltd's (McCain) Delmas plant, near the town of Delmas Mpumalanga Province, South Africa.

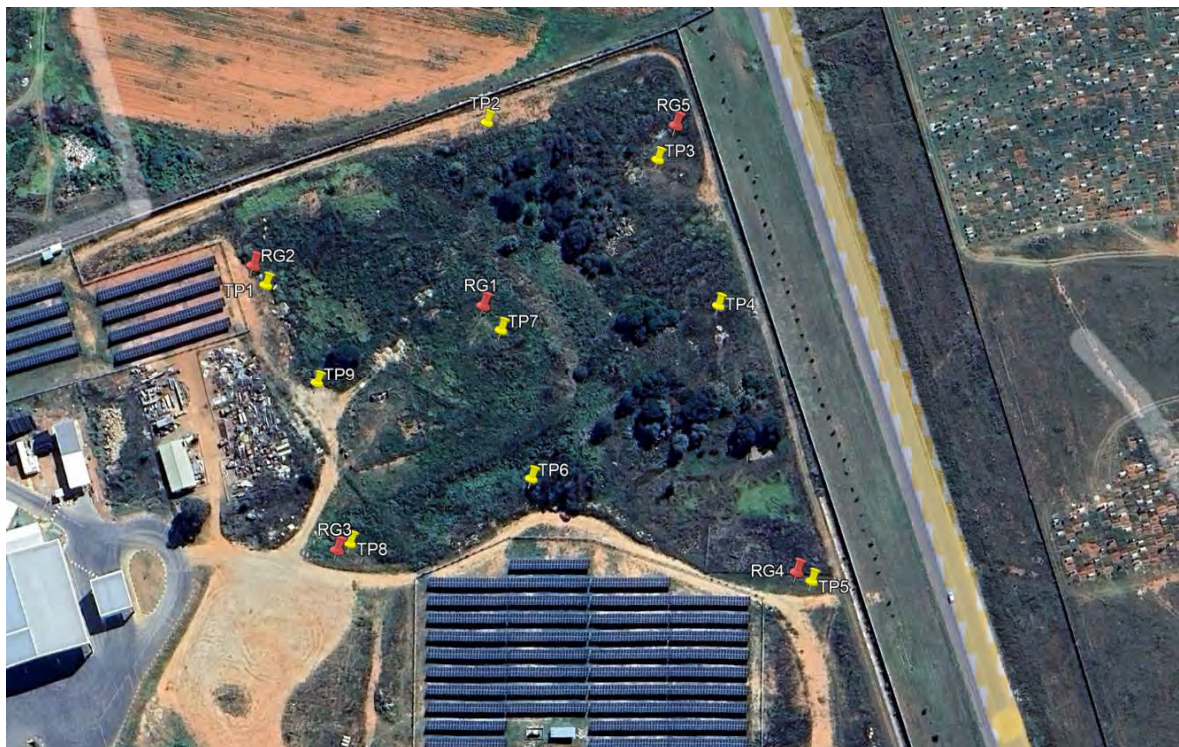
**Figure 2-2: Locations of test pits and boreholes**

The site is located at McCain's Delmas plant, near the town of Delmas Mpumalanga Province. Refer to Figure 2-1 for the location of the site and Figure 2-2 for a zoomed in image of the site and various test pits and percussion boreholes.

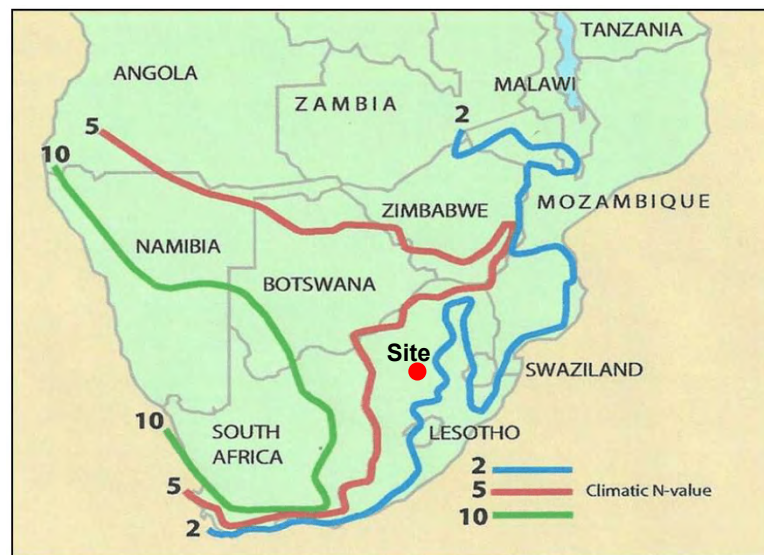
**Figure 3-1: Climatic N-Value after Weinert (1978)**

The site has a Weinert (1978) climatic N value of between 2 and 5. A Weinert N value of 2 – 5 indicates chemical weathering (decomposition) to be dominant over mechanical (disintegration) weathering.

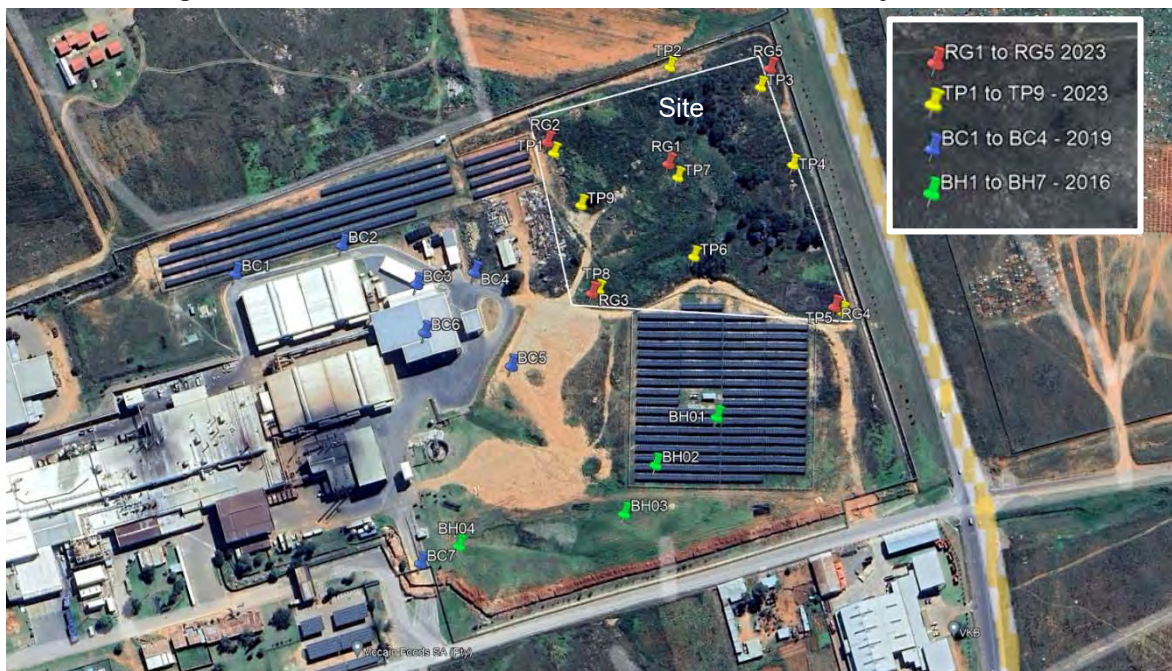
**Figure 3-3: Locations of historical boreholes in the vicinity of the site**

The historical reports include six percussion boreholes (BC1 to BC6), drilled in 2019, 80m to 300 m to the west of the site by JK Developments under direction of consultancy Martin van der Walt Engineering Geologist (van der Walt, 2016), for and on behalf of McCain, and four boreholes (BH1 to BH4) to the south and west of the site, drilled in 2016 by Hennie Erwee Drilling Contractors, under direction of Golder Associates (Nkosi and Marais, 2019) also for and on behalf of McCain. Please refer to Table 3-1 for a list of historical boreholes and to Figure 3-3 below for the locations of boreholes (blue and green pins) relative to the current investigation (yellow and red pins).

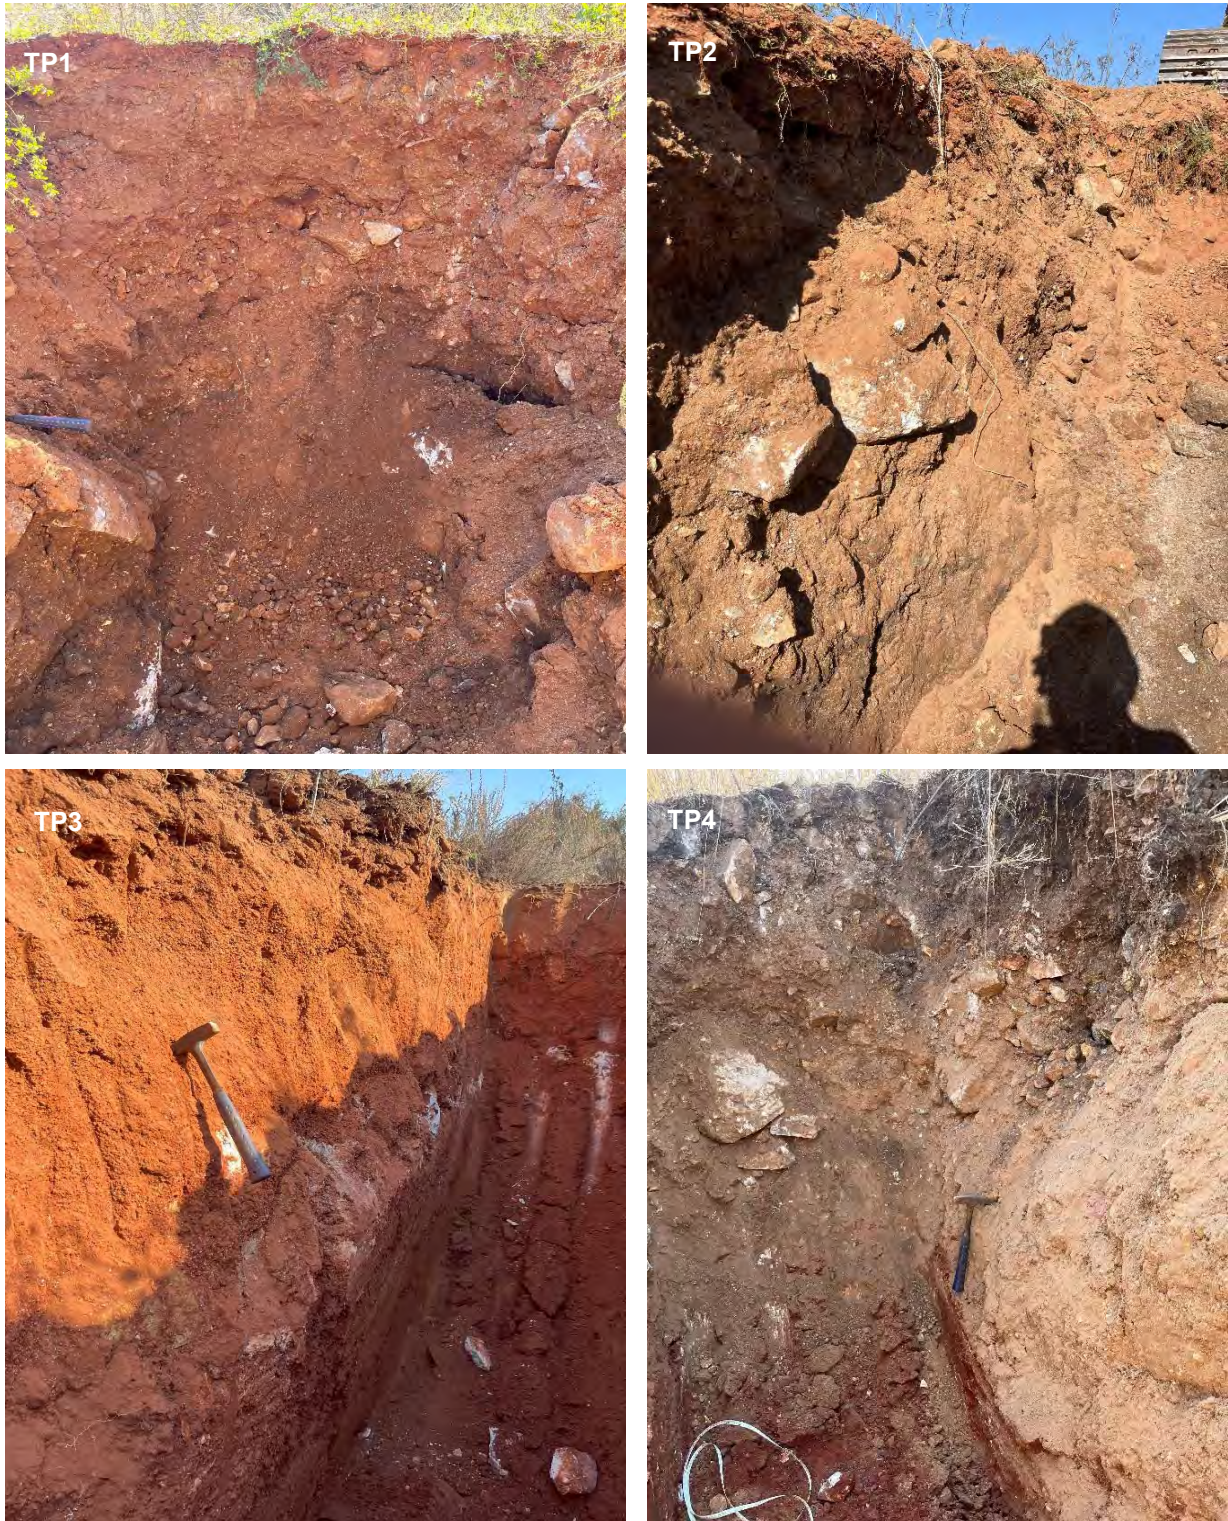
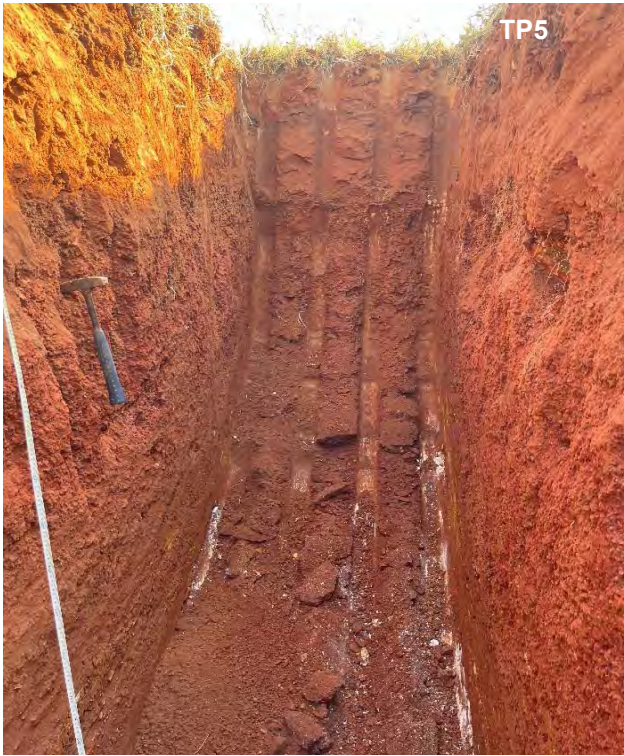
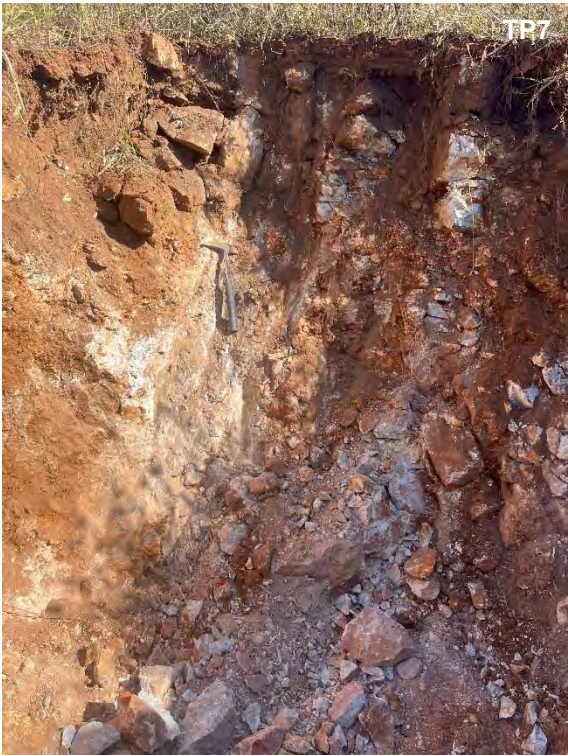
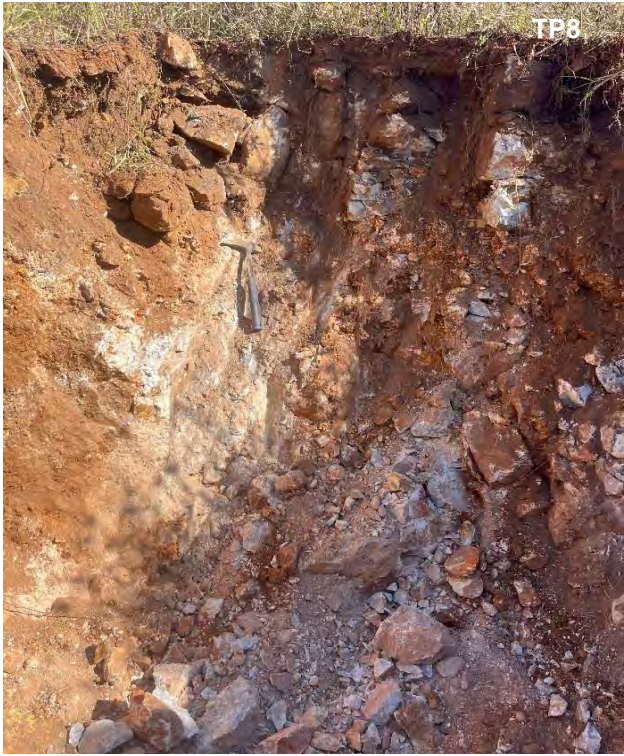
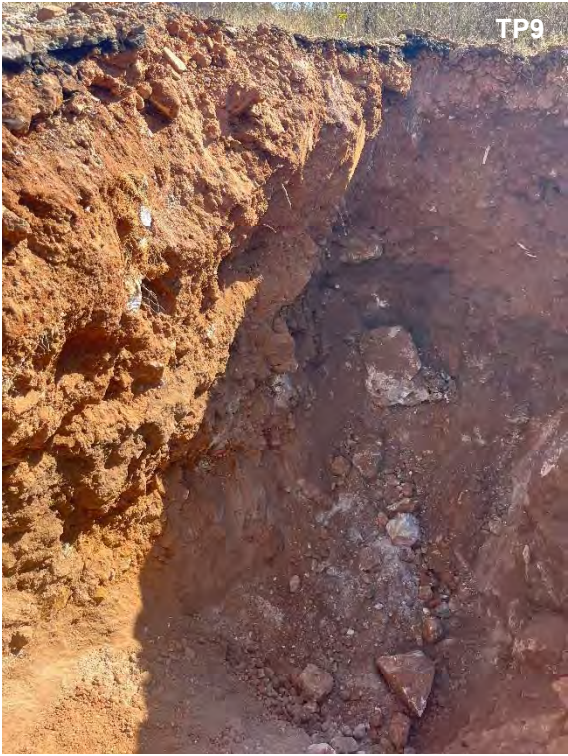
Figure 3-5: Images of the test pits

The majority of the site is overlain by fill comprising very loose to medium dense chert gravel, cobbles, boulders, building rubble and domestic waste in a matrix of silty to clayey sand. The fill is thickest in the vicinity of TP6 – TP9 (1.3m ≥3.4m). The fill was absent from test pits TP3 and TP4 while TP2 only intersected a 0.2m layer of fill.

The fill is underlain by a transported layer (hillwash and colluvium) of very loose to very dense silty to clayey sand with gravel to chert gravel, cobbles and boulders packed in a silty to clayey sand matrix. The transported materials had a slightly pinholed soil structure which is typical of collapsible soils. The transported layer had a thickness of about 1.3m to 2.3m in the test pits.

A pebble marker layer, consisting of dense clayey to sandy gravel, separated the overlying transported materials and underlying chert residuum in TP4 and TP5 and had a thickness of 0.3m – 1.0m.

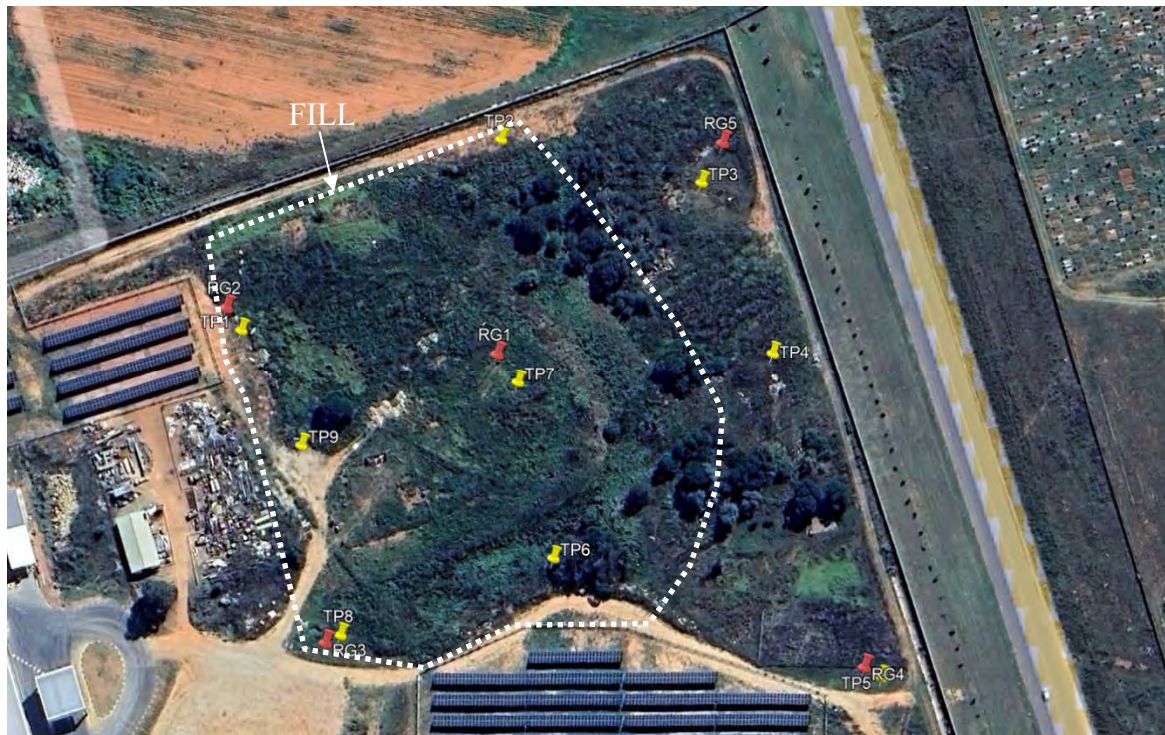
**Figure 3-6: Locations of test pits and boreholes**

Nine test pits labelled TP1 – TP9, were excavated on 21 June 2023, at the locations given in Figure 3-6 below. The horizons encountered in the test pits are summarised in the table below and the soil profile logs are contained in Appendix A. Images captured of the various test pits are given in Figure 3-5 below.
