# Berth 605 Biodiversity Compensation Plan

Development of New Berth 605 and Associated Infrastructure

**REPORT (VERSION D) PUBLIC**

**PROJECT NO. 43102871**

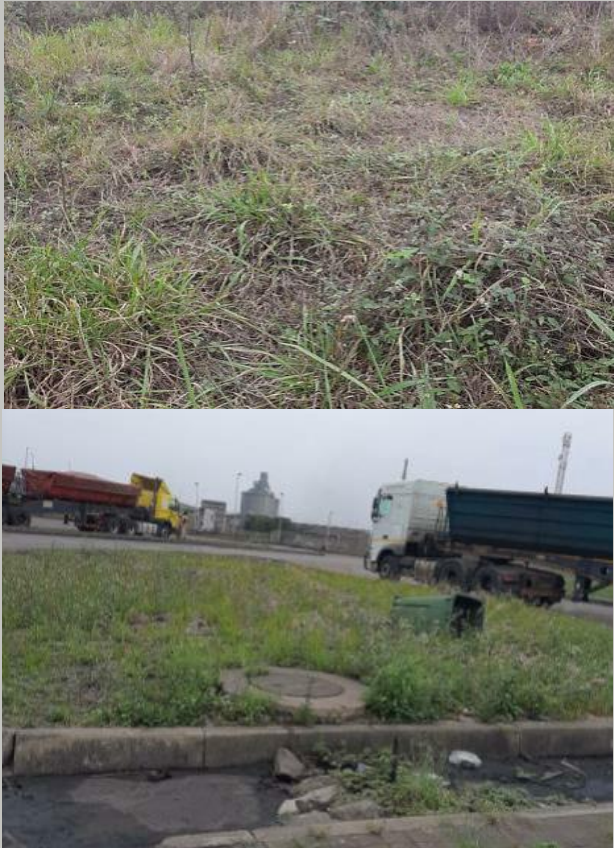
| Habitat Unit | Description and SEI | Expected SCC |
|---|---|---|
| <p>1- Completely Transformed Area (28°47'12.59"S, 32°1'46.55"E)</p> | <p>Previously disturbed areas in the LSA, with little/no ecological value. Incapable of providing suitable habitat for any SCC.</p> <p><b>SEI: VERY LOW</b></p> | <p>None.</p> |

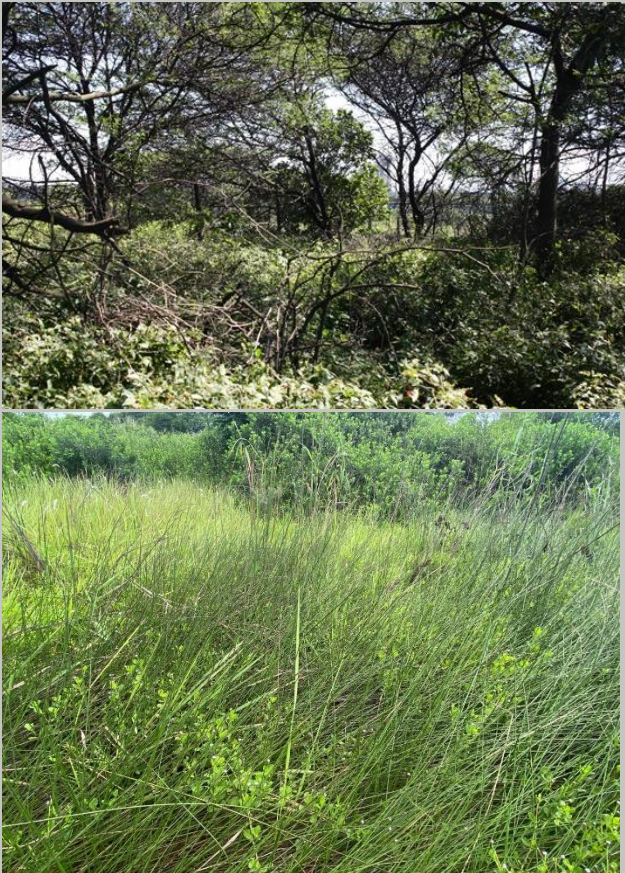
| Habitat Unit | Description and SEI | Expected SCC |
|---|---|---|
| <p>There is a habitat gradient present in this unit, with woodlands occurring south-east (28°47'26.19"S, 32° 1'50.57"E) and grasslands occurring north-west (28°47'19.92"S, 32° 1'44.25"E).</p> | <p>disturbance or previous transformation.</p> <p>Remanent woodland habitat includes <i>Vachellia kosiensis</i> secondary woodlands, <i>Cassuarina equisetifolia</i> secondary woodlands and Sub-community <i>Lantana camara</i>–<i>Schinus terebinthifolius</i> secondary shrublands.</p> <p>Remanent grassland habitat includes <i>Schinus terebinthifolius</i>, <i>Washingtonia robusta</i>, <i>Chromolaena odorata</i>, <i>Casuarina equisetifolia</i>, and artificial changes in the drainage of the landscape.</p> <p><b>SEI: MEDIUM</b></p> | <ul style="list-style-type: none"> <li>■ <i>Dioscorea sylvatica</i> – Can persist in disturbed forest margins and secondary woodland.</li> <li>■ <i>Bonatea lamprophylla</i> – Found in grasslands and forest edges; moderately disturbance-tolerant.</li> <li>■ <b><i>Mimusops caffra</i></b> – Coastal forest species that can survive in secondary thickets and disturbed areas.</li> <li>■ <b><i>Sideroxylon inerme</i></b> – Hardy species; often found in degraded coastal forest and woodland edges.</li> </ul> <p><b>Mammal SCC</b></p> <ul style="list-style-type: none"> <li>■ Blue Duiker – Can adapt to secondary forests and thickets.</li> <li>■ Red Duiker – Shows some tolerance to fragmented and secondary forest habitats.</li> <li>■ Common Dasymys – Found in moist grasslands and tolerant of agricultural and disturbed wetland edges.</li> <li>■ Least Dwarf Shrew – Occurs in grassy and shrubby areas, including disturbed zones.</li> <li>■ <b>African Clawless Otter</b> – Uses human-modified wetlands and riverbanks.</li> <li>■ Anchieta's Pipistrelle, Light-winged Lesser House Bat, Butterfly Bat – Roost in buildings and forage in disturbed woodland and grassland mosaics.</li> </ul> <p><b>Herpetofauna SCC</b></p> <ul style="list-style-type: none"> <li>■ Spotted Shovel-nosed Frog – Found in disturbed grasslands and temporary wetlands.</li> </ul> |

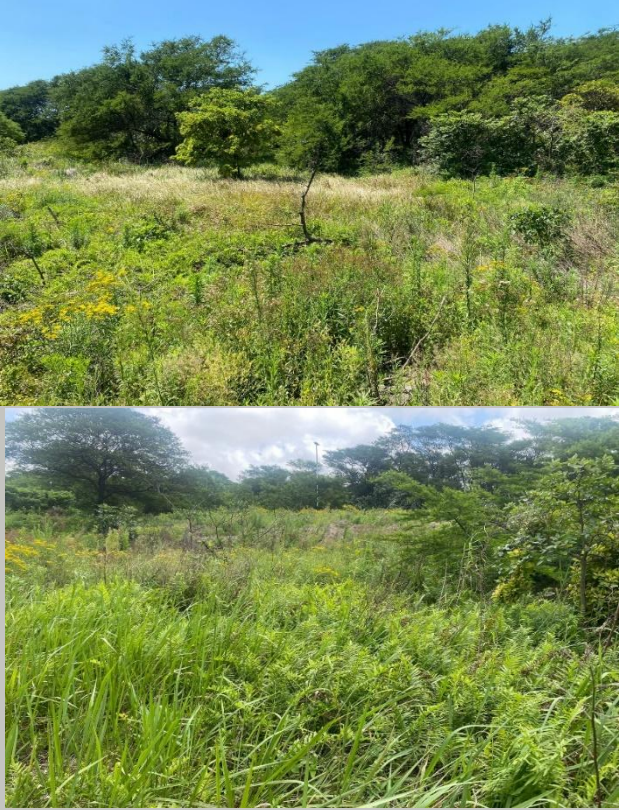
| Habitat Unit | Description and SEI | Expected SCC |
|---|---|---|
| <p>3- Moist Grasslands (28°47'24.58"S, 32° 1'28.21"E)</p> | <p>There is limited anthropogenic disturbance in this habitat unit. Wetland and grassland ecosystem functioning still occurs. Faunal and floral species are present. In addition, the area provides habitat connectivity and ecosystem corridors.</p> <p>Moist grasslands in South Africa are typically found in high-altitude or coastal lowland regions with moderate to high rainfall, supporting a rich diversity of grasses, forbs, and geophytes</p> <p>These ecosystems are characterized by deep, fertile soils, seasonal waterlogging, and a dense herbaceous layer dominated by C4 grasses. Moist grasslands often occur in valley bottoms, floodplains, and gentle slopes, where water retention is higher, and are interspersed with wetlands, seeps, and occasional woody vegetation. They provide critical habitat for a range of specialist fauna, including amphibians, small mammals, and grassland-dependent birds.</p> <p><b>SEI: MEDIUM</b></p> | <p><b>Herpetofauna SCC</b></p> <ul style="list-style-type: none"> <li>■ Gaboon Adder (<i>Bitis gabonica</i>) – Prefers moist, forested grasslands and thickets; known from northern KwaZulu-Natal.</li> <li>■ Spotted Shovel-nosed Frog (<i>Hemisus guttatus</i>) – Associated with moist grasslands and wetlands; often found in interdune depressions.</li> <li>■ Pickersgill's Reed Frog (<i>Hyperolius pickersgilli</i>) – Critically Endangered; endemic to coastal moist grasslands and reed beds in KwaZulu-Natal.</li> </ul> <p><b>Avifauna SCC</b></p> <ul style="list-style-type: none"> <li>■ Southern Banded Snake Eagle (<i>Circaetus fasciolatus</i>) – Utilizes Forest edges and moist grasslands for hunting.</li> <li>■ Spotted Ground Thrush (<i>Geokichla guttata</i>) – Prefers dense, moist forest undergrowth and adjacent grasslands; vulnerable due to habitat fragmentation.</li> </ul> <p><b>Plant SCC</b></p> <ul style="list-style-type: none"> <li>■ <i>Dioscorea sylvatica</i> – Occurs in moist forest margins and grasslands; vulnerable due to harvesting and habitat loss.</li> <li>■ <i>Bonatea lamprophylla</i> – Found in moist grasslands and forest margins; rare and localized.</li> <li>■ <i>Ficus trichopoda</i> – Associated with swamp forests and moist lowland areas.</li> <li>■ <i>Barringtonia racemosa</i> – Found in swampy areas and estuarine margins; overlaps with moist grassland ecotones.</li> </ul> |

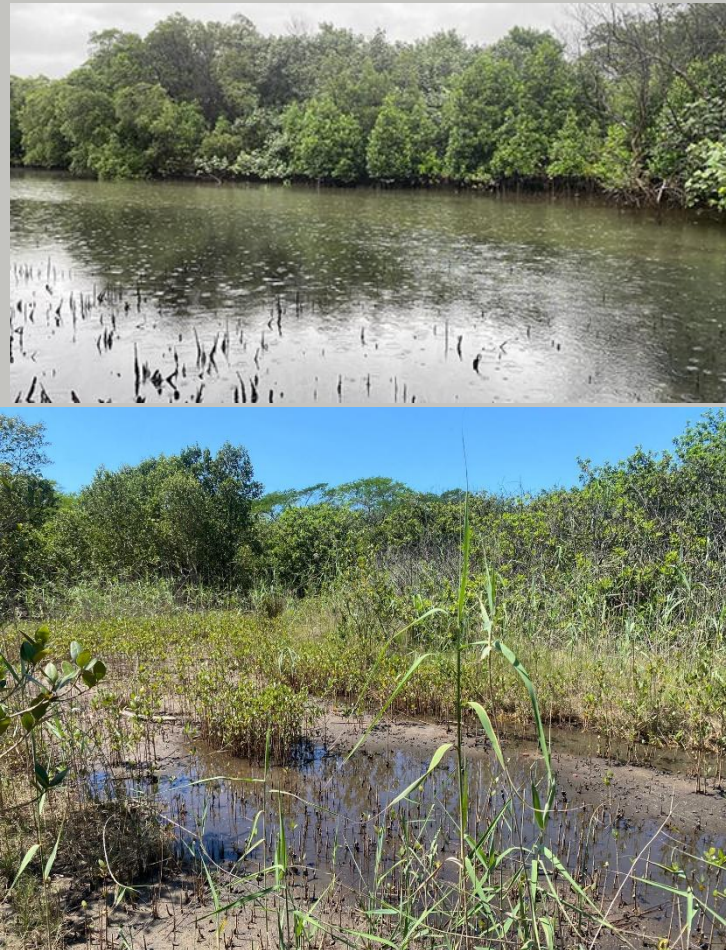
| Habitat Unit | Description and SEI | Expected SCC |
|---|---|---|
| <p>4- <i>Bruguiera gymnorhiza</i> mangrove forests (28°47'28.39"S, 32° 1'31.93"E)</p> | <p><i>Bruguiera gymnorhiza</i> is a mangrove species found in the intertidal zones of estuaries and sheltered coastal areas throughout tropical and subtropical regions. It typically occupies the landward margins of mangrove forests, where tidal inundation is less frequent but soils remain brackish, muddy, and oxygen poor.</p> <p>This species thrives in fine alluvial sediments, often forming dense stands along estuarine banks and creek edges. It is adapted to daily tidal flooding, and its knee roots (a form of aerial root) facilitate gas exchange in anaerobic soils while stabilizing the substrate. <i>Bruguiera gymnorhiza</i> is often found in association with other mangrove species such as <i>Rhizophora mucronata</i> and <i>Avicennia marina</i>, contributing to the structural complexity and ecological resilience of mangrove ecosystems.</p> <p>Its tolerance to salinity and sedimentation makes it a key species in coastal protection, carbon sequestration, and nursery habitat provision for estuarine fauna.</p> <p><b>SEI: VERY HIGH</b></p> | <p><b>Plant SCC</b></p> <ul style="list-style-type: none"> <li>■ <i>Bruguiera gymnorhiza</i> (Black Mangrove) – Core mangrove species; thrives in intertidal mudflats and estuarine zones</li> <li>■ <i>Avicennia marina</i> (White Mangrove) – Found in seaward mangrove zones; tolerant of salinity and tidal fluctuations.</li> <li>■ <i>Rhizophora mucronata</i> (Red Mangrove) – Common in sheltered estuarine areas; forms dense mangrove stands.</li> <li>■ <i>Barringtonia racemosa</i> – Occurs in swamp forests and estuarine margins; transitional between mangrove and freshwater systems.</li> <li>■ <i>Ficus trichopoda</i> – Found in swampy, estuarine environments; overlaps with mangrove ecotones.</li> <li>■ <i>Zostera capensis</i> (Cape Eelgrass) – Found in shallow estuarine waters near mangrove zones; recorded (28° 47' 31.39" S, 32° 01' 29.99")</li> </ul> <p><b>Mammal SCC</b></p> <ul style="list-style-type: none"> <li>■ <b>African Clawless Otter</b> – Uses mangrove creeks and estuarine channels for foraging.</li> <li>■ Common Hippopotamus – May utilize estuarine floodplains adjacent to mangroves.</li> <li>■ Sundevall's Leaf-nosed Bat, Geoffroy's Horseshoe Bat, Schreibers's Long-fingered Bat, Butterfly Bat – Roost in forested areas near mangroves; forage over wetlands.</li> <li>■ Swynnerton's Horseshoe Bat, Anchieta's Pipistrelle, Light-winged Lesser House Bat</li> </ul> |

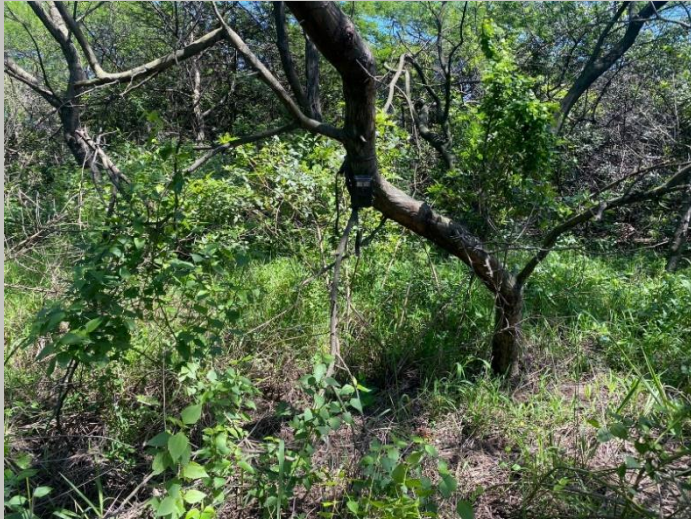
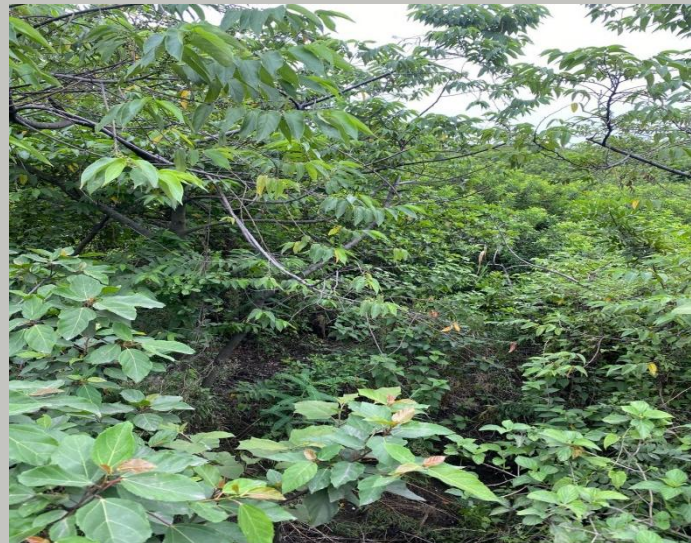
| Habitat Unit | Description and SEI | Expected SCC |
|---|---|---|
| 5- Coastal Forest (28°47'30.57"S 32°, 1°33.00"E) | South Africa's coastal forests are found along the eastern seaboard, primarily in KwaZulu-Natal and the Eastern Cape, where warm, moist climatic conditions support a rich | <p><b>Plant SCC</b></p> <ul style="list-style-type: none"> <li>■ <b><i>Adenia gummifera</i> var. <i>gummifera</i></b> – Found in forest margins and coastal thickets.</li> </ul> |

diversity of evergreen and semi-deciduous tree species. These forests typically occur on dune systems, low-lying coastal plains, and riverine floodplains, often forming part of a mosaic with mangroves, swamp forests, and grasslands. The vegetation is structurally complex, with a closed canopy, dense understorey, and high species richness, including many endemics and species of conservation concern.

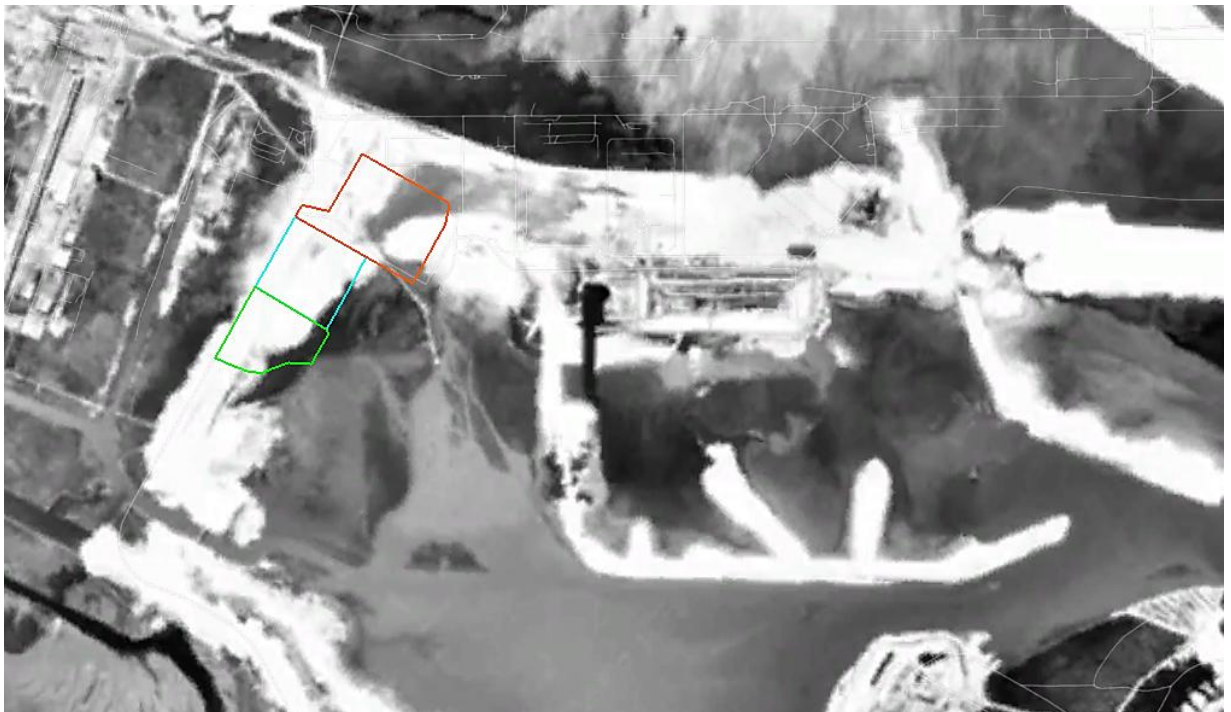
**1975** The project and compensation areas in relation to initial sand backfill and stabilisation as part of early port development earthworks. Note the redirected river mouth south of Harbour road and the development of a sand barrier north of which the initial Port basin was deepened.

**Figure 4-1 - Aerial views of the project development area (container handling facility footprint in orange, berth basin in blue) and compensation area (in green) over time, to provide an indication of the transformation of the site from prior to development of the port through to current. Time periods shown are 1960, 1975, 1984, 1997, 2004, 2006, 2015 and 2026.**

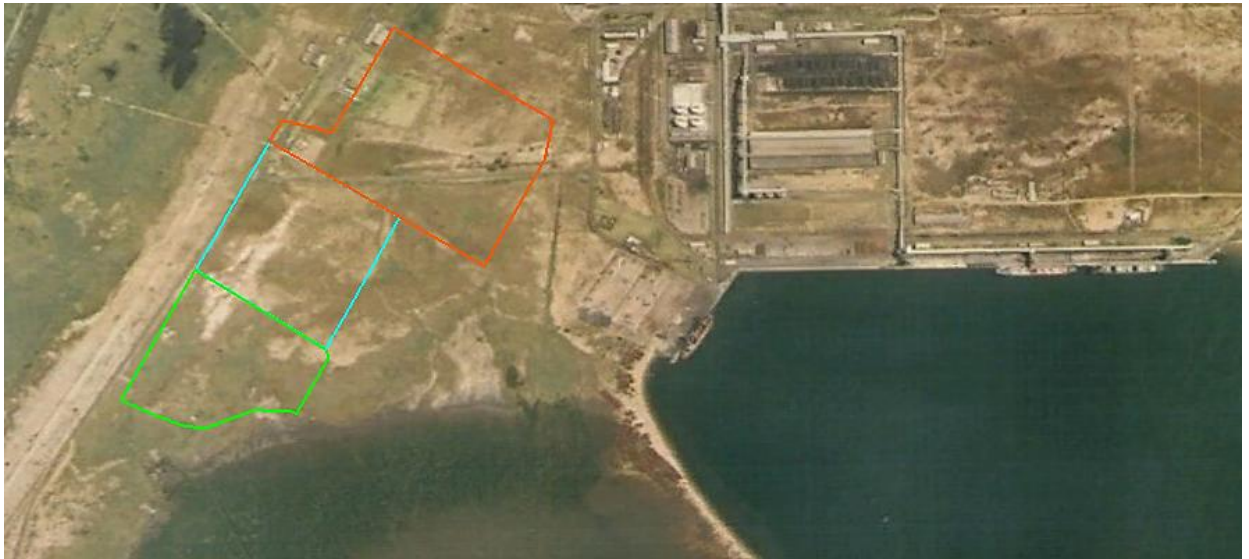
**1984** Grass re-establishment evident on disturbed areas within the project footprint. Note the original estuary edge to the south of the compensation area. No woody vegetation present. The original sand barrier was the precursor to the current sand spit and still connected to land

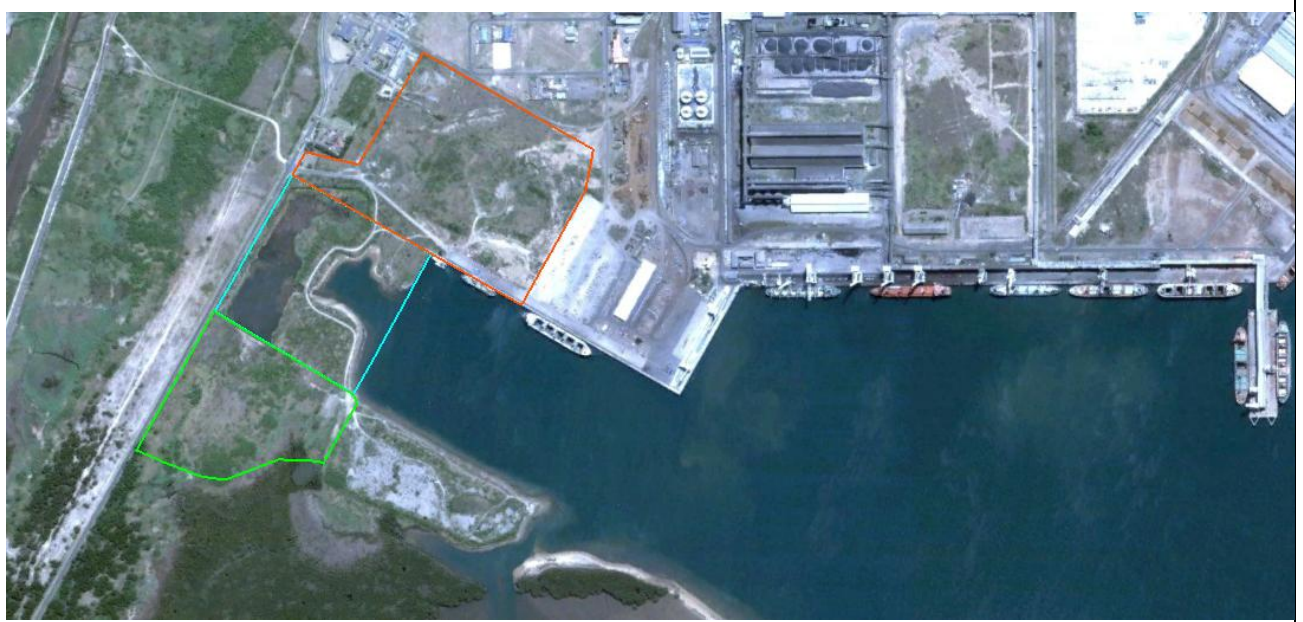
**2004** Note the extent to which excavated materials from the 600 series berth basin have settled / sloughed into the mangroves. Note also the extent to which disturbance has pushed into the compensation area

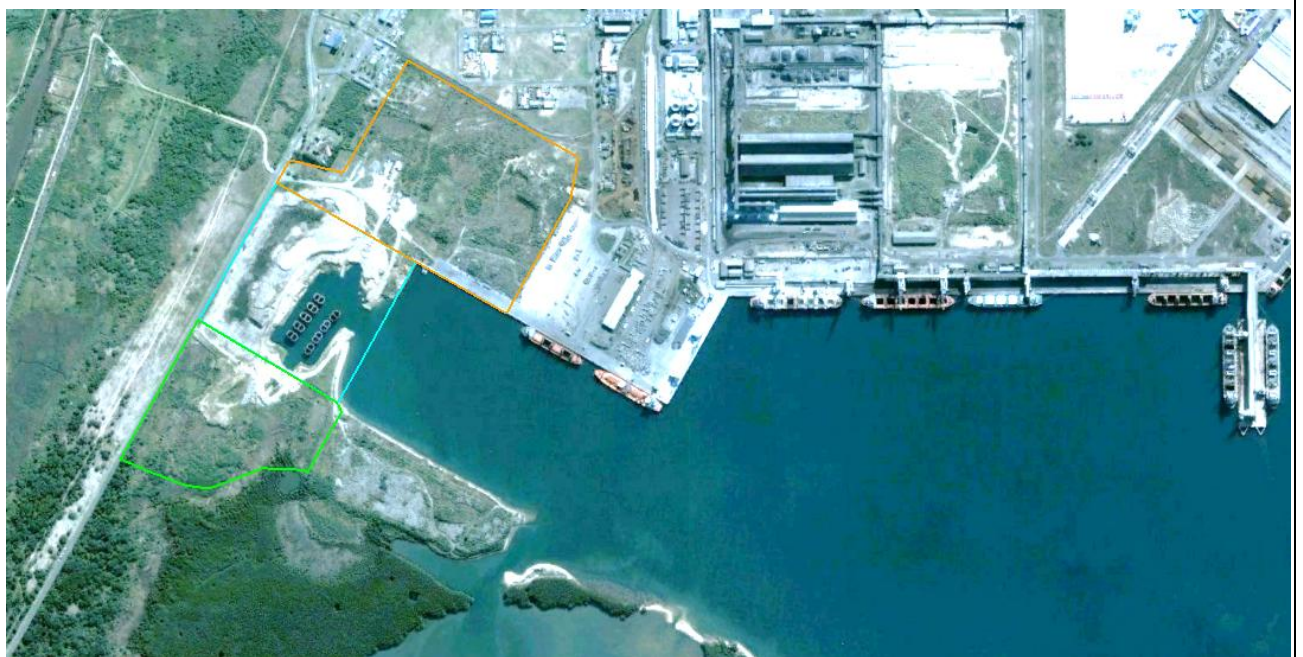
**2006** Reshaping in the Berth 605 basin to create what has become the mangrove tidal pool. Note the commencement of natural establishment of woody vegetation in the compensation area and on the adjacent eastern rock terrace. Note the limited vegetation development on material sloughed into the mangrove zone

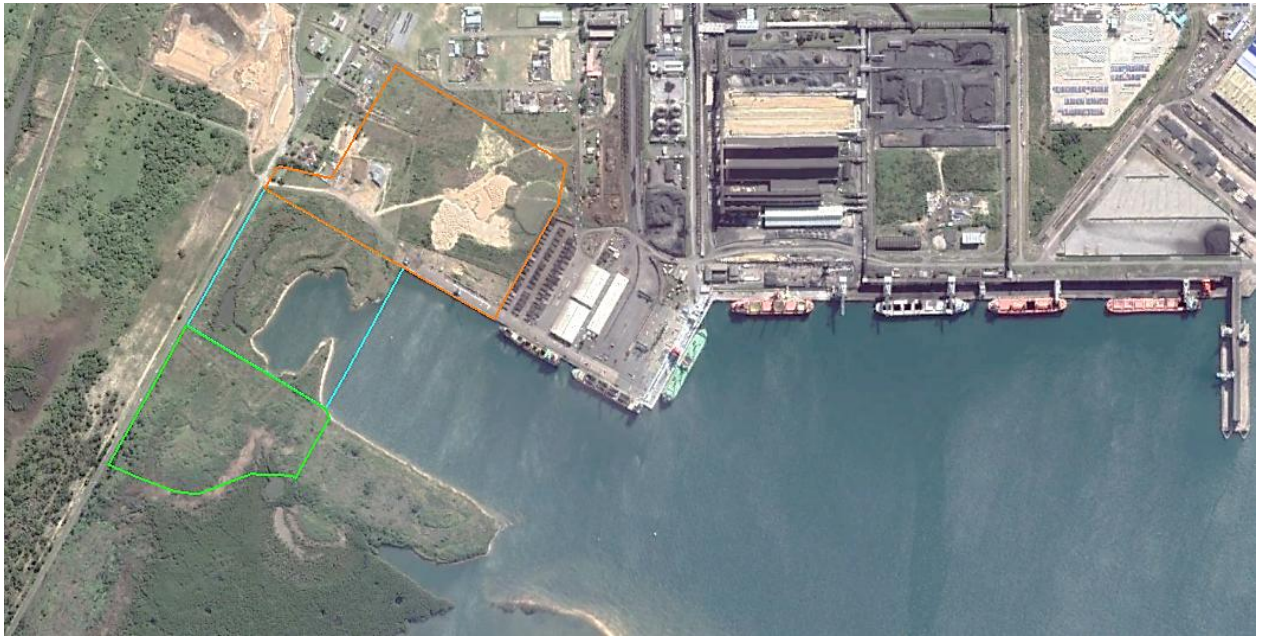
**2015** Compensation area and berth basin (green and blue) show signs of recovery while there is ongoing materials storage and handling within the container footprint. Note start of mangrove development within the tidal pool and woody vegetation developing within compensation area

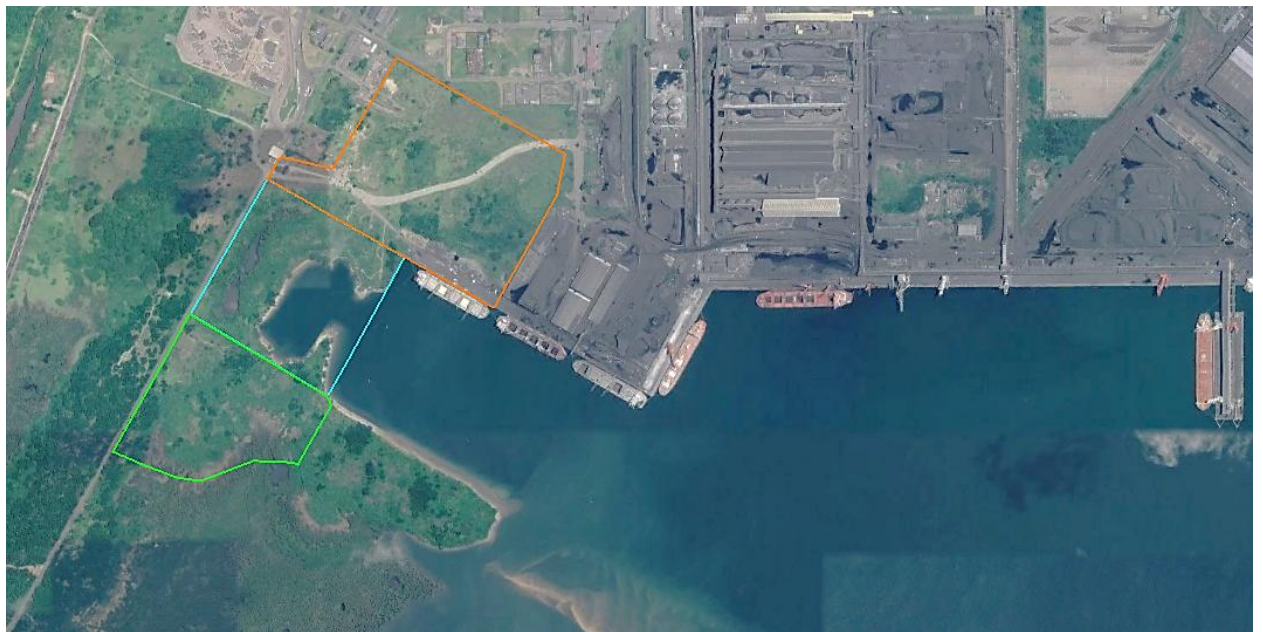
**2026** Nominal disturbance at the site other than road traffic passing through the container facility footprint. Berth basin and compensation areas progressing towards coastal forest. Sand spit continues to erode

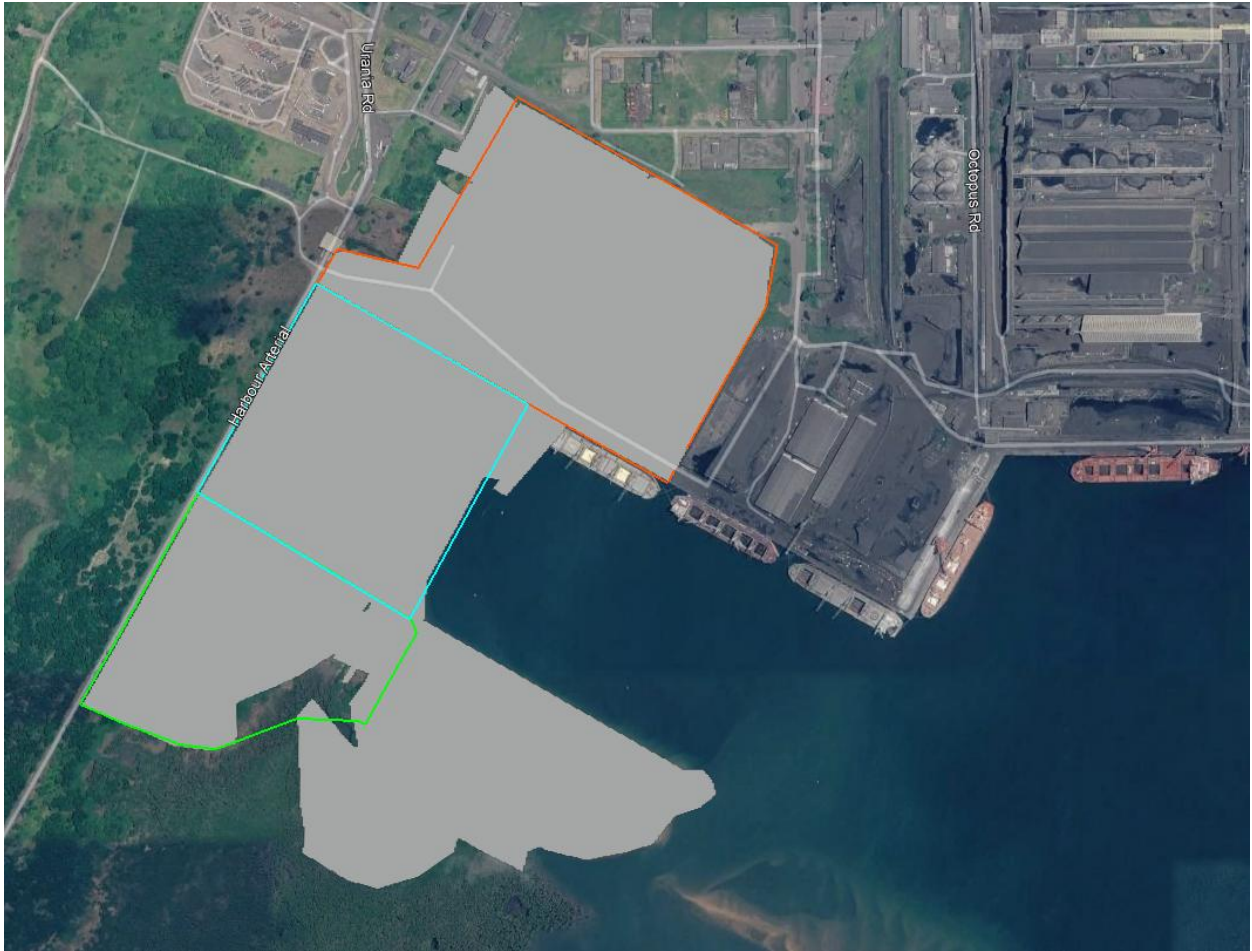
**Figure 4-3 - Combined footprint of disturbance within the project and compensation areas, reflecting all disturbance evident since development of the Port commenced in 1975 to date**
