# THE PROPOSED SASOL SECUNDA GAS TO POWER FACILITY

Geotechnical Site Sensitivity Verification Report

REPORT (REV0) CONFIDENTIAL

PROJECT NO. ZA0068671.2768

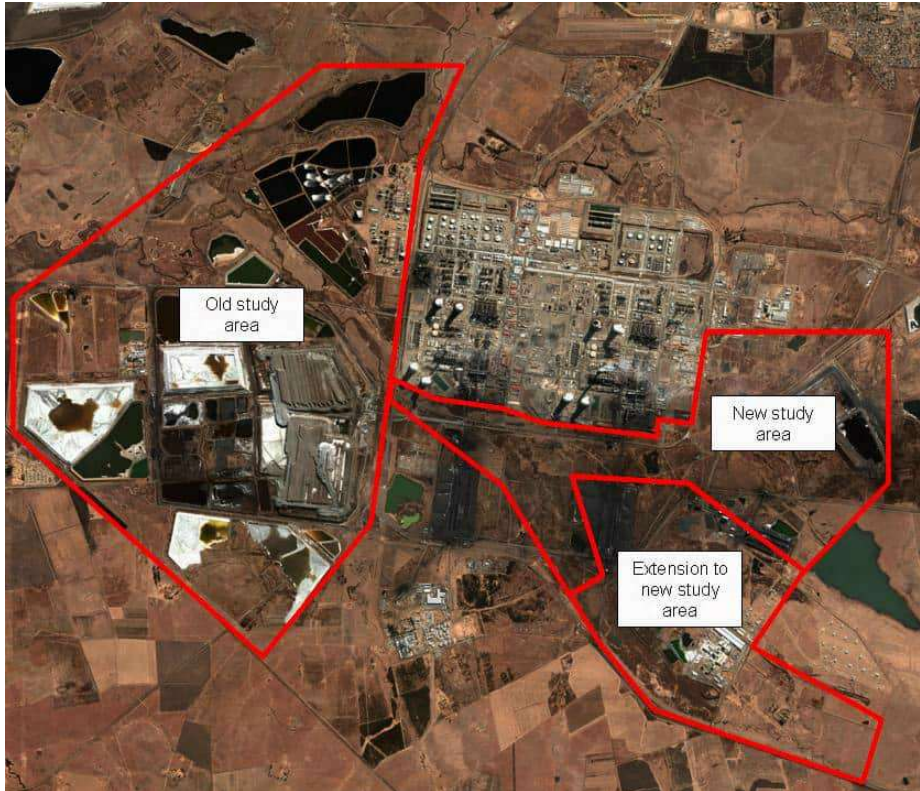
Figure 1 shows the old as well as the new study area. The extension to the new study area is also shown. A fundamental difference between the previous study area and the new study area is that contaminated surface runoff contributes a large percentage of the pollutants in the new study area. In the old study area, pollutants reaching the stream were mostly from seepage sources. This theory was based on the monitoring results during rainfall events. Surface water modelling was therefore included in the new study.

**Figure 1 Study areas covered during this and the previous seepage study**

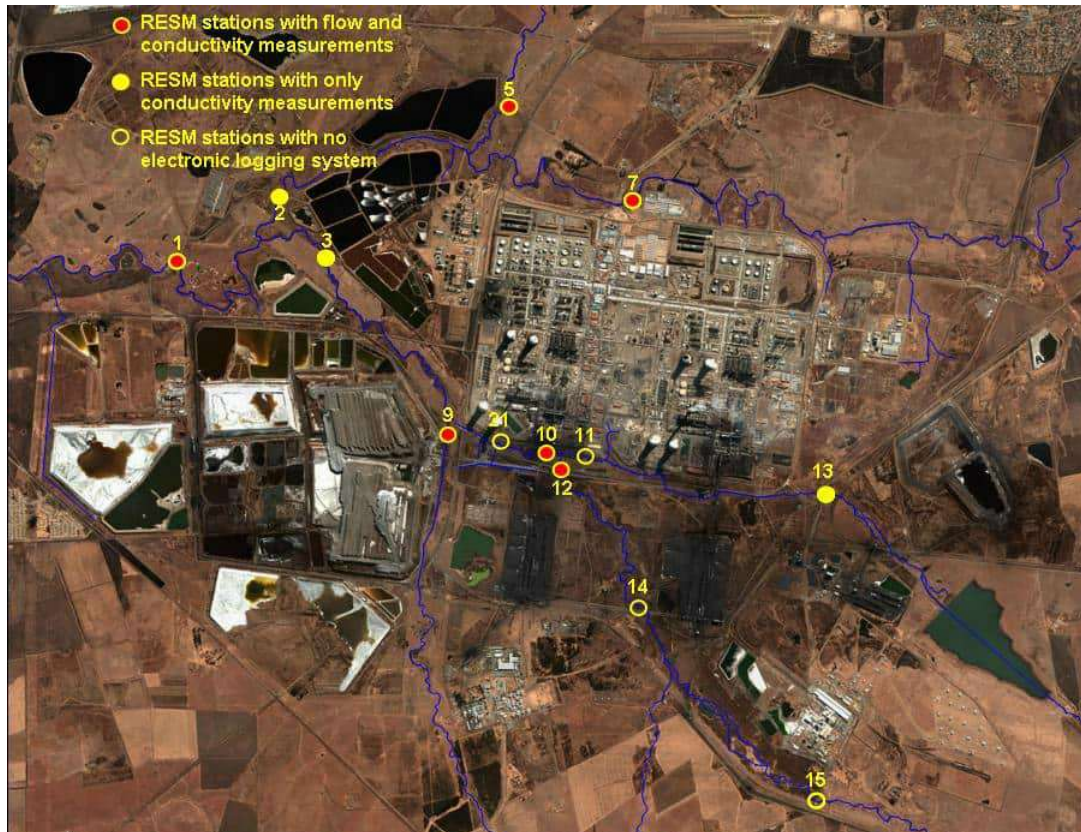
The positions of the RESM stations are indicated in Figure 2. The 15 minute database from 1 January 2002 to 4 September 2006 from the relevant RESM stations was analysed. In an attempt to reduce the data, daily and monthly (31 day) averages were calculated and a second database was produced.

Only five RESM stations with electronic logging systems are applicable to this study. These are shown in Figure 2 and may be summarised as follows:

- RESM 13      Bossiespruit before confluence with the Groot Bossiespruit
- RESM 12      Groot Bossiespruit before confluence with the Bossiespruit
- RESM 3 & 10   Bossiespruit after confluence with the Groot Bossiespruit
- RESM 1      Kleinspruit (after confluence of Bossiespruit & Trichardspruit)

**Figure 2 Relevant RESM stations in and around the study area**

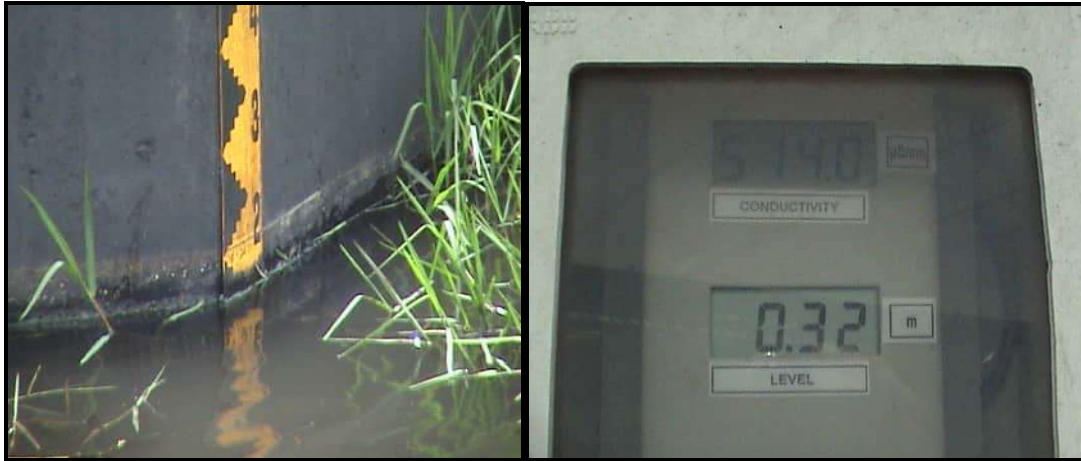
Depth measurements are made by means of pressure transducers and logged electronically. An electronic display of the transducer output has been installed at the RESM stations as shown in Figure 4. These transducers are installed at a fixed depth below the weir and hence an offset specific to each weir, is used. Depth measurements can also be made manually using the gauge plate installed at each RESM station as shown in Figure 4.

**Figure 4 Weir gauge plate as well as the electronic display for depth and conductivity**

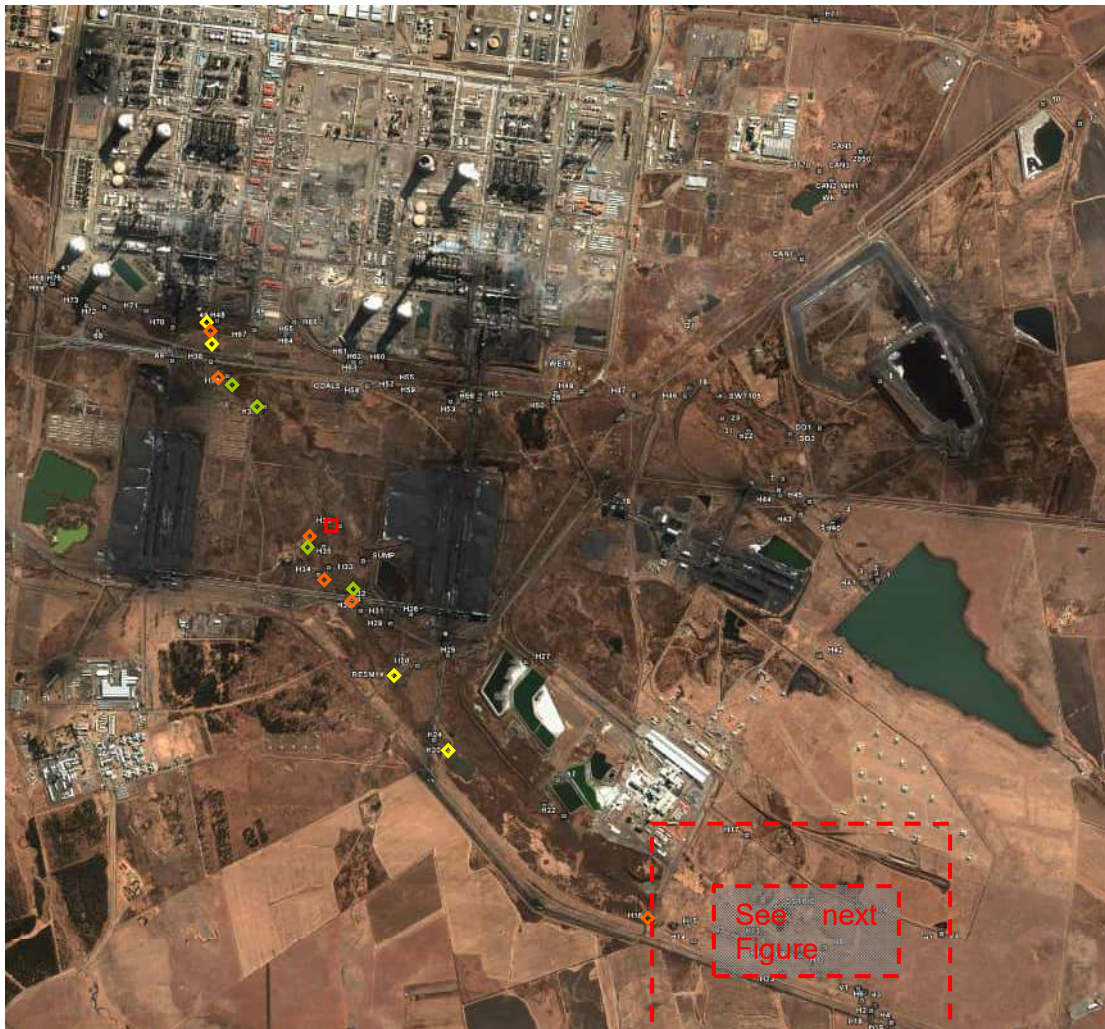
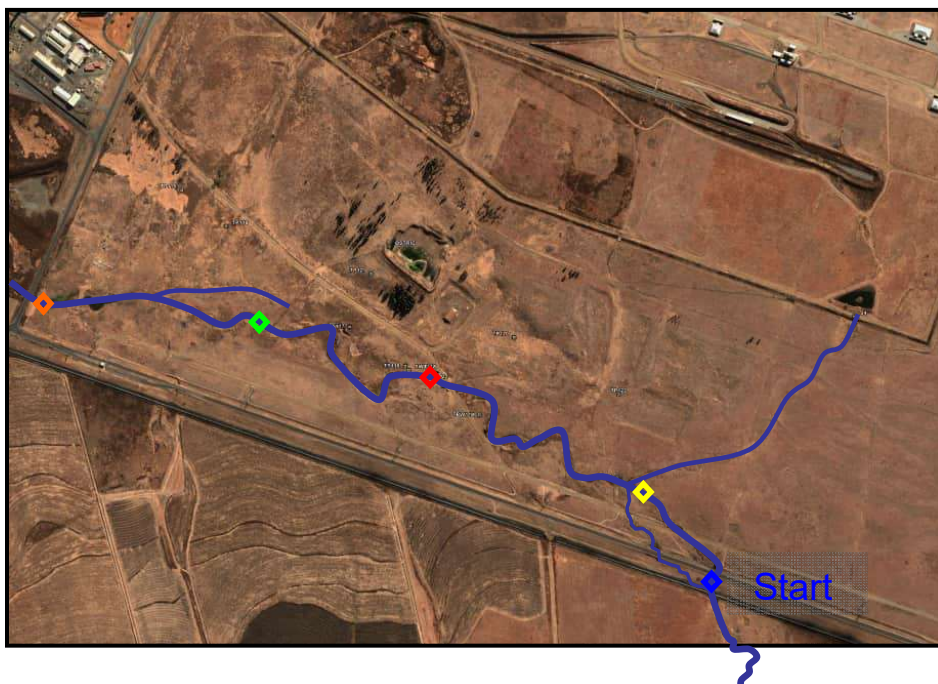
The results of the low flow stream survey of the Groot Bossiespruit in terms of conductivity and rate of change in conductivity are summarised in Figure 18, Figure 19 and Figure 20. The coloured markers represent the rate of change in conductivity between two points as described in Table 3. Electrical conductivity measurements along the river vary from 310  $\mu\text{S}/\text{cm}$  to 2,830  $\mu\text{S}/\text{cm}$ . The volume of water in the river was very low, the upper sections of the stream seemingly stagnant.

As mentioned previously, the original scope of work was restricted to the area downstream of RESM 15 (solid line in Figure 18) as the upstream area was also investigated previously. The stream survey revealed that the conductivity of the Groot Bossiespruit entering the study area was already relatively high (2,145  $\mu\text{S}/\text{cm}$ ). Further investigation was thus required upstream of RESM 15 and consequently, the scope of work was revised to include this area as shown on Figure 20. An additional survey was carried out six weeks later (broken line in Figure 18). Due to some rainfall in the interim period, the conductivity measurements were slightly less than before, resulting in a slight discontinuity of measurements at RESM 15.

**Figure 18 Graph of conductivity in the Groot Bossiespruit measured during the low flow stream survey**

**Figure 19 Locations of steam survey points during the low flow survey of the Groot Bossiespruit**

**Figure 20 Additional area upstream of RESM 15**

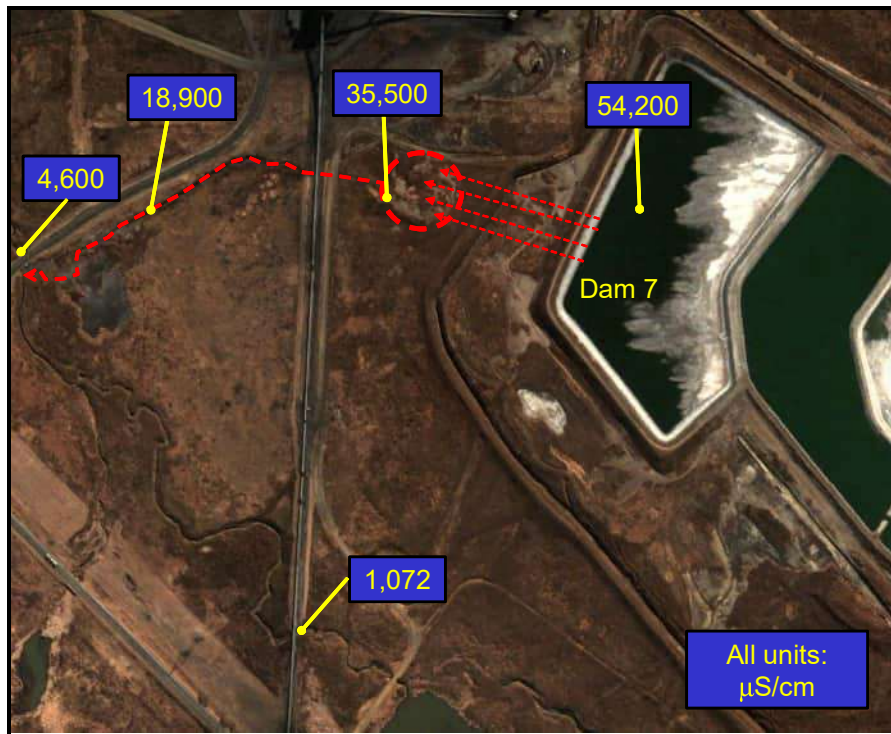
Figure 23 Conductivity measurements in the vicinity of Fertiliser Dam 7

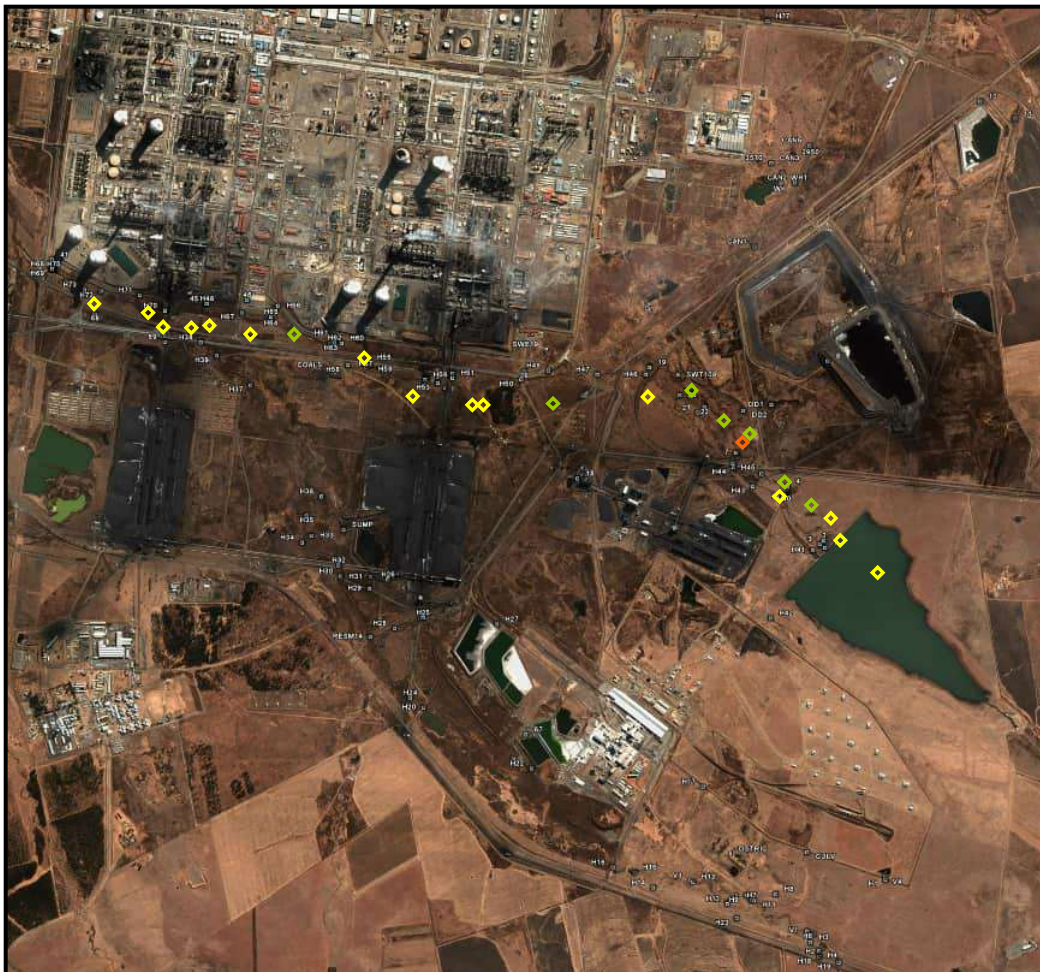
The results of the low flow stream survey of the Bossiespruit in terms of conductivity and rate of change in conductivity are summarised in Figure 26 and Figure 27. The coloured markers represent the rate of change in conductivity between two points as described in Table 3. Electrical conductivity measurements along the river vary from 209  $\mu\text{S}/\text{cm}$  to 512  $\mu\text{S}/\text{cm}$ . Note the almost constant increase in conductivity in this stream. Both the magnitude and the magnitude of variation in conductivity over the length of the river is thus considerably less than that of the Groot Bossiespruit.

Figure 26 Conductivity in the Bossiespruit as measured in low flow stream survey

Figure 27 Conductivity in the Bossiespruit as measured in low flow stream survey

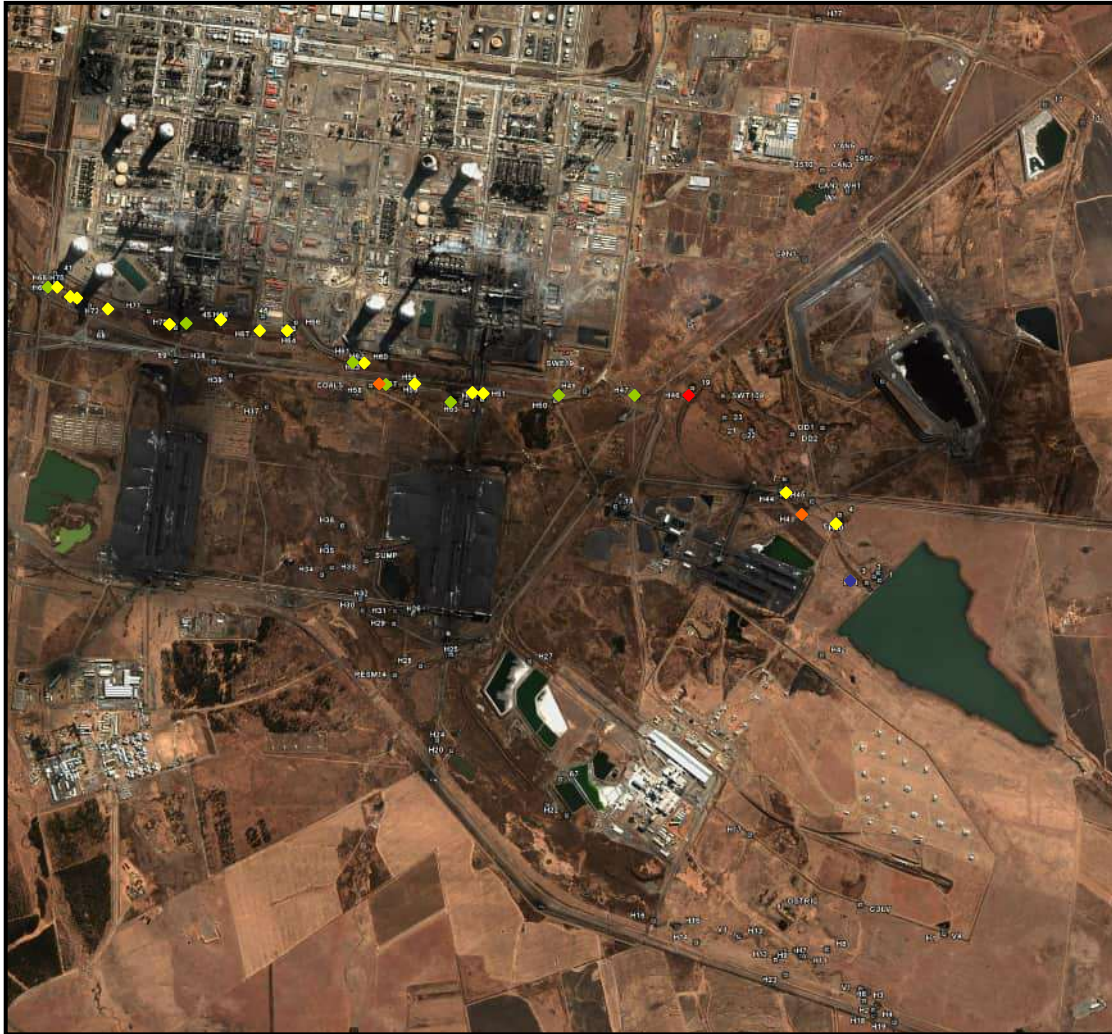
**Figure 29 Conductivity in the Bossiespruit measured in high flow stream survey**

In both stream surveys an increase in conductivity of the Bossiespruit was noted from directly downstream of the Bossiespruit dam to the north-western corner of the railway loop. The upper section of this area, upstream of the railway loop, shows a gradual increase in conductivity. This may be attributed to seepage from the Twistdraai Export plant PC dam on the western side of the Twistdraai Export plant as well as to contamination from coal that has fallen from the conveyor belts crossing the Bossiespruit. The Twistdraai Export plant PC dam was further investigated by testpitting.

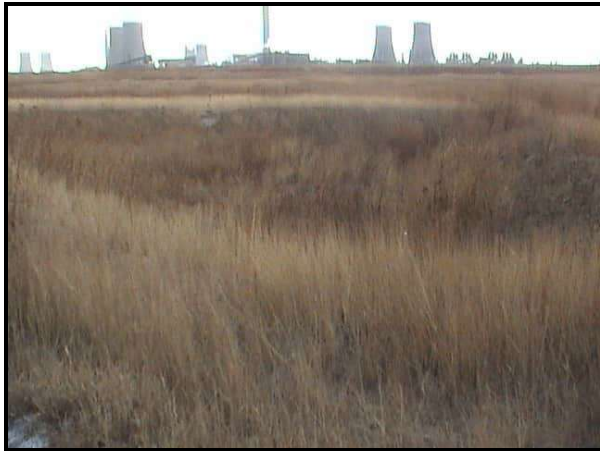
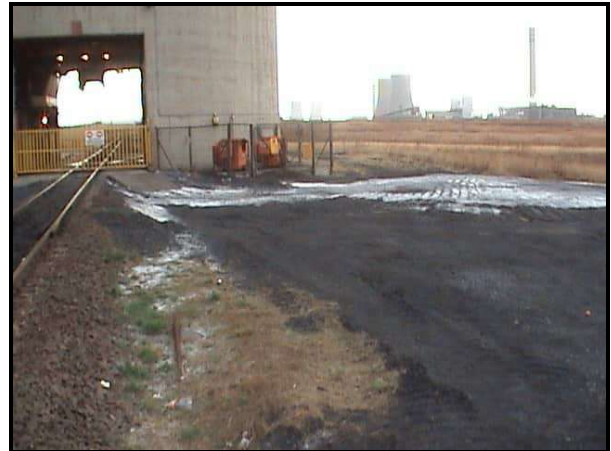
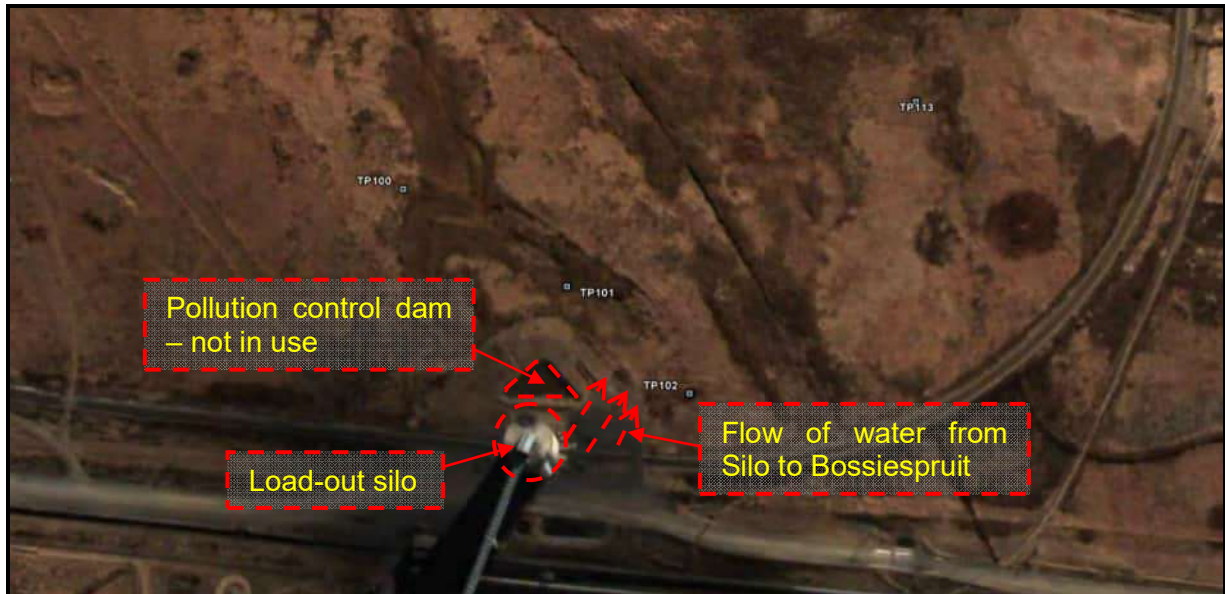
**Figure 30 Load-out silo at Twistdraai Export plant showing a pollution control dam (a), flow of contaminated water towards river past dam (b) and a general layout of the area (c)**

Water from coal stored in the load-out silo flows freely to the wetland that has established itself on route to the Bossiespruit. A pollution control dam has been built between the silo and river to retain this contaminated water as shown in Figure 30a. The water collection system to route the water to this pollution control dam is not functioning, resulting in the flow of water past the pollution control dam as shown in Figure 30b. The general arrangement of the area is shown in Figure 30c.

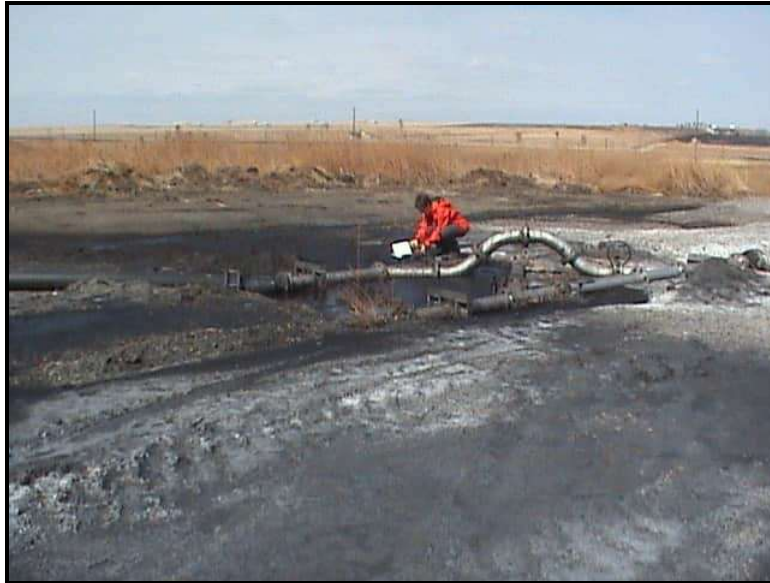
**Figure 31 Photograph of leaking valve below Twistdraai Export plant discard dump**

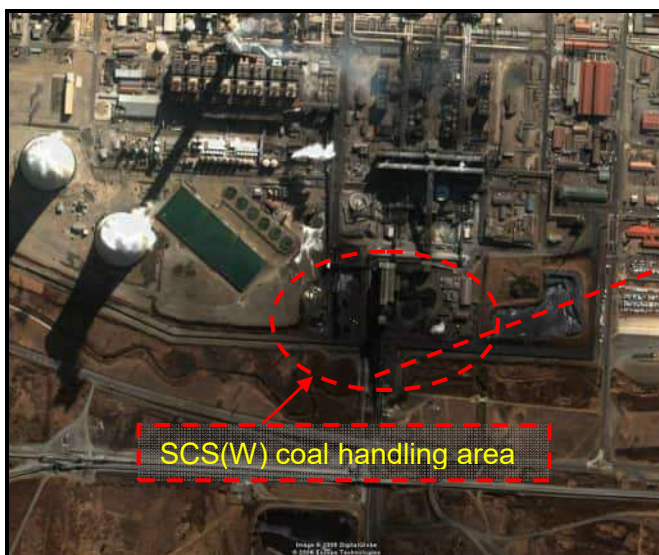
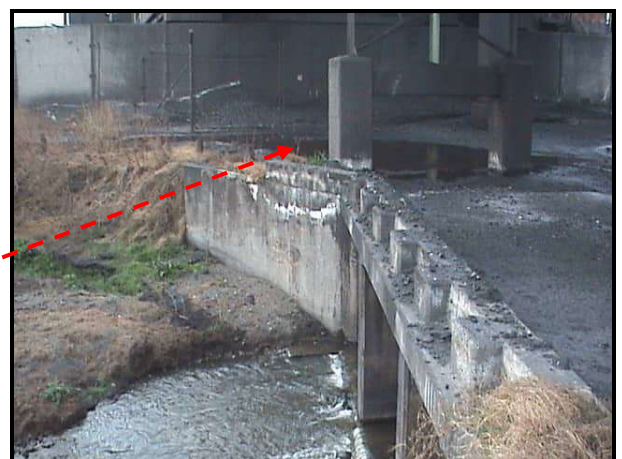
**Figure 32 General layout of (a) and water ponding adjacent to (b) SCS(W) coal handling facility**

The first source identified was runoff water from the drive house and coal handling facility supplying coal to the Synfuels plant from SCS(W), shown in Figure 32b. This area was found to be wet all year round, indicating that process water was seeping out of the area, and that furthermore, no obvious dirty water management (containment) system could be identified to intercept runoff from this area.

This area is associated with the gradual increase in conductivity along the Bossiespruit. As the Bossiespruit is however flowing strongly in this area the contaminant contribution of this area is believed to be high. The area below the conveyor belt next to RESM 12 was found to be very moist all year round as seen in Figure 32.

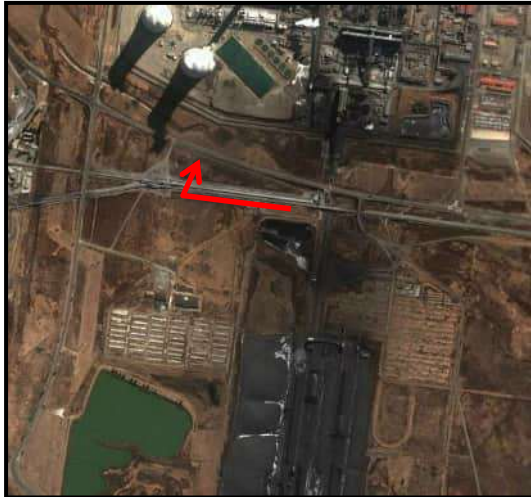
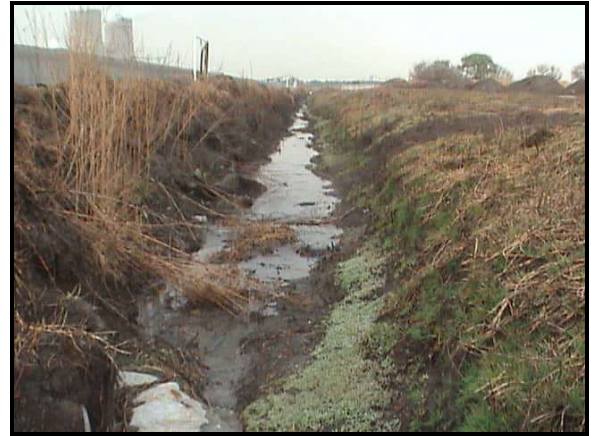
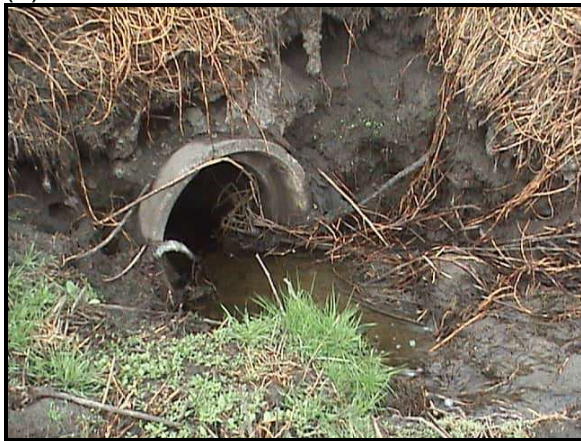
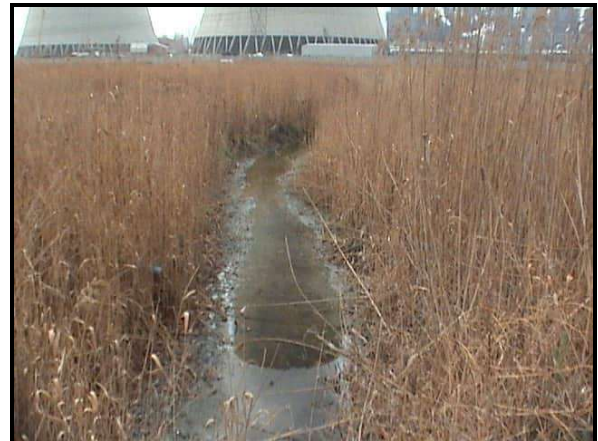
**Figure 33 Water canal north west of SCS(W) showing (a) layout of canal, (b) canal next to conveyor belt, (c) canal crosses conveyor via pipe and (d) canal between conveyor belt and Bossiespruit**

The second source identified in this area is a canal that was originally built to divert clean water around the ash conveyor in the vicinity of SCS(W) as shown in Figure 33. Water in this stream was however found to be highly contaminated with a conductivity of 6,200  $\mu\text{S}/\text{cm}$  during the low flow survey.

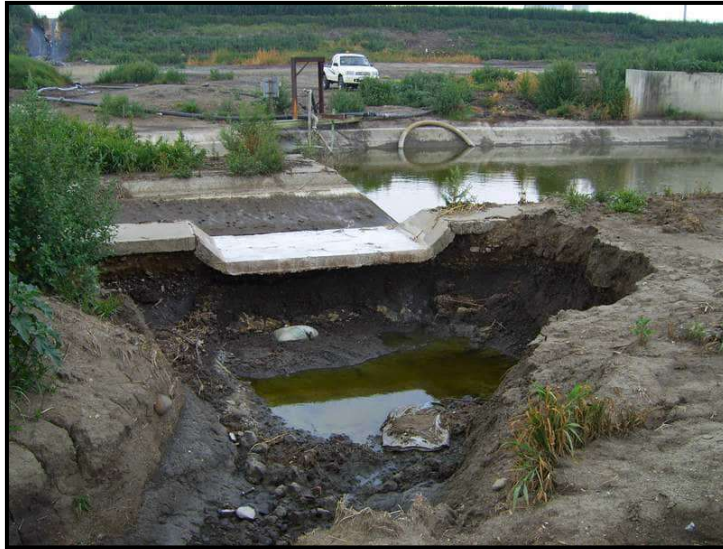
**Figure 37 Erosion downstream of Fertiliser dam 8 due to overtopping**

Runoff from the Fertiliser area is collected in a canal and routed to a pollution control dam known as Fertiliser dam 8 shown in Figure 37. The volume of this dam was estimated to be  $600\text{m}^3$  (by approximating the surface area and depth of the dam). Conductivity in the Groot Bossiespruit increased from  $792\text{ }\mu\text{S/cm}$  upstream to  $1,072\text{ }\mu\text{S/cm}$  downstream of this area during the high flow survey. Furthermore, the conductivity of the small pond that had formed downstream of the dam spillway as shown in Figure 37, was found to be  $4,750\text{ }\mu\text{S/cm}$ .

The spillway of Dam 8 is shown on Figure 37. Erosion downstream of the spillway bears evidence of overtopping of this facility. Although this facility probably has little influence on the stream quality during dry periods, it is clear that it will have a major effect on stream quality during rainfall events.

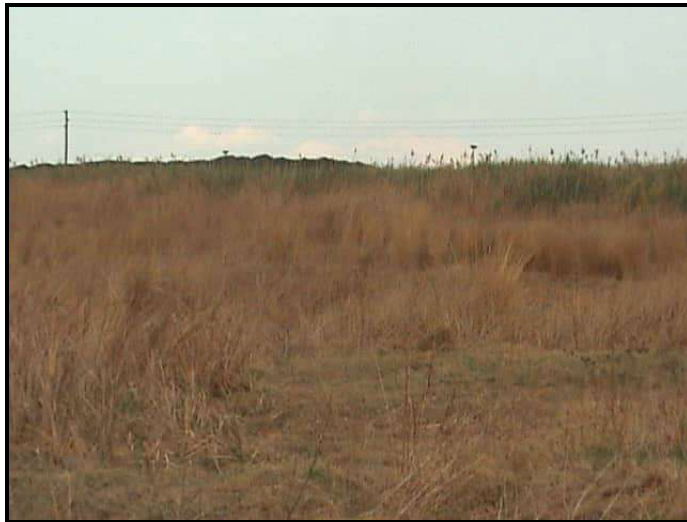
**Figure 39 Reeds SCS(E) PC dam wall**

An increase in conductivity was noted during the low flow survey in this area. Reeds were also growing in places below the pollution control dam as shown in Figure 39, indicating possible seepage. The conductivity in the pollution control dam was high (12,200  $\mu\text{S}/\text{cm}$ ). It was thus decided to investigate the entire area by testpitting.

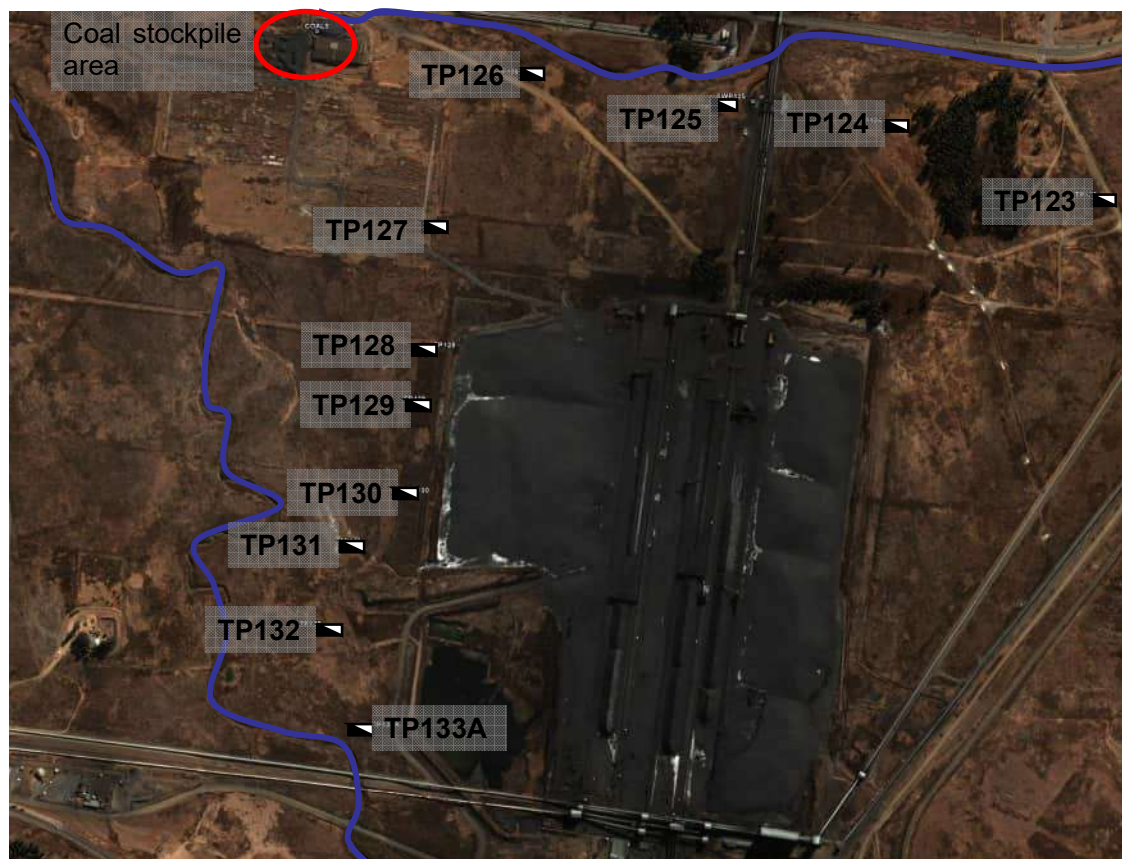
**Figure 40 Testpits around SCS(E)**

The northern line of testpits indicated on Figure 40 are relevant to this area, i.e. TP123 to TP126. Of note is the moderate rate of seepage measured in TP125 at a conductivity of 2,238  $\mu\text{S}/\text{cm}$ . This testpit was situated next to the conveyor belt, reasonably close to the area where water was seen ponding under the conveyor belt. The seepage was noted in the residual Siltstone layer.

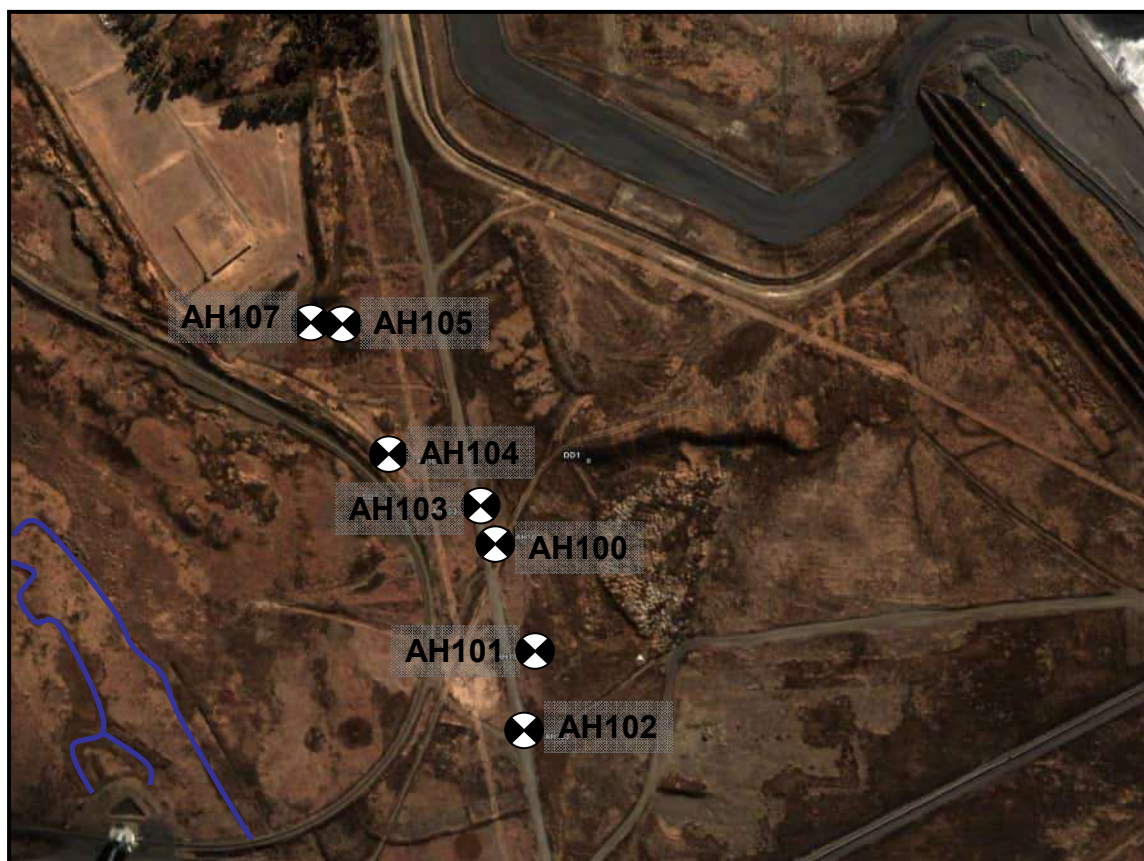
**Figure 43 Auger holes around Twistdraai Export plant Load out Silo and Discard dump**
