# **HERITAGE IMPACT ASSESSMENT: PROPOSED IGOLIDE WEF 132KV GRID CONNECTION, POTSHEFSTROOM MAGISTERIAL DISTRICT, GAUTENG PROVINCE**

Required under Section 38(8) of the National Heritage Resources Act (No. 25 of 1999)

SAHRA Case ID: 22864

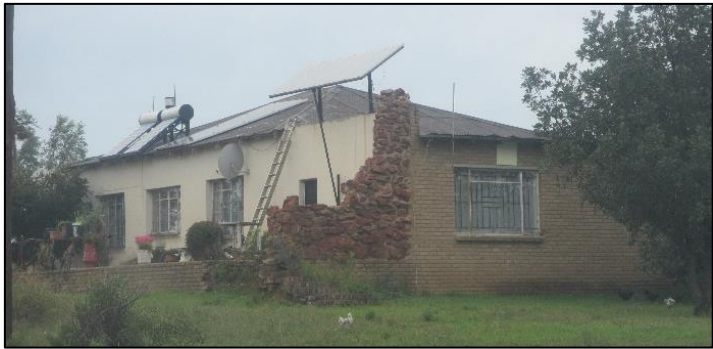
| Waypoint | Location | Description | Significance Grade |
|---|---|---|---|
| 4304 | S26 26 09.4<br>E27 30 43.4 | House that predates 1938. It is likely not much older than that and has no special heritage qualities.<br> | Low<br>--- |

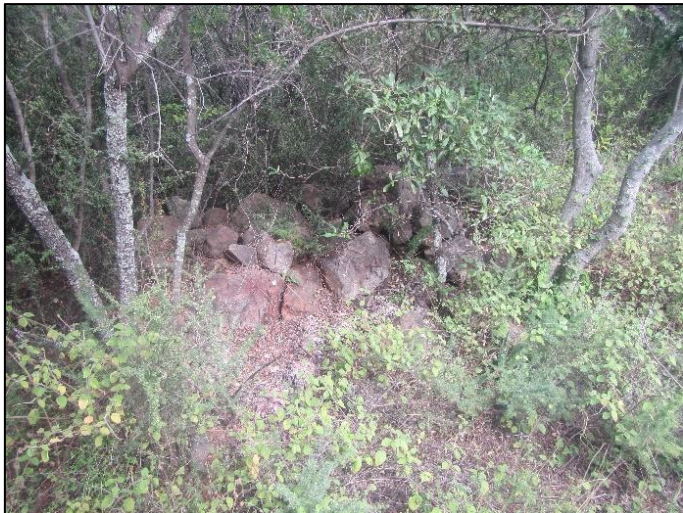
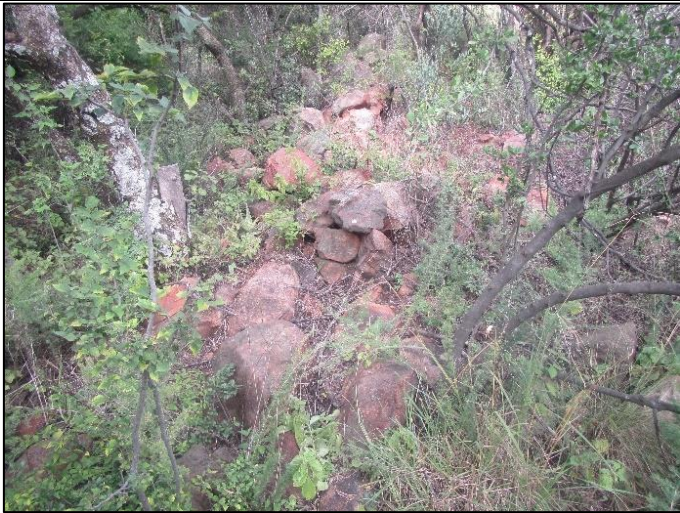
| Waypoint | Location | Description | Significance Grade |
|---|---|---|---|
| 4305 | S26 24 53.7<br>E27 30 26.8 | This is a Late Iron Age stone-walled settlement measuring about 30 m by 90 m and located in a heavily overgrown area at the foot of a steep slope which rises to its west. Due to the very dense bush, it was not possible to determine the extent of the site towards the base of the slope to the west and towards the south. Walling was seen over an area of about 30 m by 90 m though.<br> | Medium<br>GPA |

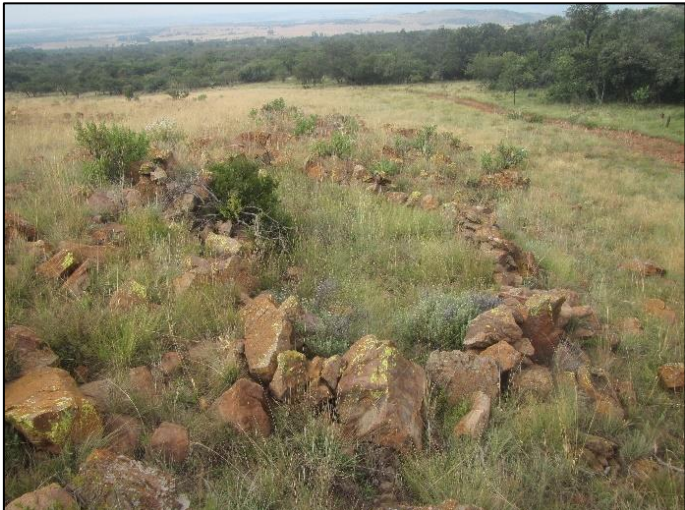
| 4321 | S26 24 59.2<br>E27 30 30.4 | <p>This is a stone-walled enclosure measuring about 3 m by 8 m. It is built on the side of a rocky area 150 m south of the Late Iron Age settlement described above and 75 m south of the long stone wall. Whether it is related to those features is unknown. The walling is about 0.5 m high and no associated artefacts were seen. It is assumed to date to the Late Iron Age.</p> | Low<br>GPB |

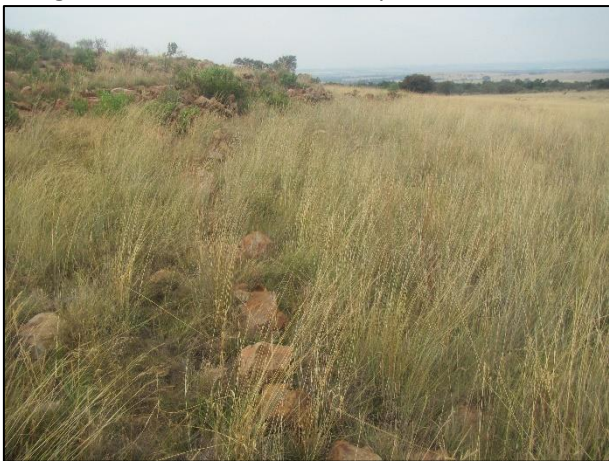
| 4322 | S26 25 15.8<br>E27 30 30.9 | A stone wall similar to that described above. It is about 100 m long and runs across a grassy area towards, and then along, the base of a rock outcrop. | | Low<br>GPB |

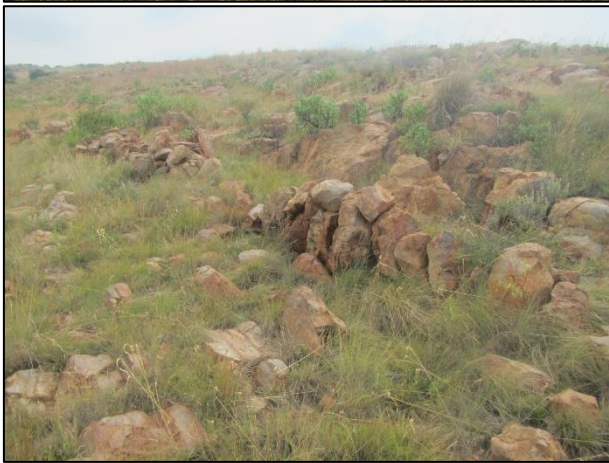
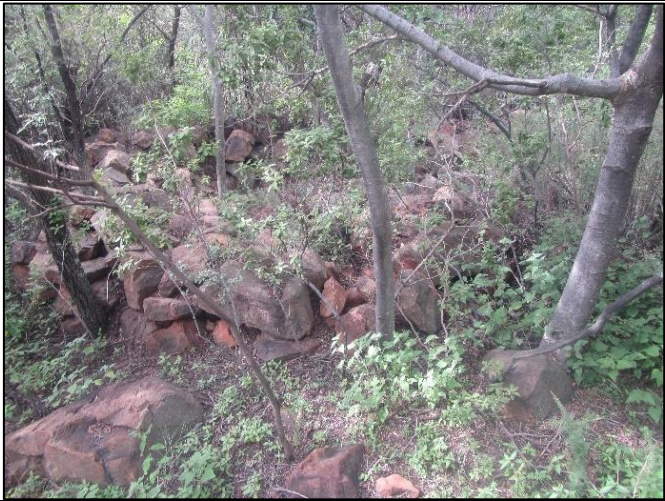
| 4328 | S26 25 38.1<br>E27 30 32.7 | This is a Late Iron Age settlement measuring about 120 m by 150 m and located against the south-eastern side of a rock outcrop. There are many enclosures but only a small area was examined. Much of it was heavily overgrown with bush. The full extent of the site was mapped from modern and historical aerial photography. | | Medium<br>GPA |

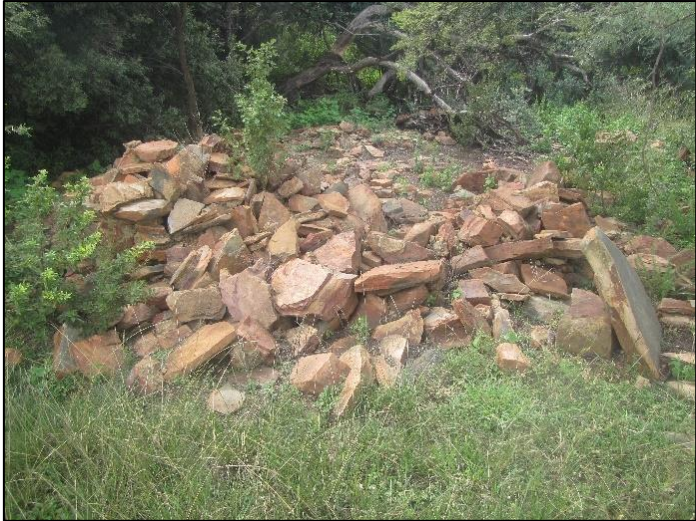
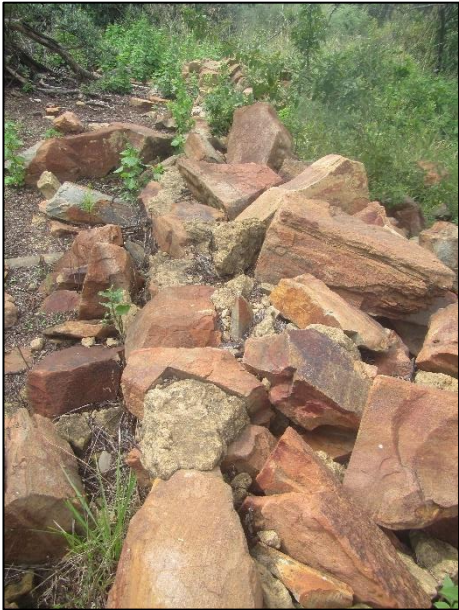
| 4342 | S26 25 28.0<br>E27 30 32.6 | <p>This site is the collapsed remains of a small stone and cement house measuring about 4 m by 7 m. The cement is a weak mix and must be of 20<sup>th</sup> century age. No details besides floor size could be determined. The feature is not visible on the 1938 aerial photography but was likely too small to show up.</p> | Very low<br>GPC |

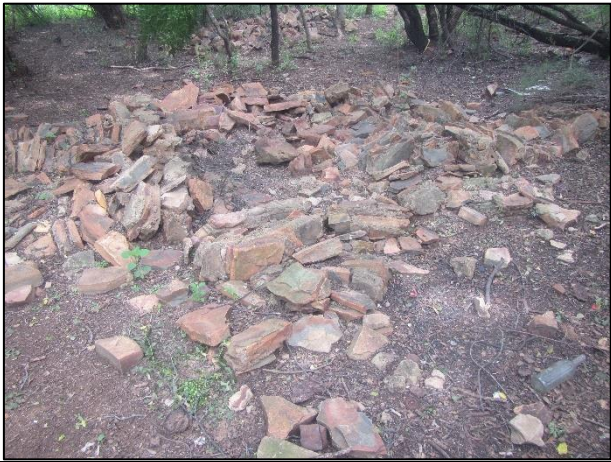
| 4343 | S26 25 26.4<br>E27 30 32.2 | <p>This is the collapsed remains of a small stone and cement structure measuring about 2 m by 2 m. It is 20<sup>th</sup> century in age. Some modern glass and plastic debris was present in the area. The feature is not visible on the 1938 aerial photography but was likely too small to show up.</p> | Very low<br>GPC |

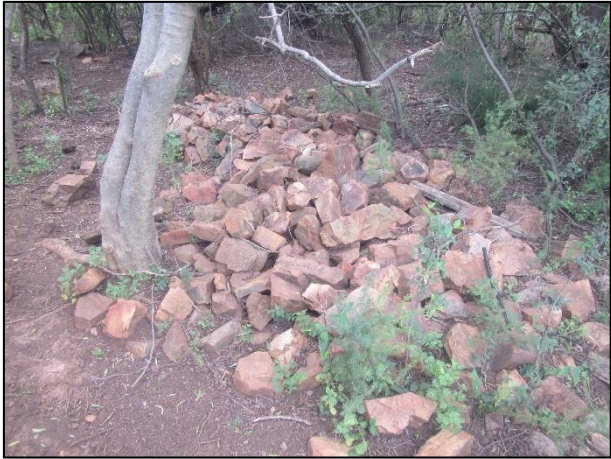
| 4344 | S26 25 26.5<br>E27 30 31.9 | <p>This is a pile of stones located about 6 m west of waypoint 4343. There is no cement so it is not a collapsed structure.</p> | Very low<br>GPC |

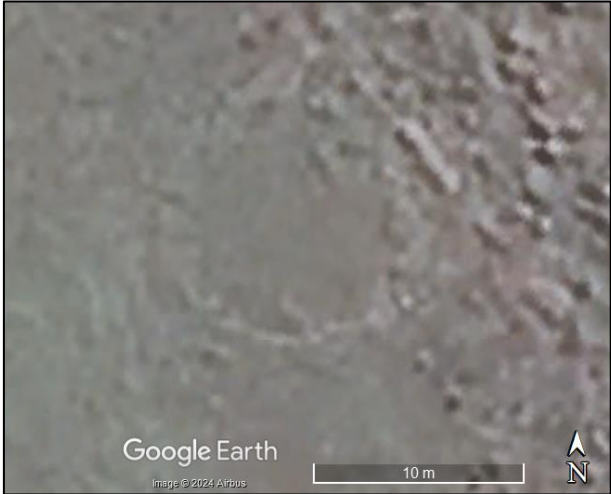
| 4345 | S26°25'14.5"<br>E27°30'30.2" | <p>This site was not seen in the field despite having walked along the adjacent rocky ridge within about 12 m of it. It was seen on aerial photography and identified based on the appearance of other sites. It is a single enclosure about 10 m in diameter.</p> | Low<br>GPB |

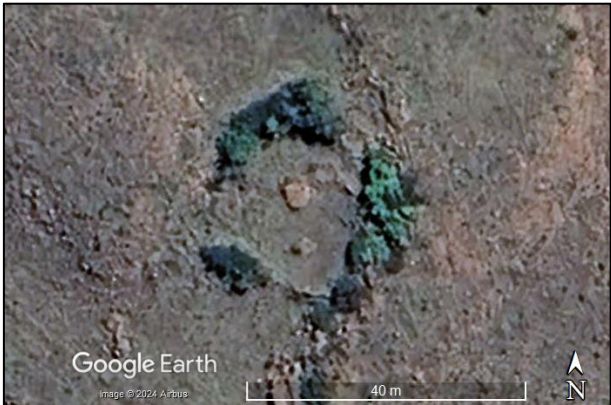
| 4346 | S26°25'27.7"<br>E27°30'11.7" | <p>This site was not seen in the field and is located a short distance outside the study area. It was recorded from aerial photography and added here for precautionary reasons. It is a single stone-walled enclosure measuring about 21 m by 24 m. It is located 50 m northeast of waypoint 4347.</p> | Low<br>GPB |

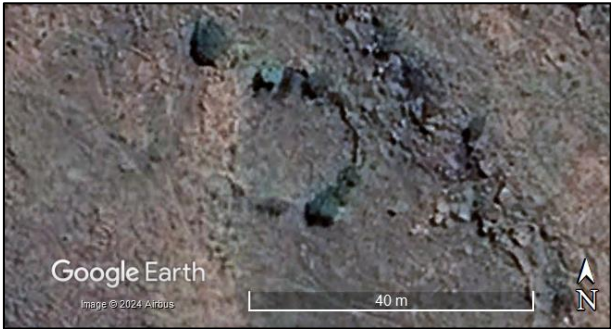
| 4347 | S26°25'29.7"<br>E27°30'10.4" | <p>This site was not seen in the field and is located a short distance outside the study area. It was recorded from aerial photography and added here for precautionary reasons. It is a single stone-walled enclosure measuring about 16 m by 20 m. It is located 50 m southwest of waypoint 4346.</p> | Low<br>GPB |

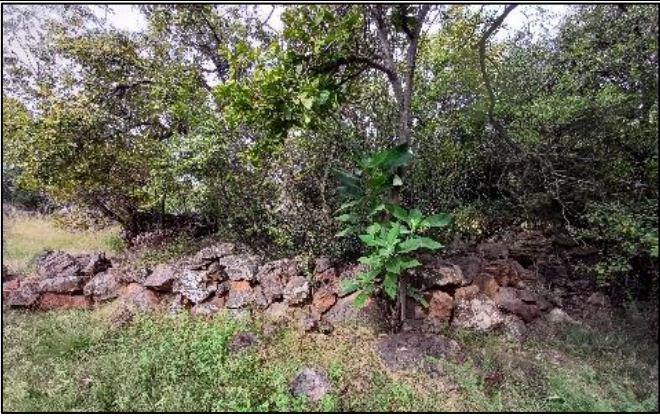
| 1811 | S26 24 55.9<br>E27 29 51.6 | <p>This is a packed stone wall less than 0.5 m high. It was not recorded over its full length since the western end extended far out of the study area. However, the western extent (at waypoint 1811) was mapped from aerial photography.</p> | Low<br>GPB |

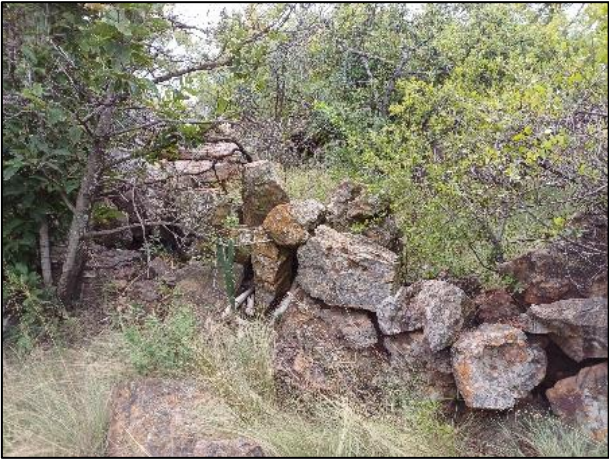
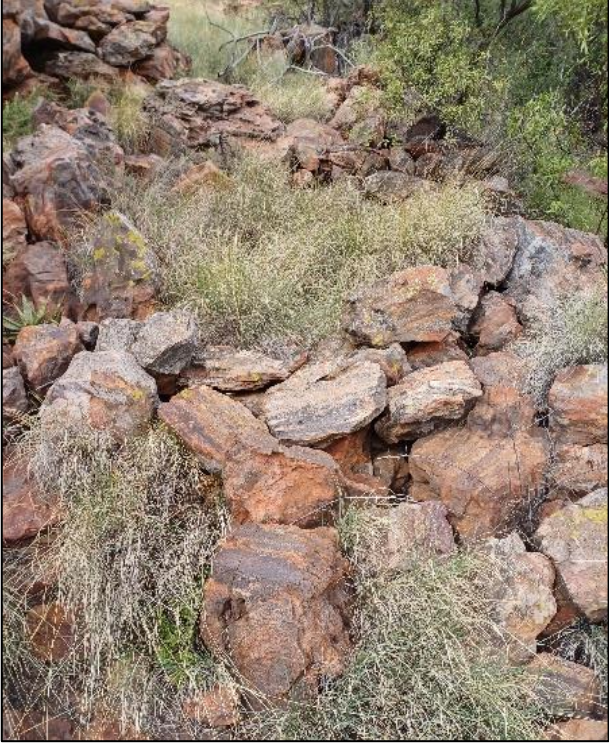
| 1816 | S26 24 53.2<br>E27 30 14.0 | <p>This is a Late Iron Age settlement measuring about 30 m by 60 m near the summit of a hill. Most walling is about 0.5 m high but some extends to about 1 m. The enclosures are in various shapes and include some that are fairly square or rectangular. Some have preserved entrances.</p> | Medium<br>GPA |

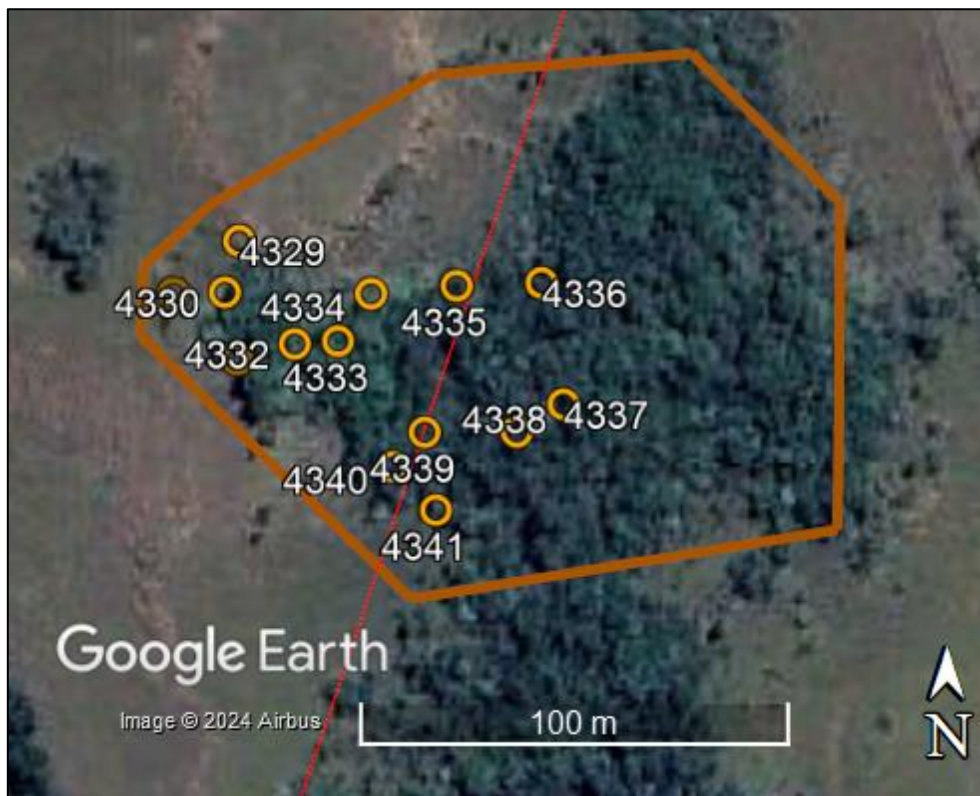
**Figure 16:** Enlargement showing the LIA site at waypoints 4329 to 4341.

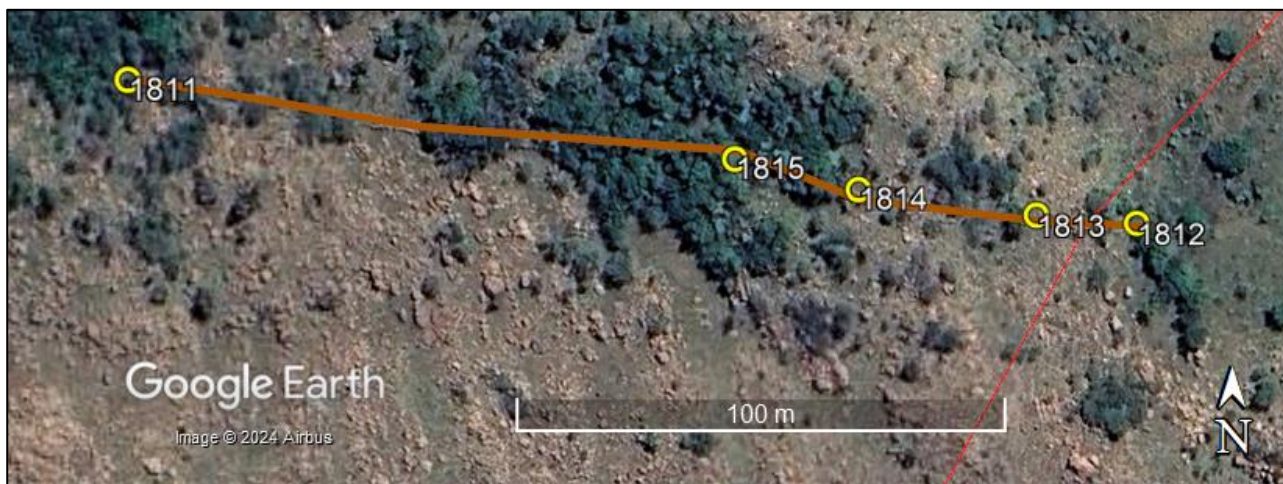
**Figure 20:** Enlargement showing the stone wall at waypoints 1811 to 1815.
