# Appendix G.15

## **SHE RISK ASSESSMENT**

**HIGH LEVEL SAFETY HEALTH AND  
ENVIRONMENTAL RISK ASSESSMENT FOR  
THE DEVELOPMENT OF A BATTERY ENERGY STORAGE  
SYSTEM AT THE PROPOSED ABO UVEMVANE WIND  
ENERGY FACILITY 1, NEAR BALFOUR, IN THE  
MPUMALANGA PROVINCE AND HEIDELBERG IN  
GAUTENG PROVINCE**

**21<sup>st</sup> August 2026**

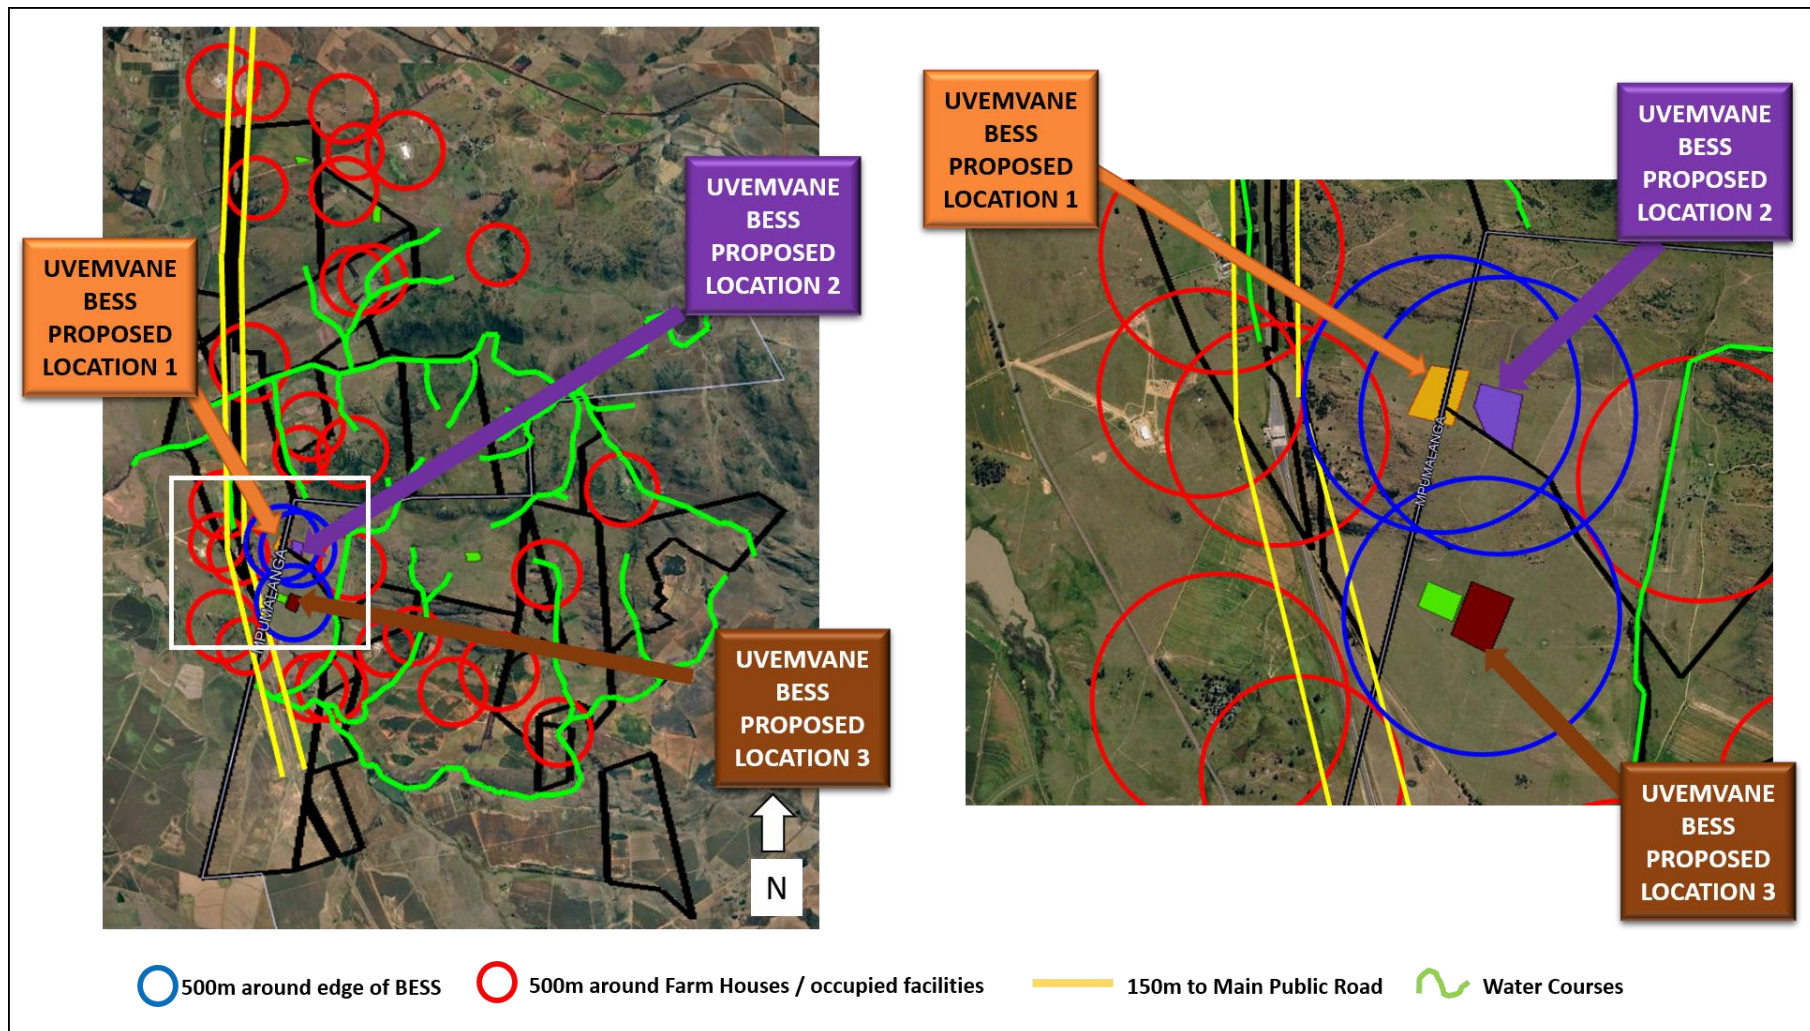
Figure 2.1.3 – 500m circles around the proposed electrical infrastructure hub where the BESS facility would be located within (Blue) and Location of Occupied Facilities (Red) and Nearby Water Courses/Bodies (Green) in the immediate vicinity of the BESS

Figure 2.1.3 shows 500m circles (from the edge of the site) around the proposed BESS Facilities (Blue) as well as local farmsteads/occupied developments with (red 500m circles) main public road (yellow 150m on either side), and near-by water courses/bodies (green).

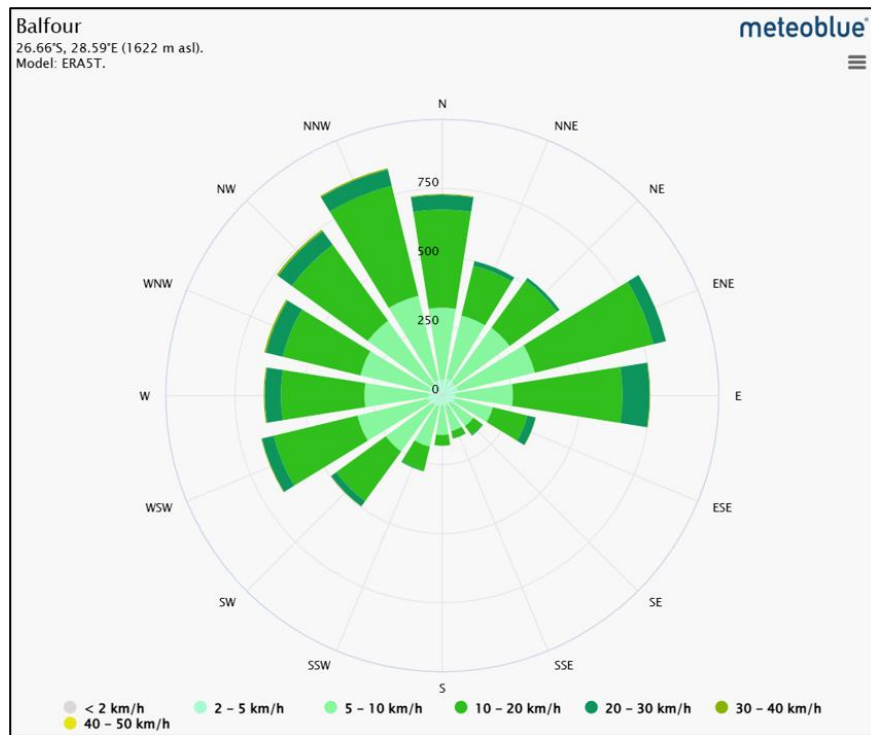
**Figure 2.2.1 Wind rose indicating the typical wind conditions for the Balfour area**

The site is located on the highveld and weather conditions for the closest major town of Balfour, for which only simulated data is available, could be applied for the site. Refer to a wind rose below in Figure 2.2.1 and temperature and precipitation in Figure 2.2.2 (simulated historical climate and weather data from MeteoBlue).

- Winds which blow mostly from the north north west and the east north east.
- Winds very seldom blow from south or south west.
- Moderate temperature conditions in summer during the day.
- Rainfall is in the summer.
- Cold conditions in winter with some precipitation, mostly in the form of frost.
- Temperature inversions, which trap air in a stagnant layer near the earth surface, occur on cold nights and early mornings.
- Day night variations are typically 11 - 15 degrees Celsius.

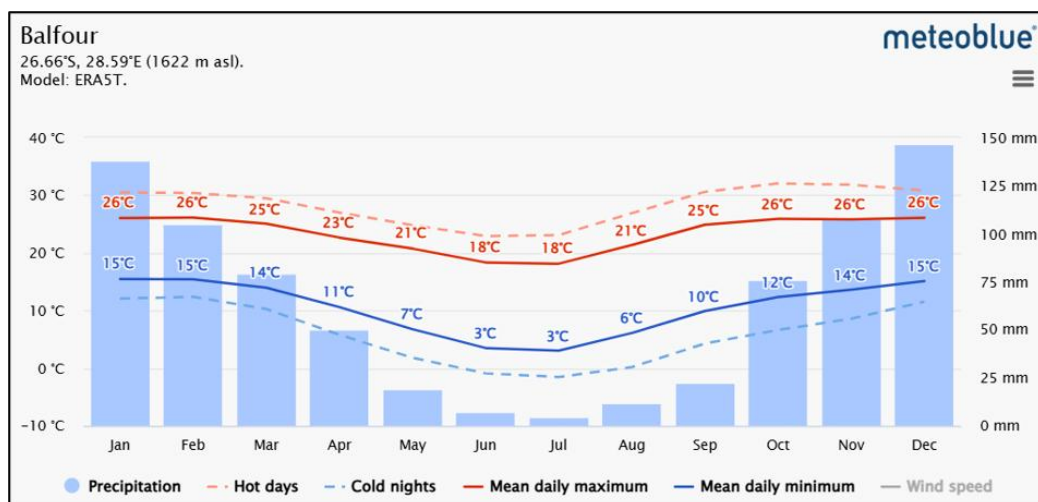
**Figure 2.2.2 Temperatures and Precipitation for the area**

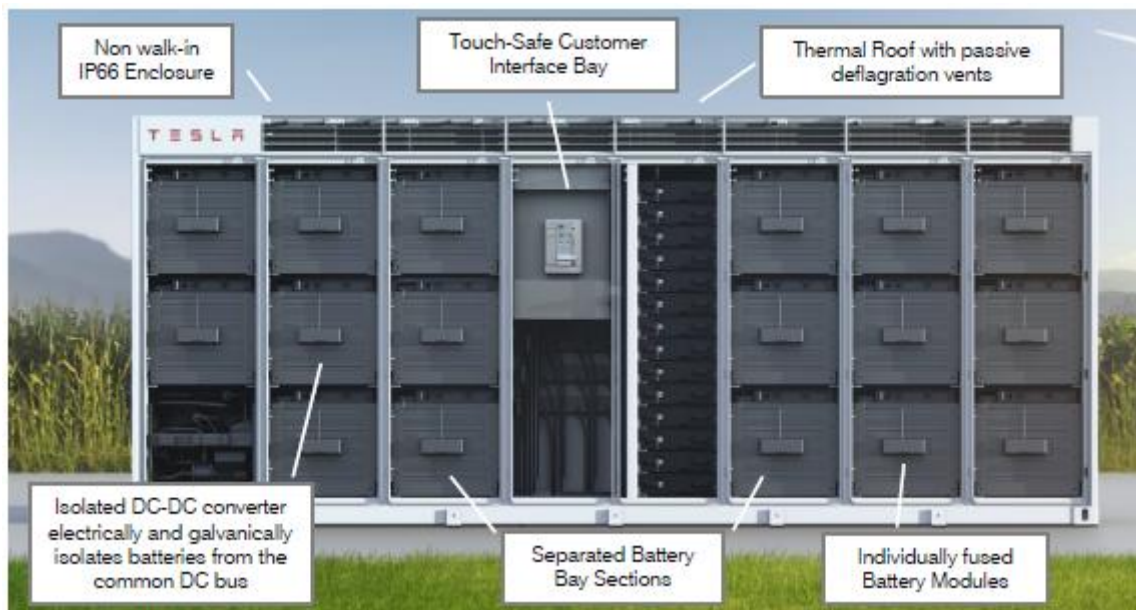
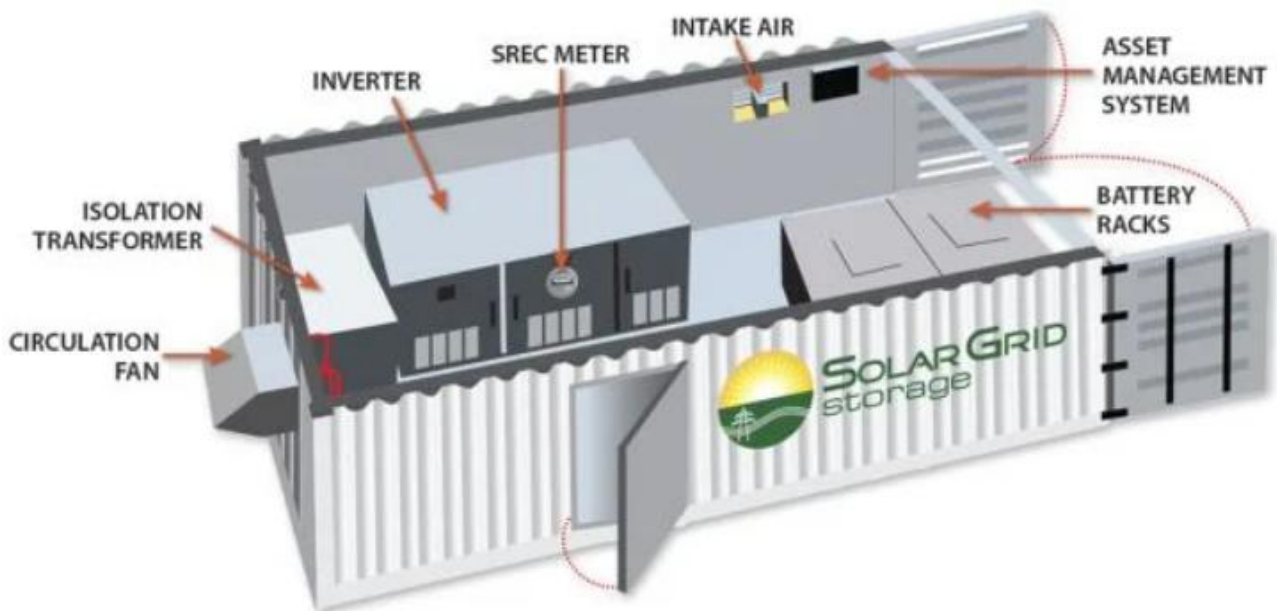
**FIGURE 2.3.1.2 – Typical Battery Modules in a BESS with the Separated Sections**

One type of battery technology being considered for the BESS is Lithium-ion Battery (LIB) which consists of multiple battery cells that are assembled together to form modules. Each cell contains a positive electrode, a negative electrode and an electrolyte which can contain a small amount of liquid/polymer. The BESS will comprise of multiple battery units or modules housed in shipping containers and/or an applicable housing structure which is delivered pre-assembled to the project site. Containers are usually raised slightly off the ground and laid out in rows. They can be stacked if required although this may increase the risk of events in one container spreading to another container. Supplementary infrastructure and equipment may include substations, power cables, transformers, power converters, substation buildings & offices, HV/MV switch gear, inverters and temperature control equipment that may be positioned between the battery containers. The pictures in Figure 2.3.1.1 are typical BESS installations servicing renewable power farms ( in this case depicted as solar but could be wind and arrangement of BESS would be similar). Figures 2.3.1.2 & 2.3.1.3 show typical battery modules in the BESS facility.

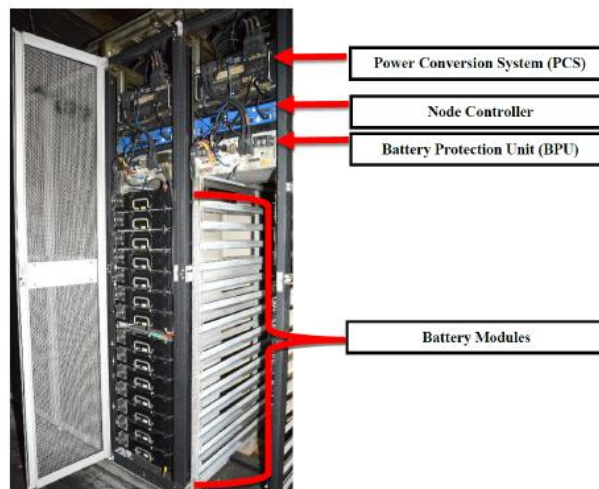
**FIGURE 2.3.1.3 – Typical Battery Modules in a BESS with the Power Conversion Systems in with the Batteries**

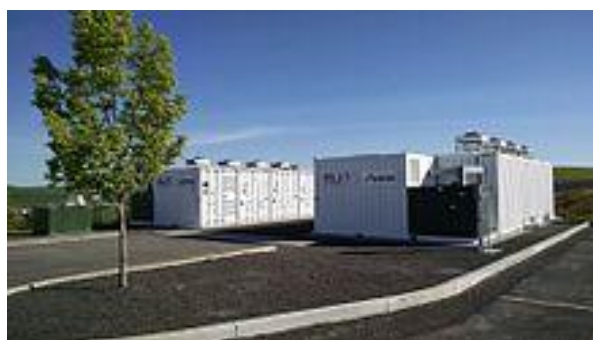
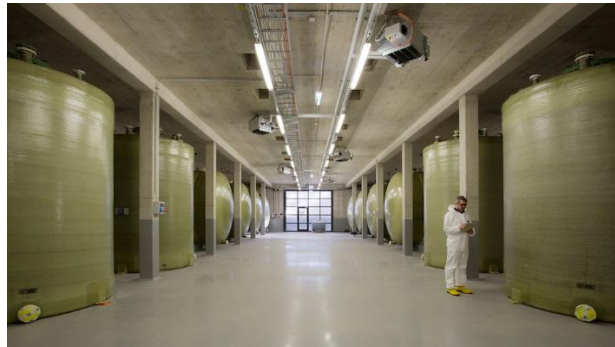
**FIGURE 2.3.2.1 – Images of Some Redox Flow BESS Systems – containerized systems or buildings with tanks of electrolyte and battery systems**

1 MW 4 MWh containerized vanadium flow battery owned by Avista Utilities and manufactured by UniEnergy Technologies

One of the types of battery technology being considered for the Battery Energy Storage System (BESS) would be Redox Flow Batteries, typically Vanadium chemistry based (VRFB). These energy storage systems can be supplied either as containerized units or as a fixed installation within a building etc. For this project containerized units are envisioned. However, in order to present contrasting hazards with the containerized lithium batteries in the section above, this report will discuss redox flow systems housed within a large battery building. If containerized systems are used, the essential hazards remain the same, but may just be slightly smaller in magnitude. The pictures in Figure 2.3.1 are typical Redox Flow BESS installations. For this project (up to 500 MW or 2000MWh) there are expected to be up to 720 containers, each with six 25m<sup>3</sup> tanks of electrolyte within the containers, hence approximately 108000 m<sup>3</sup> of electrolyte in the entire project. Each container acts as bund (secondary containment) able to hold at least the volume of one tank. In addition a bund mound/trench (tertiary containment primarily for any runoff) will be constructed around the entire facility. The pictures in Figure 2.3.2.1&2 are typical Redox Flow BESS installations.

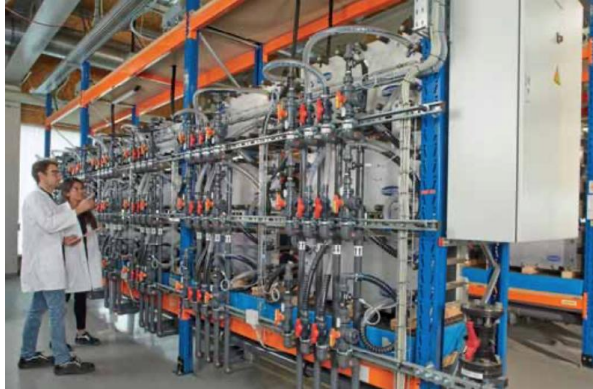
#### FIGURE 2.3.2.2 – Typical Battery Cell and Stack Set-up

Within each unit, battery cells assembled together to form stacks, the image below showing a view of typical stack.

Stacks of a 2MW/20MWh vanadium redox flow battery at Fraunhofer ICT. Image:

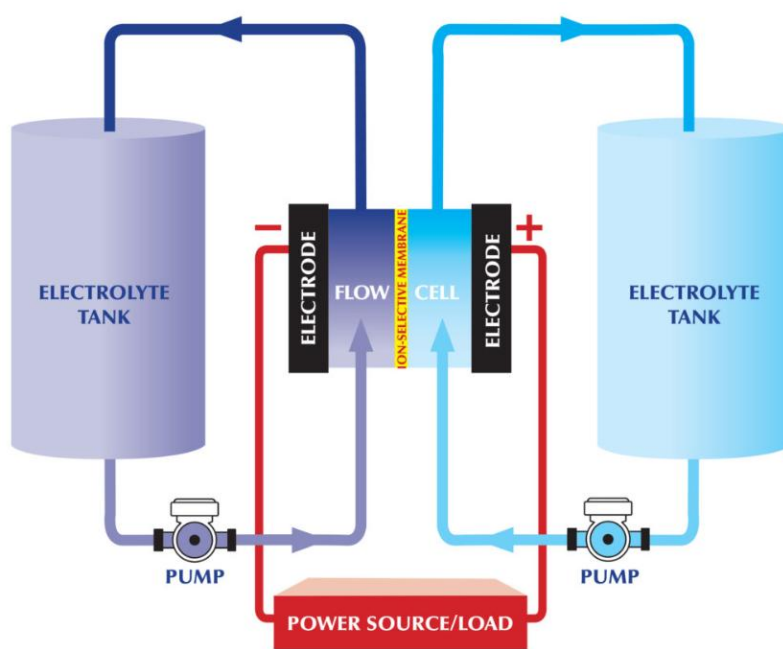
**FIGURE 3.2.1.1 – Schematic Diagrams of Redox Flow BESS**

Figure 3.2.1.1 shows the general operating principle of redox flow batteries. The energy conversion takes place in an electrochemical cell which is divided into two half cells. The half cells are separated from each other by an ion-permeable membrane or separator, so that the liquids of the half cells mix as little as possible. The separator ensures a charge balance between positive and negative half cells, ideally without the negative and positive active materials coming into direct contact with each other. In fact, however, separators are not perfect so some cross-over of the active materials always occurs and this leads to the self-discharge effect.

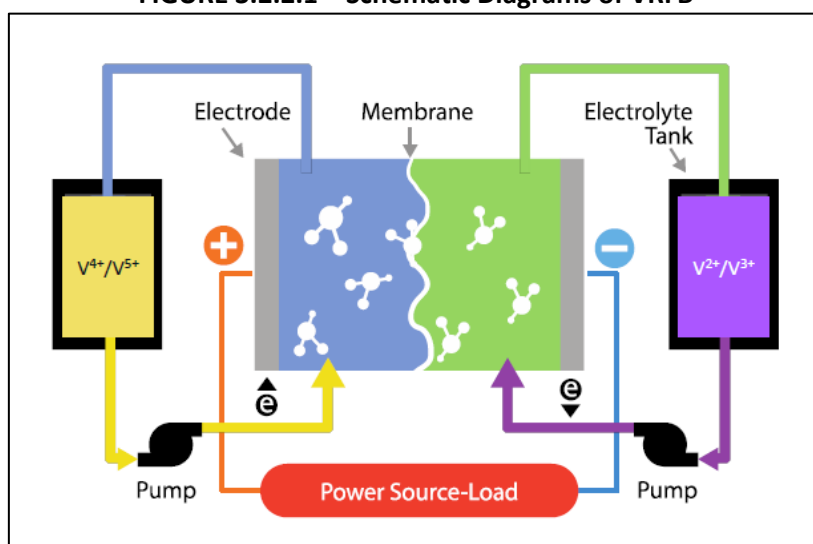
**FIGURE 3.2.2.1 – Schematic Diagrams of VRFB**

The vanadium redox flow battery is without doubt the best investigated and most installed redox flow battery for several reasons, including their relative bulkiness, most vanadium batteries are currently used for grid energy storage, i.e., attached to power plants or electrical grids. Currently, there are over 100 VRFB installations globally with an estimated capacity of over 209,800 kWh of energy and the use of vanadium in energy storage applications has doubled to 2.1% of the global vanadium consumption in 2018.

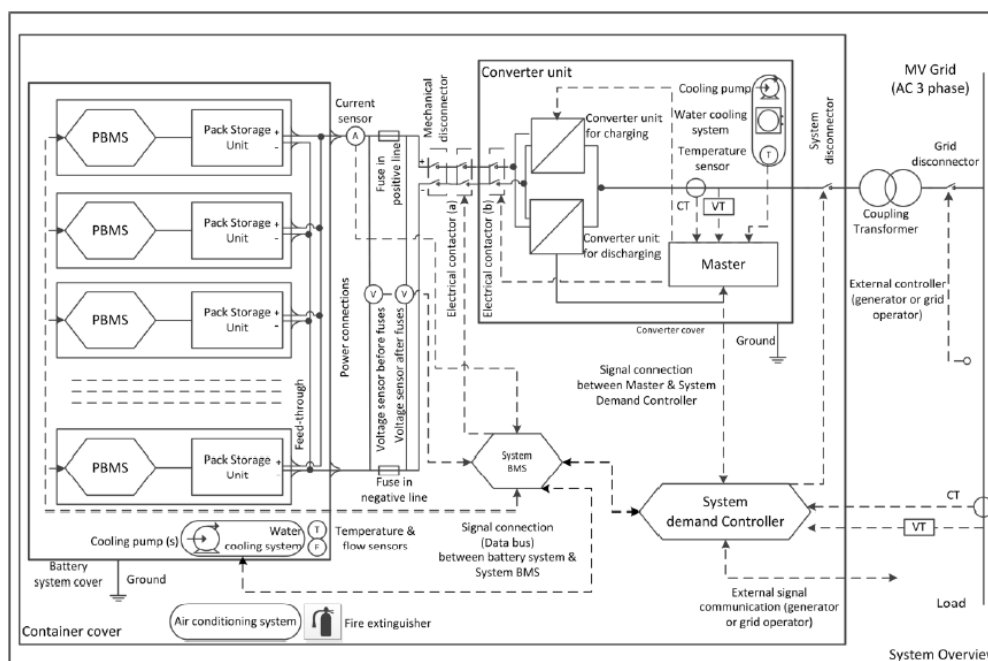
**Figure 3.3.1 – Details of Typical BMS**

The BESS is composed not only of the batteries, but also electrical connections, switches, power converters, cooling systems etc. The diagram below shows a typical complex system for a lithium facility.

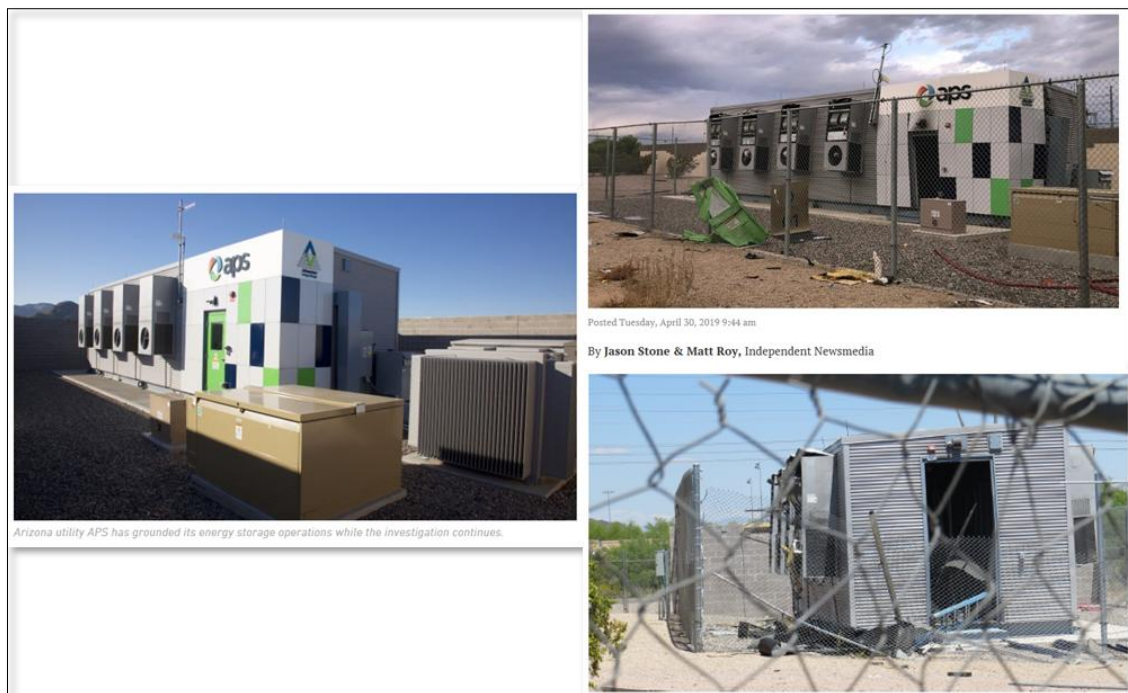
**Figure 3.4.1 – Photo of lithium battery explosion scene**

- Approximately three hours after thermal runaway began, the BESS door was opened by firefighters, agitating the remaining flammable gases, and allowing the gases to make contact with a heat source or spark. This led to the explosion.

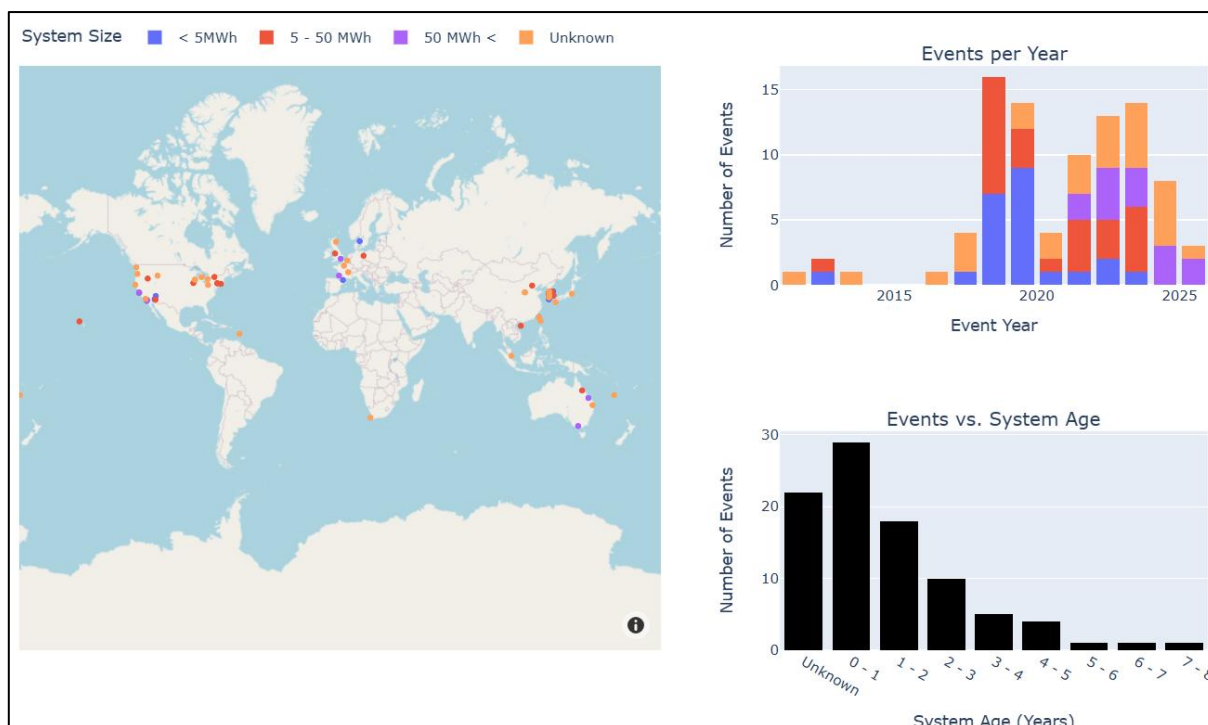
**Table 3.4.2 – Graphs of Battery Accidents**

- The Electric Power Research Institute (EPRI) of California USA maintains a list of Battery released accidents on its Wiki-Storage Page. The EPRI is an independent non-profit energy research, development and deployment organization that is funded by organizations around the world including the energy sector, academia, and governments. The graphs below summarize some of the incidents and the three accidents described in more detail below the table are typical of the types of accidents recorded. A full list of the incidents recorded up till June 2025 is in **APPENDIX B**. This list clearly shows the predominance of lithium-ion battery fires. However, it also shows that usually it is a single container that is damaged, i.e. propagation does not occur.

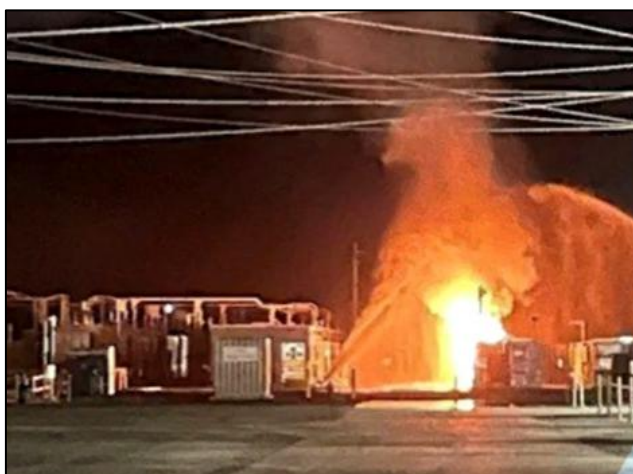
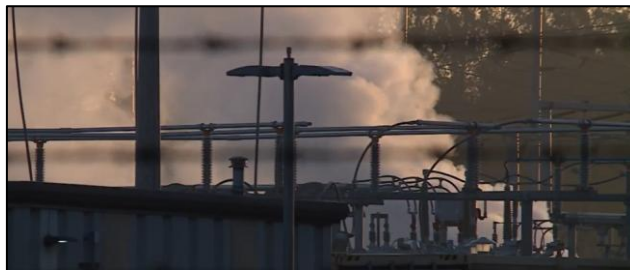
**Figure 3.4.3 – Photo of Tesla Megapack fire scene**

- There have been three incidents at the Moss Landing Power plants battery storage facility in the USA where there are 256 Tesla Mega Packs installed. The latest involved one pack which caught alight and burned out five hours later. Firefighting approach was to let the pack burn out. Near-by communities were warned to shelter-in-place and the adjacent highway shutdown due to possible toxic smoke. Only one mega pack burned out and the fire did not spread.

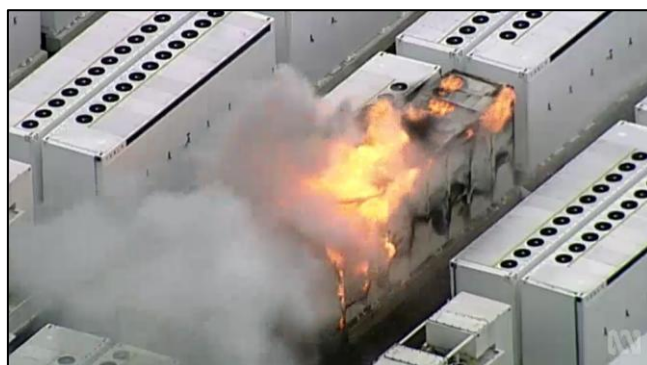
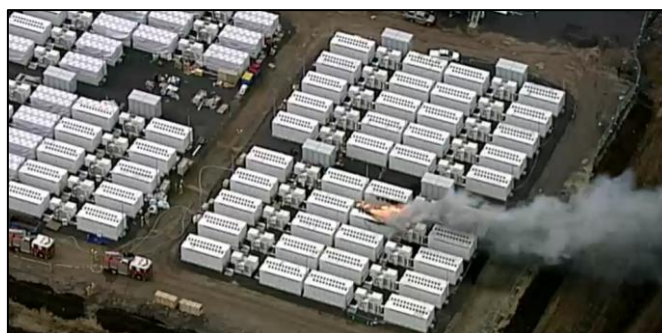
**Figure 3.4.4 – Photo of Tesla Megapack fire scene** - Electric Power Research Institute

- There was a small fire at the new Terra-Gen battery storage facility on Valley Centre Road USA. A small electrical failure produced some smoke which triggered the protection systems. Those worked exactly as planned and the failure was contained to a single battery module (meaning literally a single battery which is about the size of a DVD case). The safety systems worked exactly as planned and in addition the enclosure next to the one with the problem shut down because it also detected the smoke.
- The fire broke out during testing of a 13-tonne Tesla lithium Mega Pack at the Victorian Big Battery site near Geelong, Australia. A 13-tonne lithium battery was engulfed in flames, which then spread to an adjacent battery bank. This event indicates that if the battery pack units are not suitably separated the heat from one fire can set off an adjacent unit.

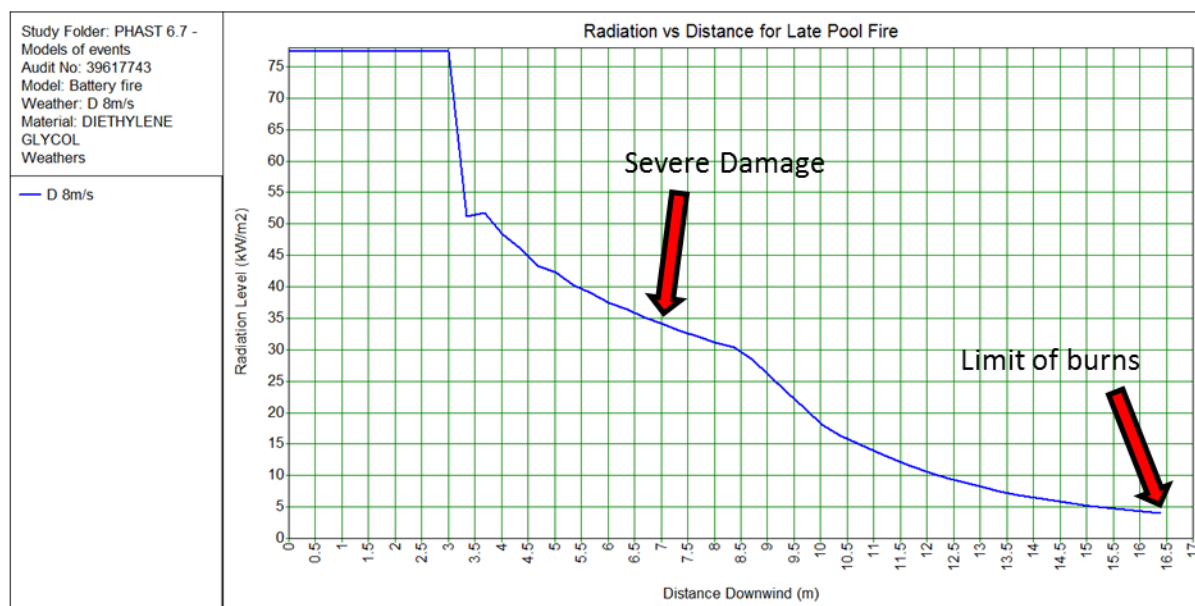
### Approximation of WORST-CASE Radiation Levels from an Entire Container on Fire

PLEASE NOTE – the modelling, especially the noxious smoke modelling, is an approximation.
